## Firefighter Safety and Photovoltaic Installations Research Project

### **Robert Backstrom**

### **David A. Dini, P.E.**

Issue Date: November 29, 2011

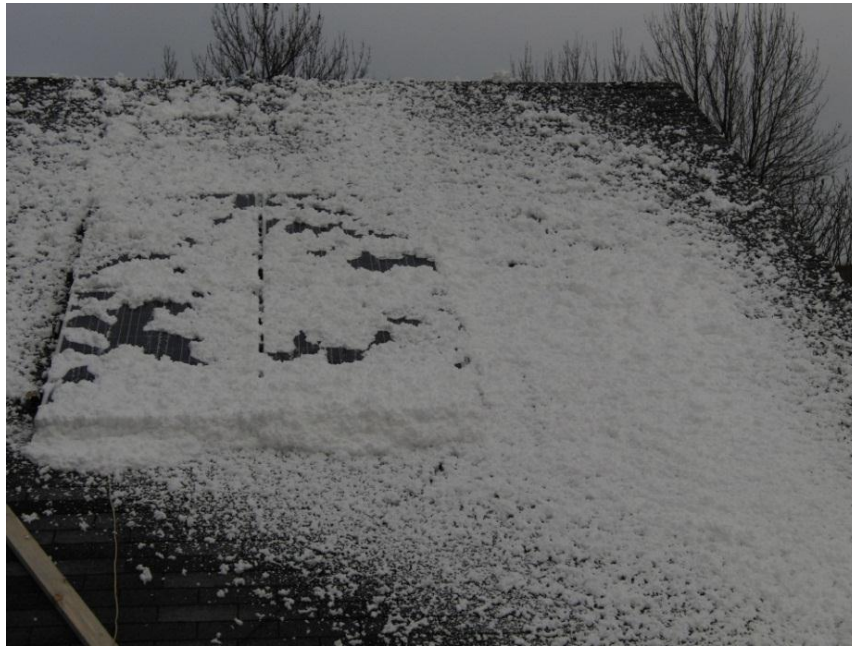
volts. After 10 minutes the voltage on the modules remained at 117 volts, and the voltage on the laminates decreased to 40 volts. The test was stopped after 10 minutes because of increasing clouds and poor sun (solar irradiance of 20 W/m<sup>2</sup>). Because of the clouds and limited sun, short circuit current measurements could not be made. It was noted that after 10 minutes the foam was still adhering well to the laminates, but gaps began to appear on the modules exposing glass surface. It was the consensus of those witnessing this experiment that this Class A foam was generally ineffective in blocking what little illumination the sun was providing that day. Figure 46 illustrates the CAFS foam layer deterioration.

**Figure 46** - After 10 minutes, gaps appearing in foam over modules

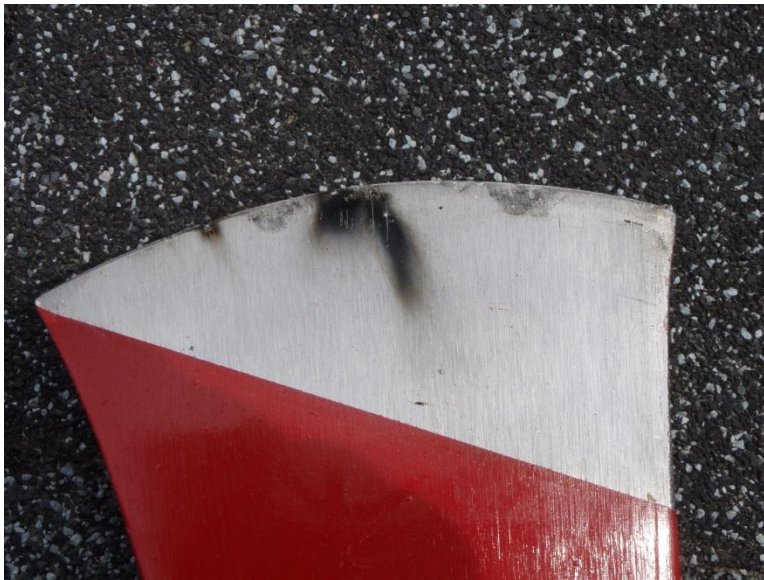
For the second test, this first test was repeated, but with making a fast blow through the wire with the cutters. This produced a current in the circuit of 1.5 A for about 40 milliseconds, and the current reduced to zero by 50 milliseconds. Figure 52 illustrates damage to axe after severing a live conductor.

Figure 52 Carbon deposit from arcing on axe blade after severing conductor

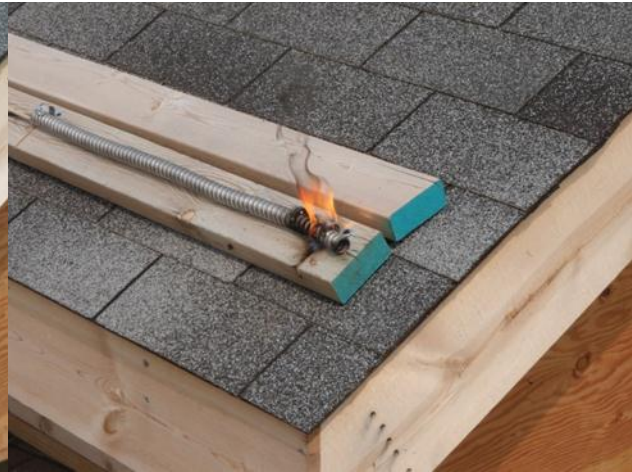
**Figure 57 Open flame from arcing**

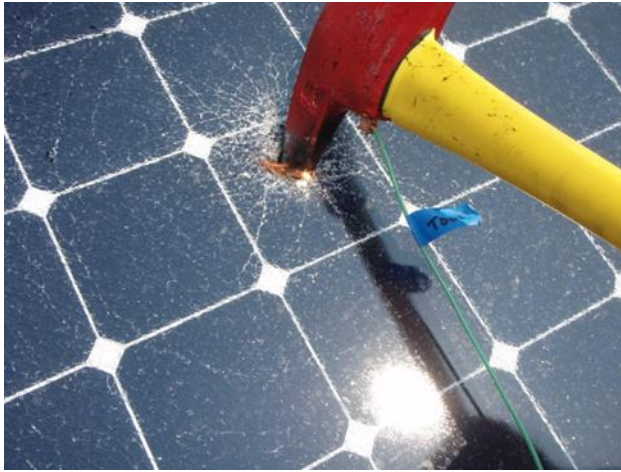
For this experiment, the poke end of the axe was used to penetrate the glass front of a PV framed module with a striking blow. This produced arcing and flame, as the grounded metal axe blade was making contact with the ungrounded (positive) energized metal parts below the glass. Figure 63 and Figure 64 illustrate arcing / ignition and damage to the PV module after being struck by the axe pick.

Figure 63 Arcing and flames from axe damage

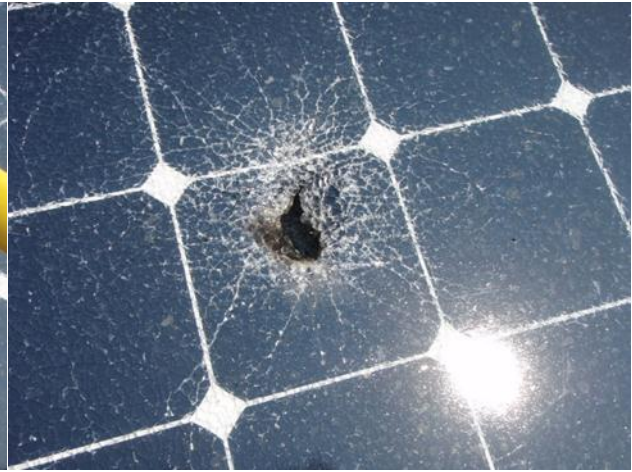
Figure 64 Resulting hole in module glass

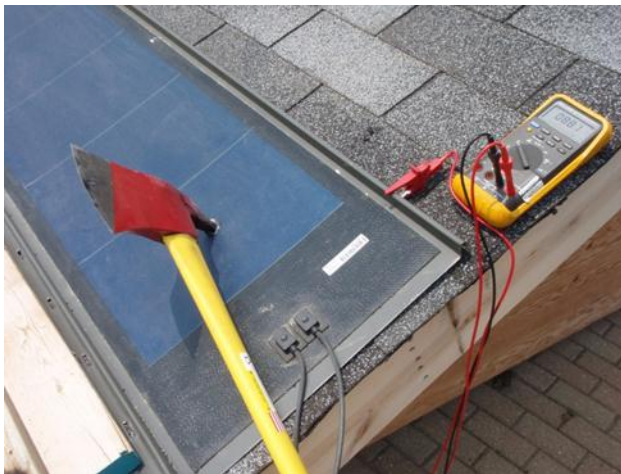
For this experiment, the poke end of the axe was used to strike the front of a PV laminate mounted to a metal pan. The striking blow was such that the axe pike penetrated both the PV laminate and the metal pan material. This caused the metal pan to become energized at the positive potential of the array. To further demonstrate the hazard here, a metal Halligan tool was inserted into the near-by earth ground. A voltmeter was then placed between the metal pan and the Halligan tool. A potential of 883 volts was measured on the meter. Figure 65 and Figure 66 illustrate the configuration of the axe and Halligan tool during the experiment.

Figure 65 Axe penetrates laminate

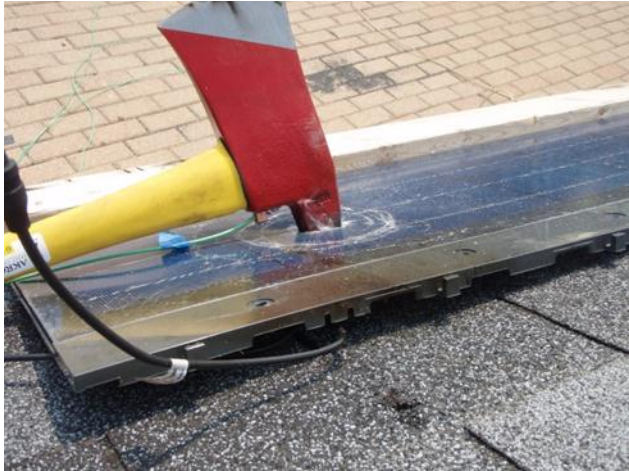
For this experiment, the poke end of the axe was used to strike the front of a PV shingle. This produced arcing and flame, as the grounded metal axe blade was making contact with the ungrounded (positive) energized metal parts within the shingle. This damage became even more evident when a Halligan tool was used to pry the shingle off the roof, and the arcing underneath was exposed. Figure 68 and Figure 69 illustrates damage to the roofing shingle sample and subsequent arcing and ignition.

Figure 68 Axe pike damages PV shingle

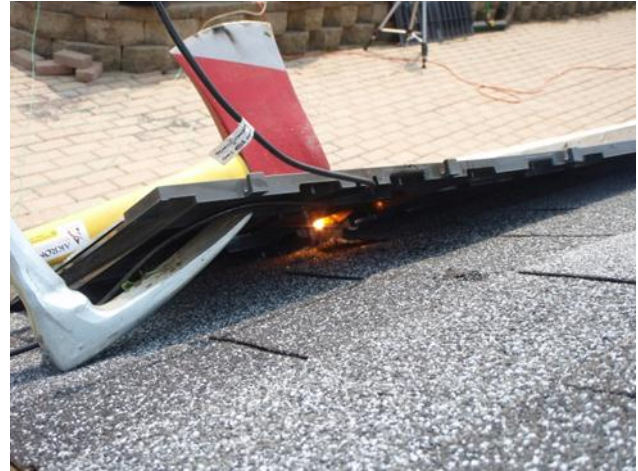
Figure 69 Resulting arcing and flame

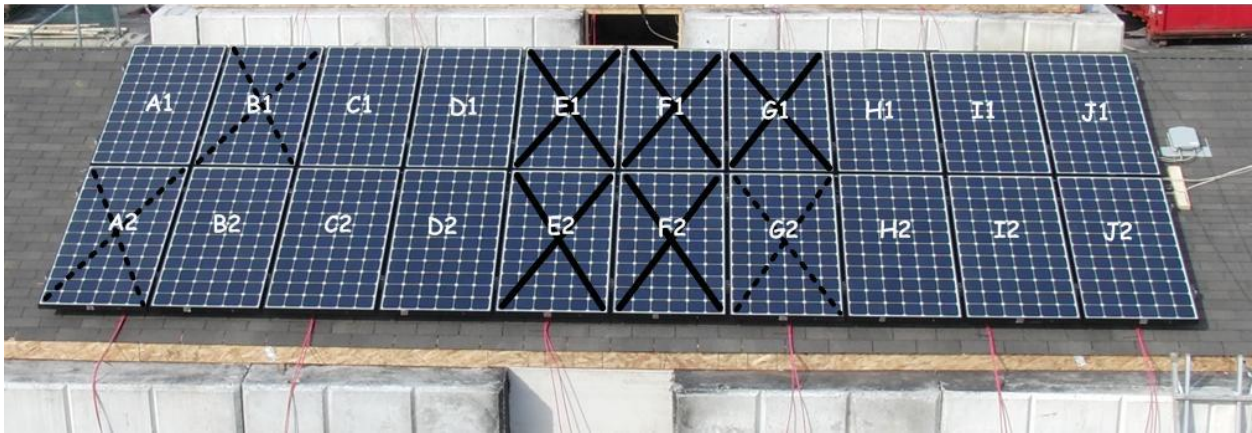
Figure 112 Roof diagram after fire: X = no power, dashed-X = partial power

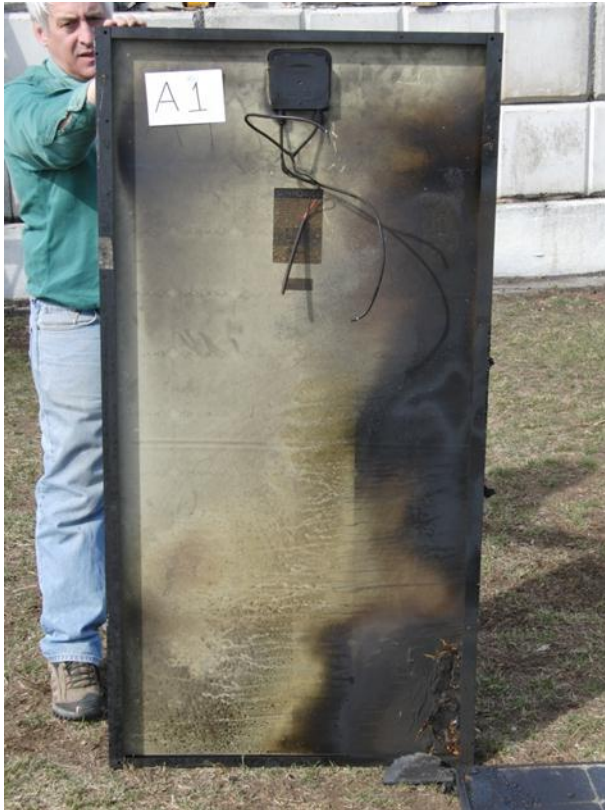
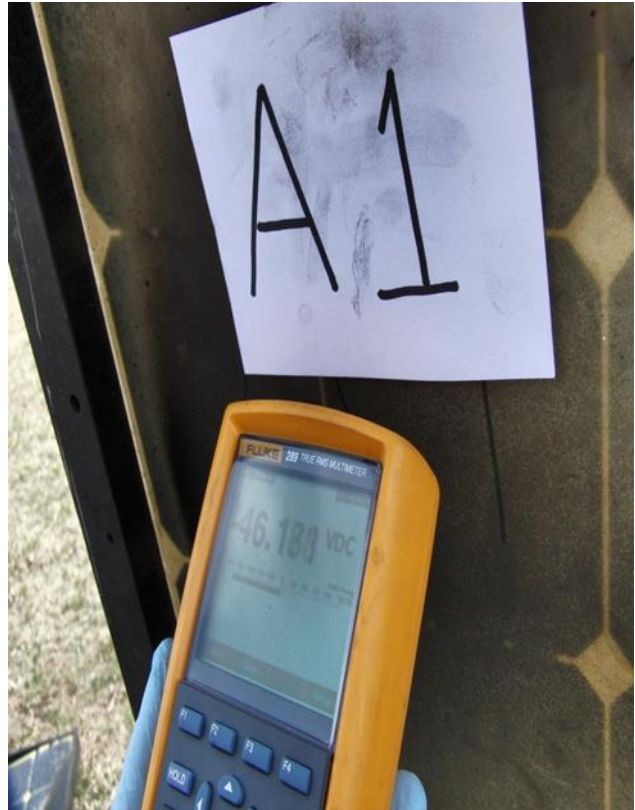
**Figure 115 Module A1 – damaged but functional and producing full voltage**

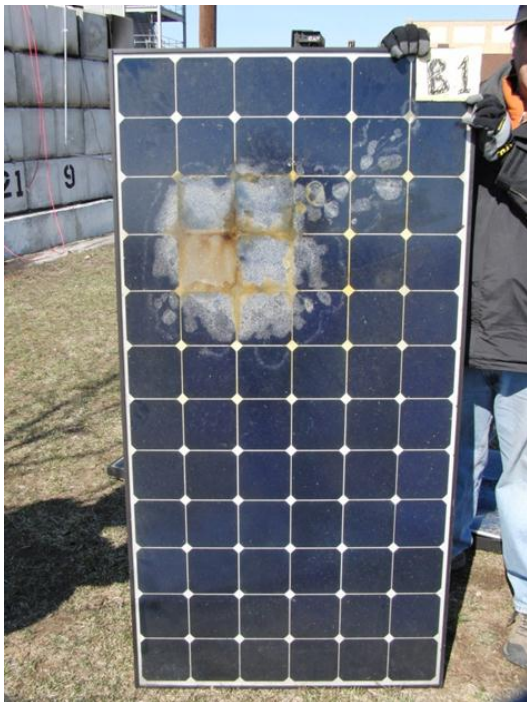
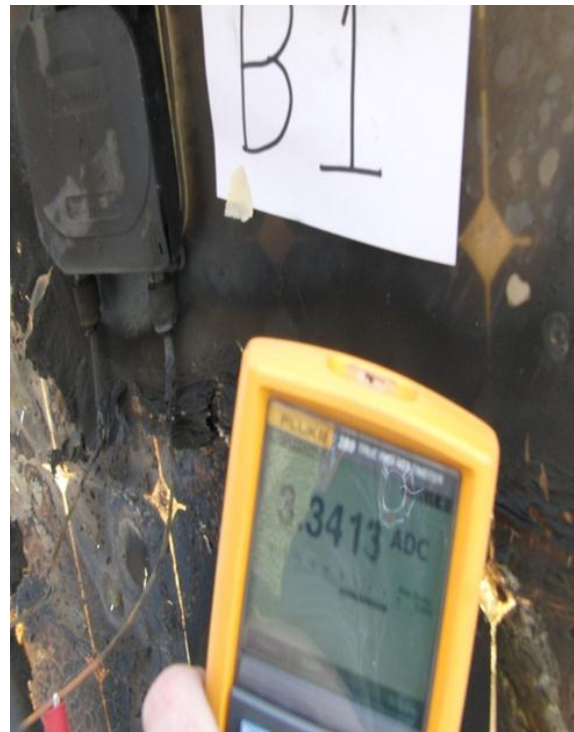
**Figure 116 Module B1 – damaged but still producing over 3 amperes**

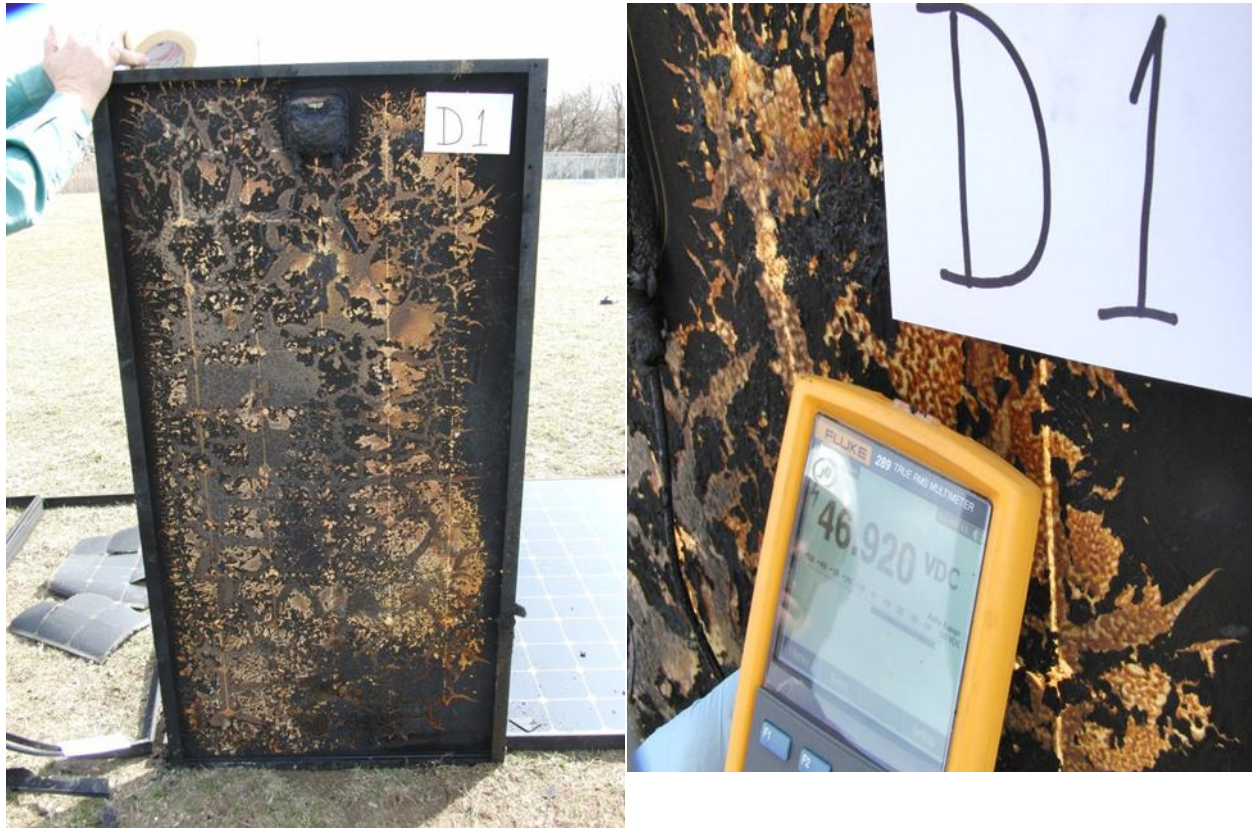
**Figure 117 - Module D1 – badly burnt on backside, but functional and producing full voltage**

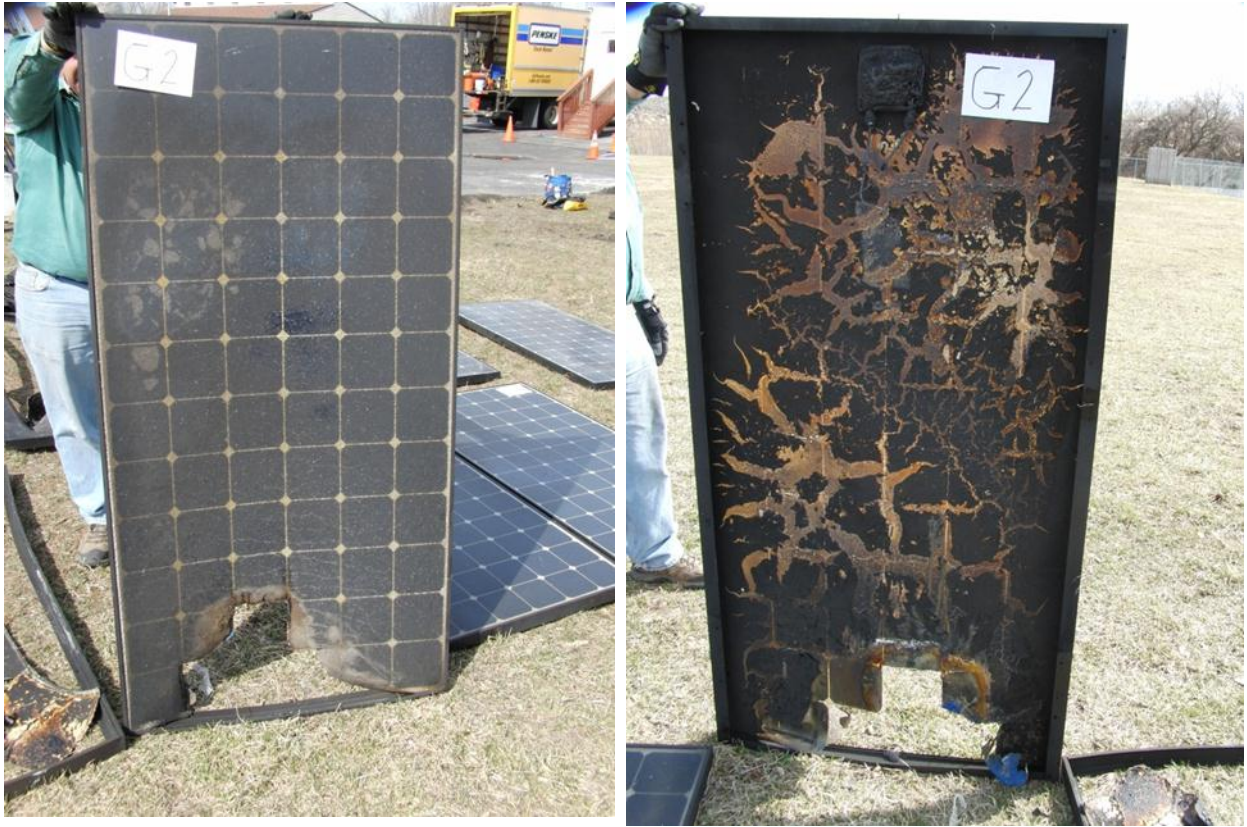
**Figure 118 Module G2 – bottom portion of module glass and cells destroyed**

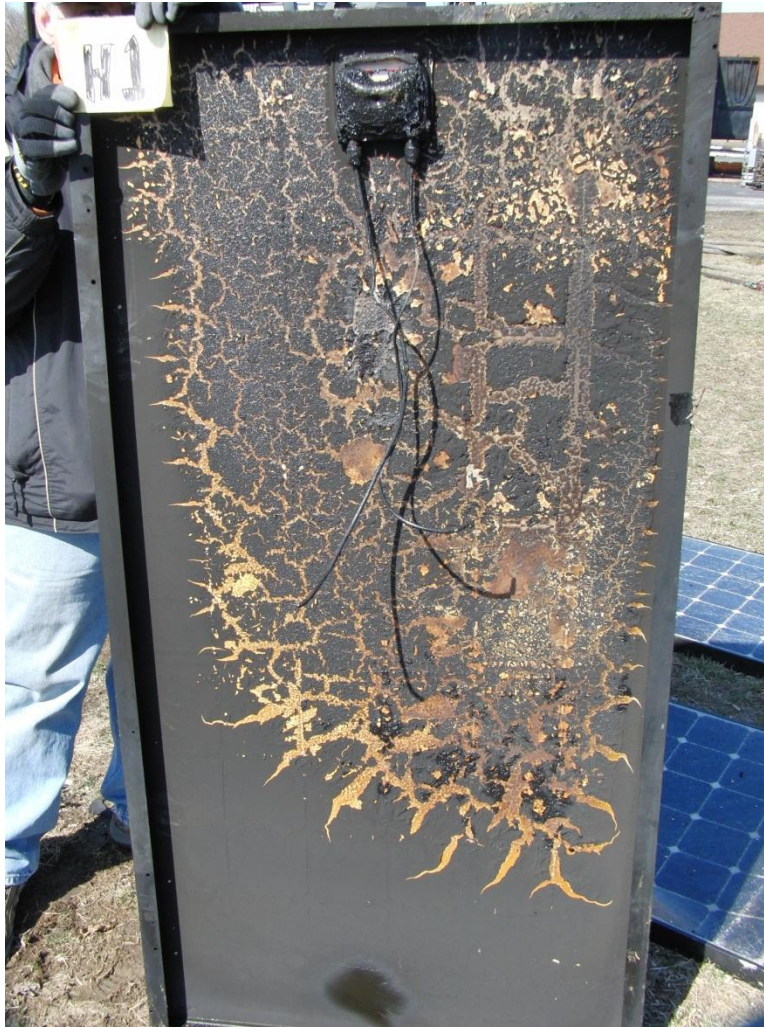
**Figure 120 Module H1 – junction box burned, but still fully operational**

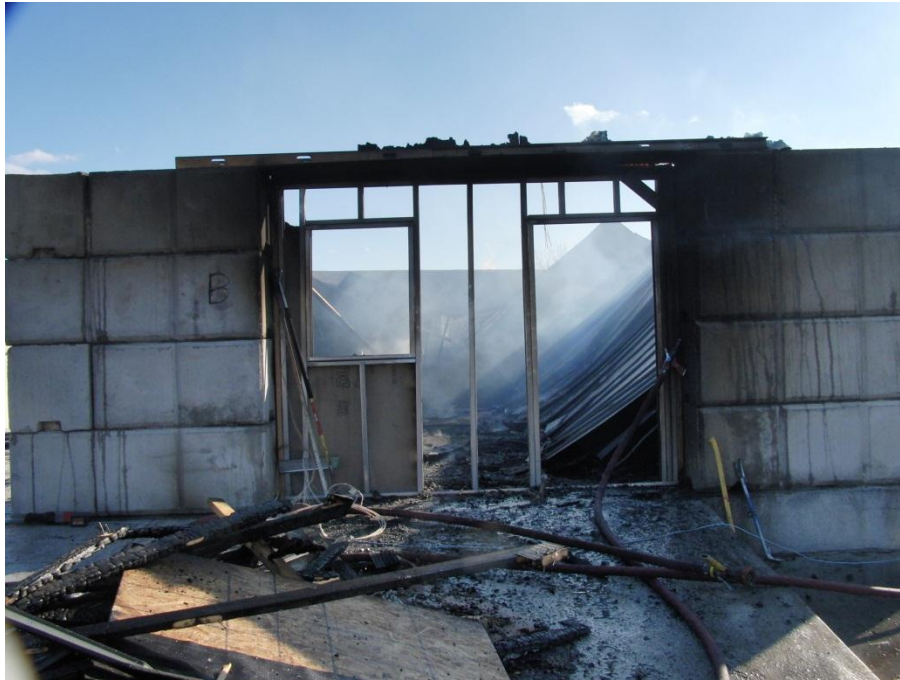
**Figure 127 Collapsed roof and laminates**

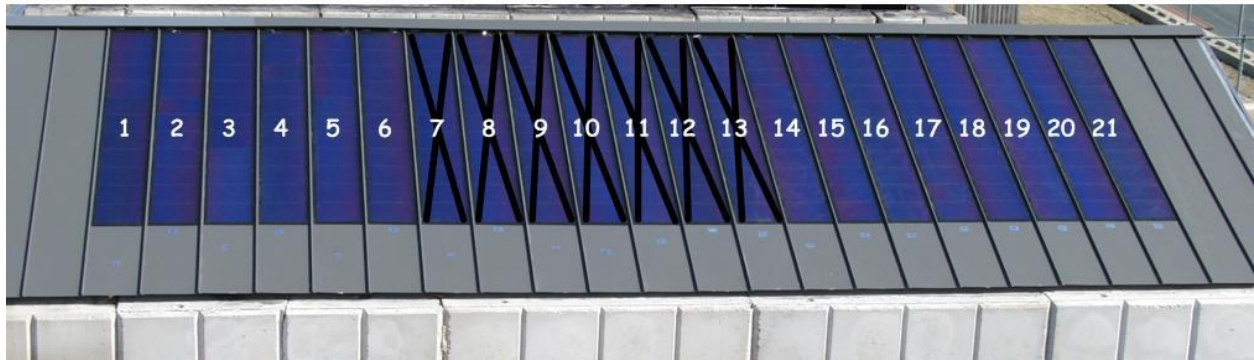
Figure 135 Roof diagram after fire: X = no power

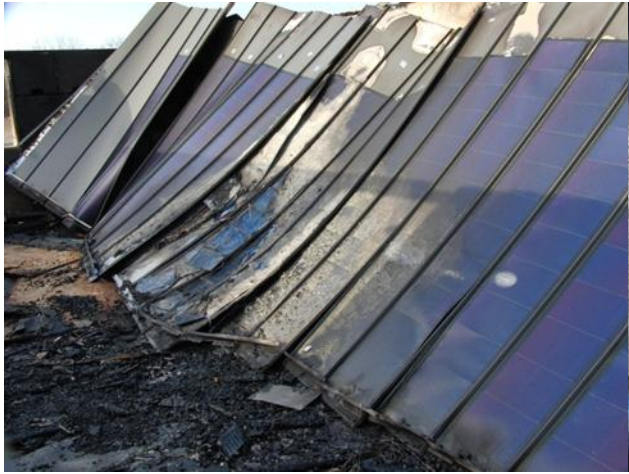
Figure 136 Collapsed and damaged laminates

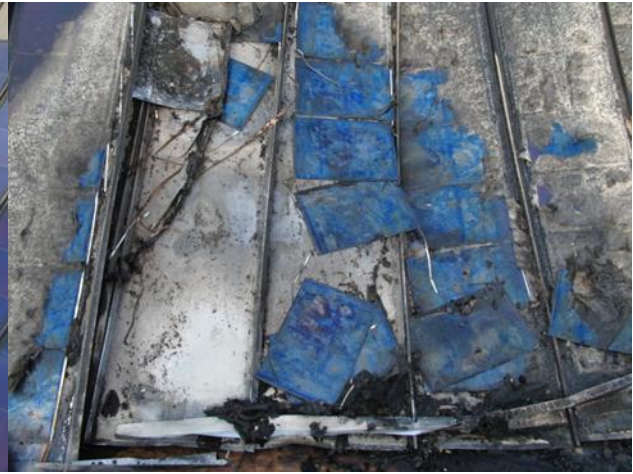
Figure 137 Exposed bare lead wires

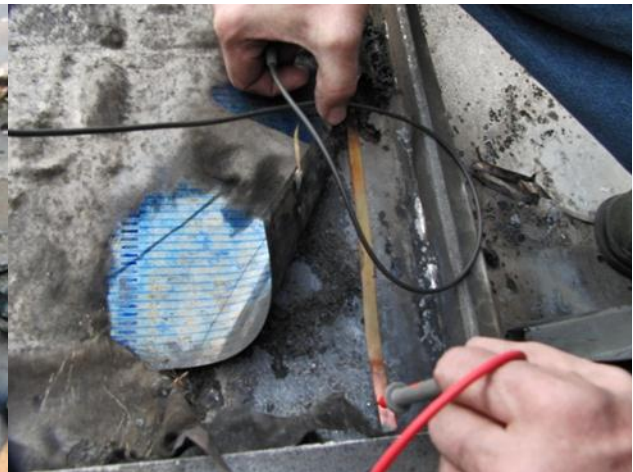
Figure 139 - Exposed bare live bus

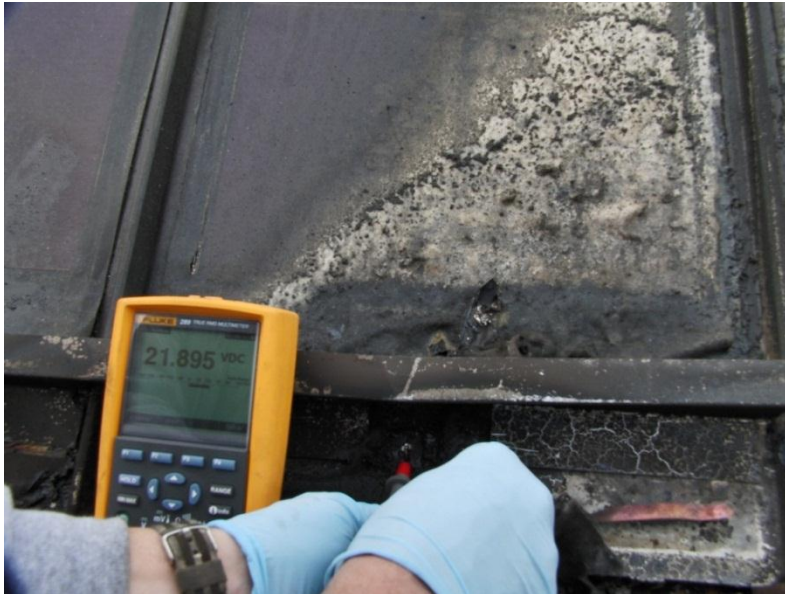
**Figure 140 Full voltage measured at damaged laminate**

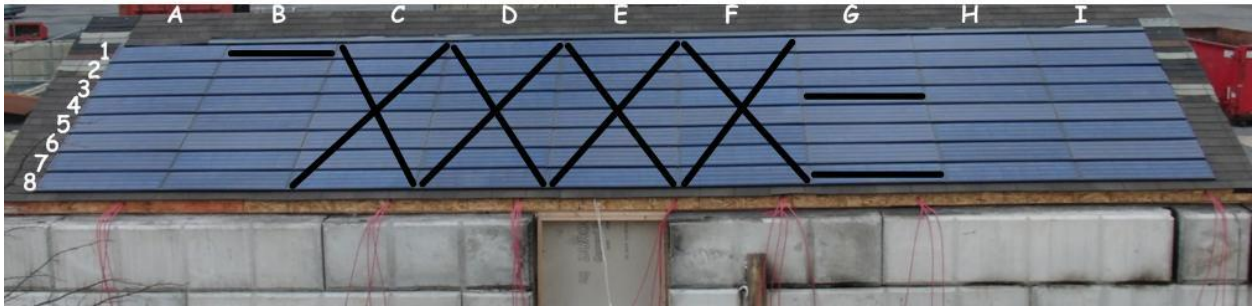
Figure 155 Roof diagram after fire test: "X" or "-" represents no power

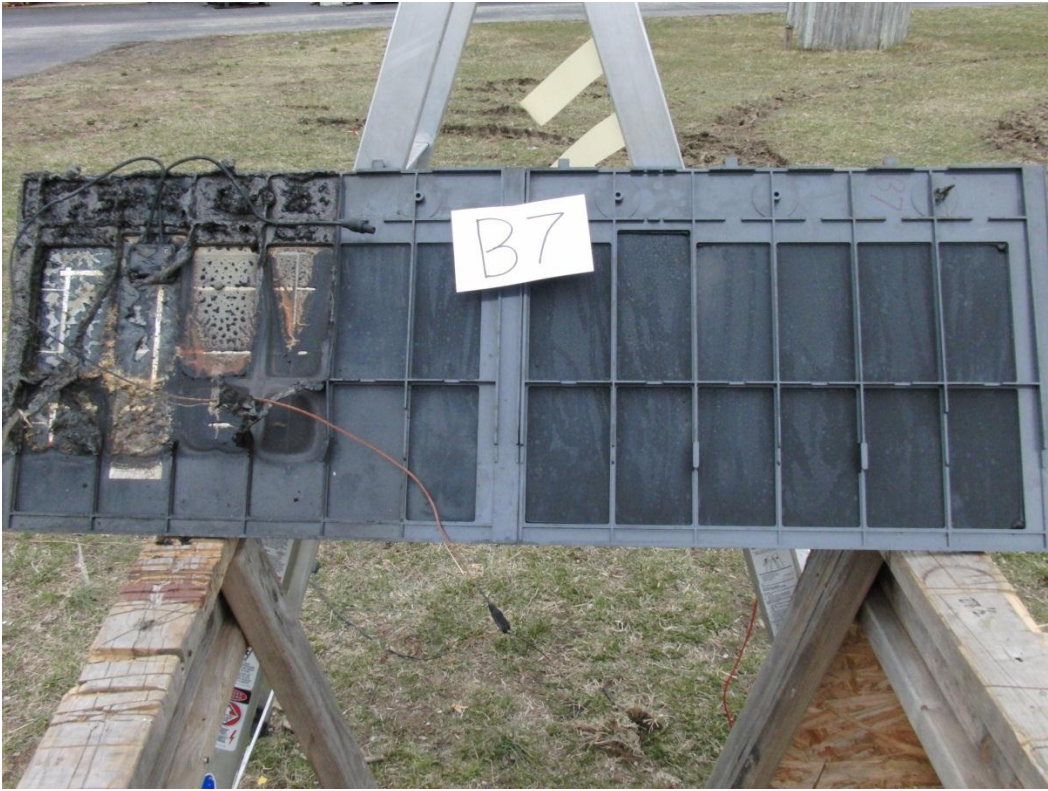
**Figure 159 Shingle B7 with exposed lead conductor**

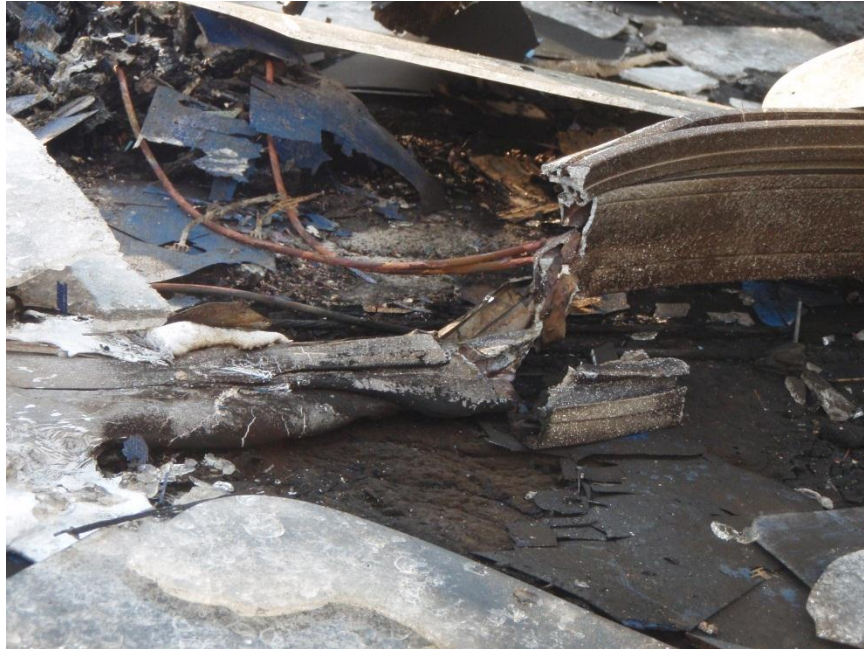
**Figure 183 Bare energized conductors contacting broken rails and metal frames**

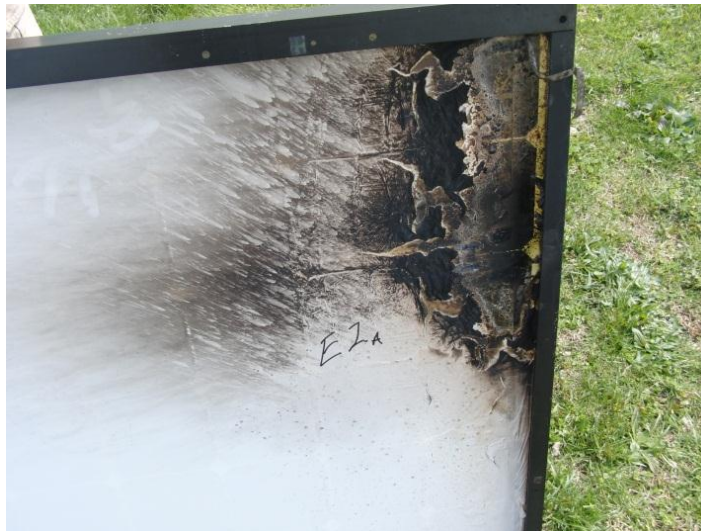
Figure 188 Module E2, partial damage

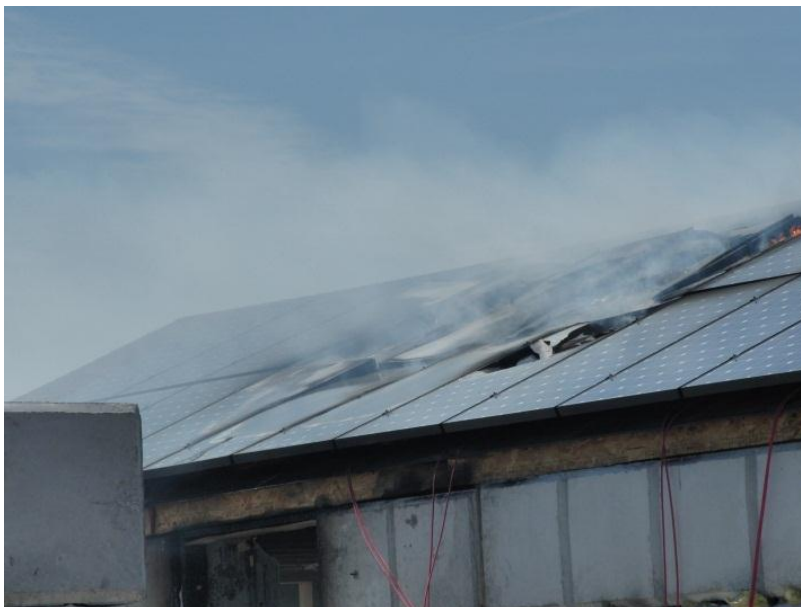
**Figure 191 Broken glass and debris**

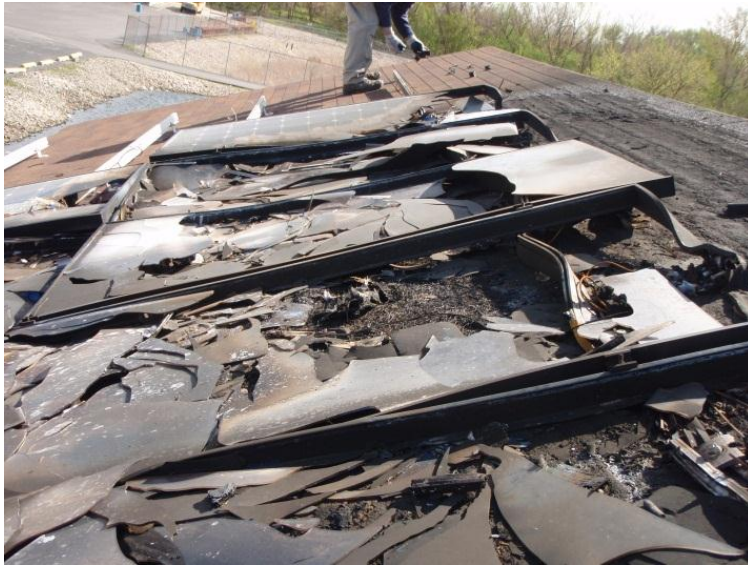
**Figure 196 Destroyed modules on roof**
