# Four Firefighters Burned in Residential House Fire - Georgia

Mark B. McKinnon  
Daniel Madrzykowski

UL's Fire Safety Research Institute  
Columbia, MD 21045

Revised April 24, 2023

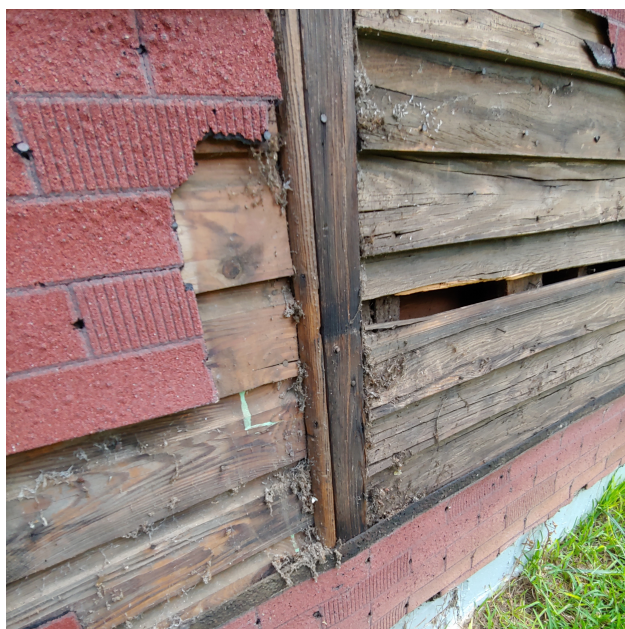
Figure 4.2: Photograph of an exterior wall of the structure showing the asphalt siding was installed over the wood siding.

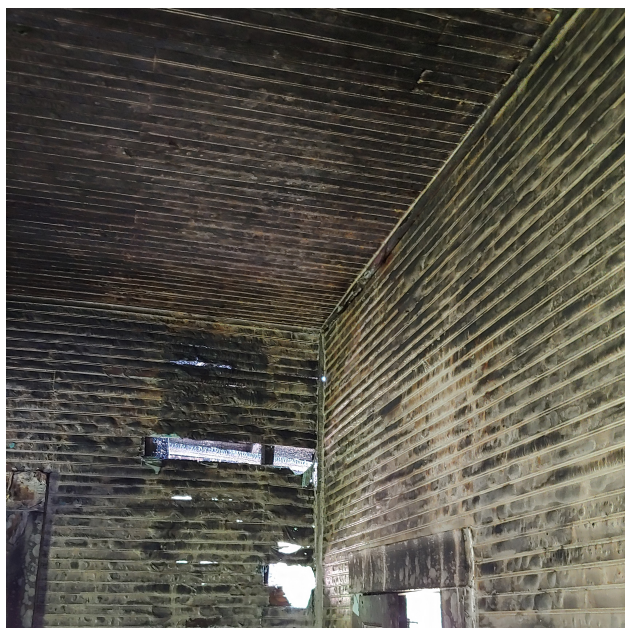
Figure 4.3: Photograph of the interior finish of the walls and ceiling of the structure. This image was taken in the living room but is representative of the bead board that formed the interior surface of the walls and ceiling in the kitchen and bedroom before the fire.

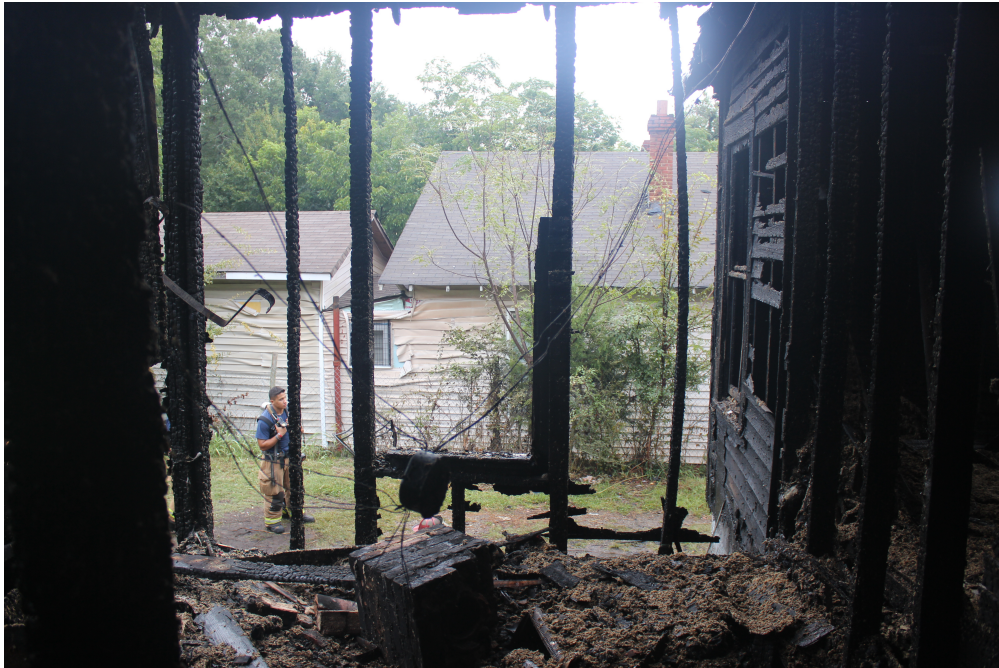
Figure 4.15: Photograph of the kitchen side D wall. Remains of the window framing for the sill can be seen.

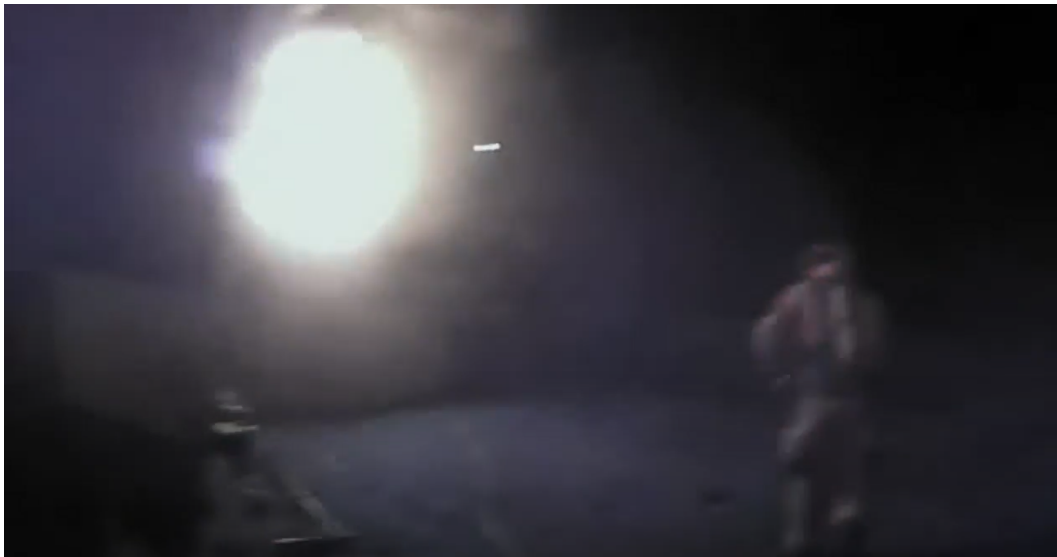
Figure 4.17: Flames extending out of the side D kitchen window at 02:57:40. E1 has been on scene for almost 1 minute [11]

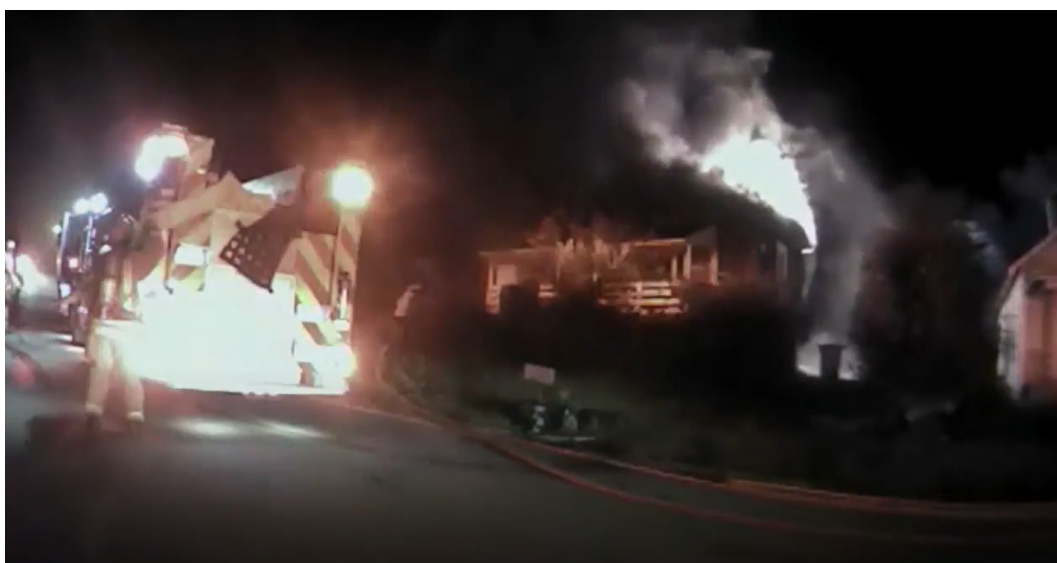
Figure 4.18: Flames extending out of the C/D corner of the structure, 02:59:50 [11].

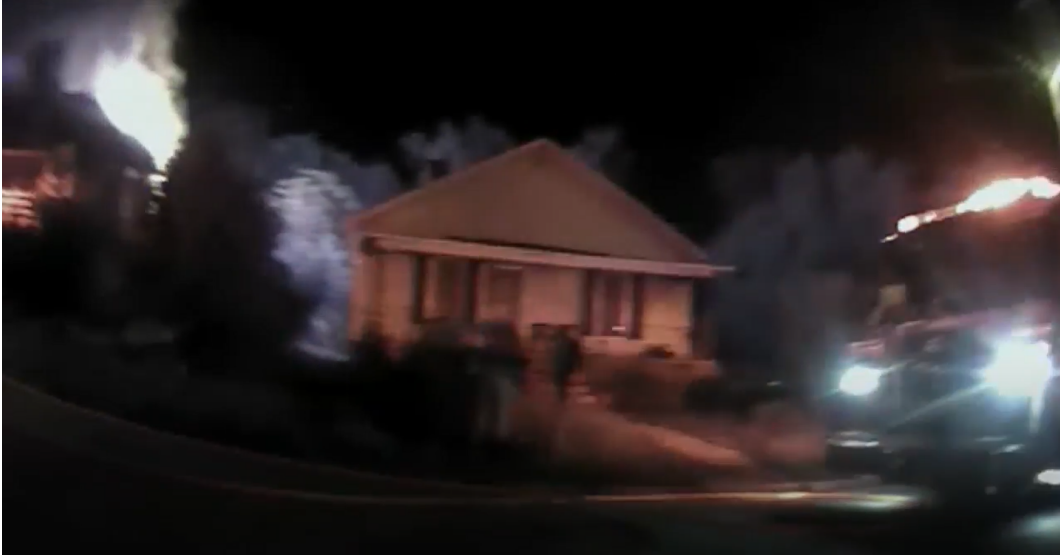
Figure 4.19: Flames continuing to extend out of the C/D corner of the structure, 03:01:53 [11]

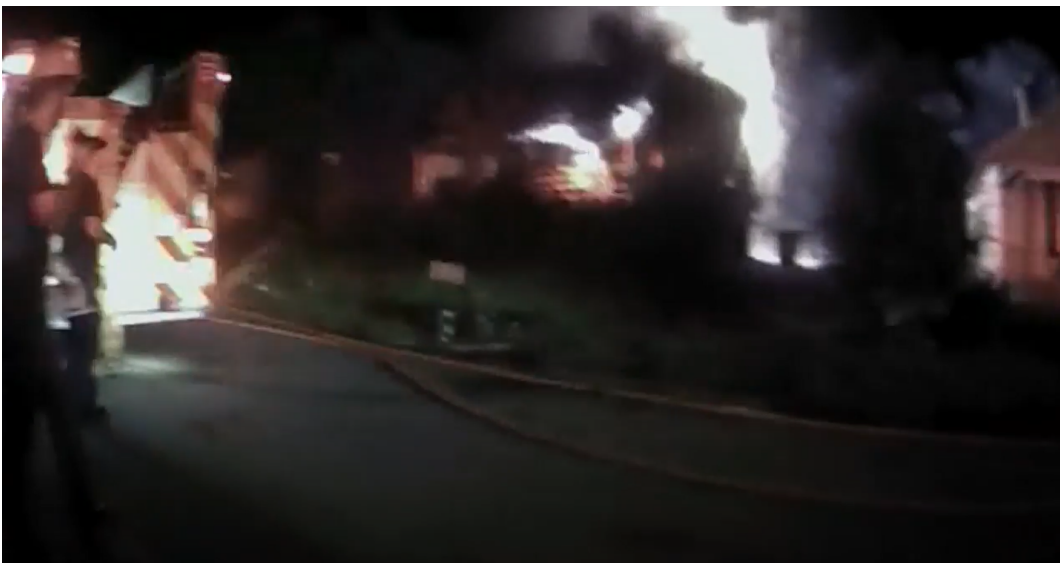
Figure 4.20: Flames extending out of the bedroom on side A, 03:03:51 [11]

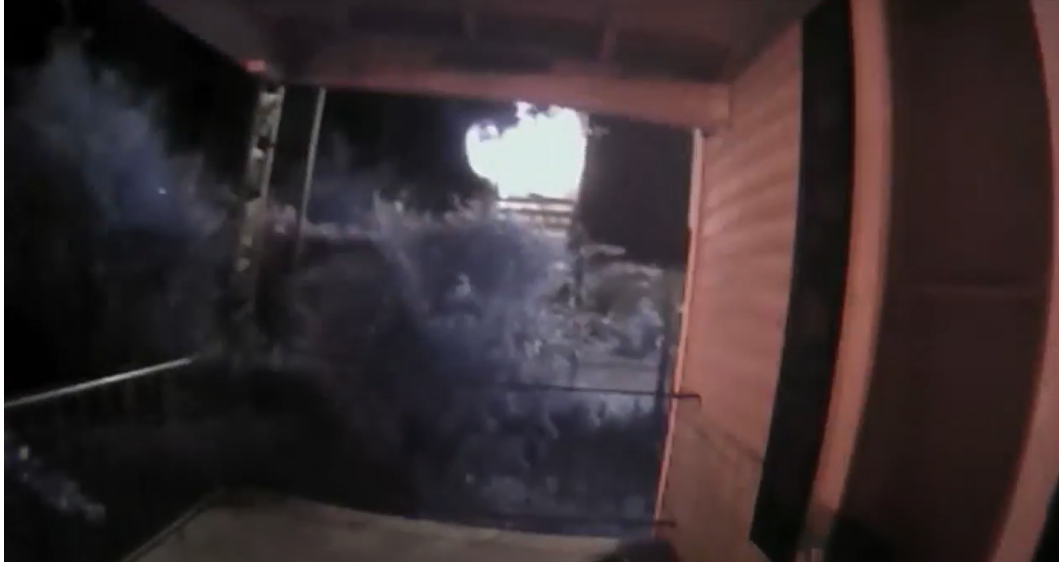
Figure 4.21: Flames extending out of the bedroom on side A at the time of the first Mayday, 03:04:38, as viewed from the neighbor's porch on side D [11]

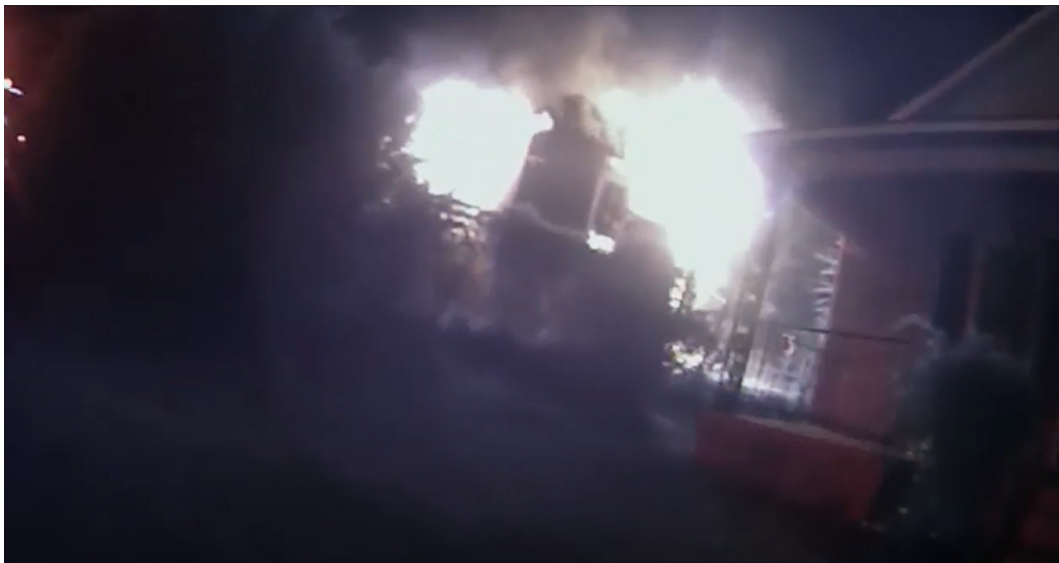
The fire continued to increase in size while IC directed E2 to bring a hoseline to side A. A view from the next door neighbor's front yard, Figure 4.22, shows the size of the fires at both the A/D and C/D corners of the house. All four firefighters were still in the structure at this time, however they were in areas on the opposite side of the house.

Figure 4.22: Flame spread at the A/D and C/D corners of the structure 40 seconds after the first Mayday, 03:05:14, as viewed from side D [11]

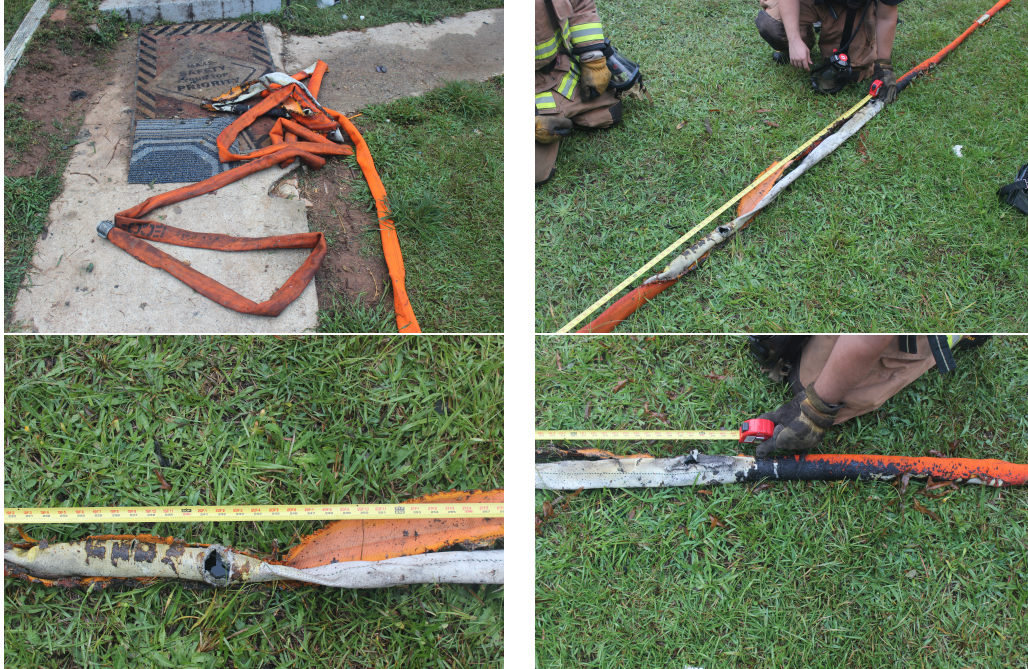
was discovered that the hoseline that passed through the bedroom and the living room had burned through near the bedroom entry door, so the Fire Control crew no longer had appropriate pressure at the nozzle when the fire spread back into the kitchen and the bedroom reached flashover conditions. Figure 4.21 provides a sense of the volume of fire that was visible on the porch from the neighbor's house at 03:04:38, about 4 seconds after the the first Mayday call.

Figure 5.20: Photographs of the hose used by the Fire Control crew

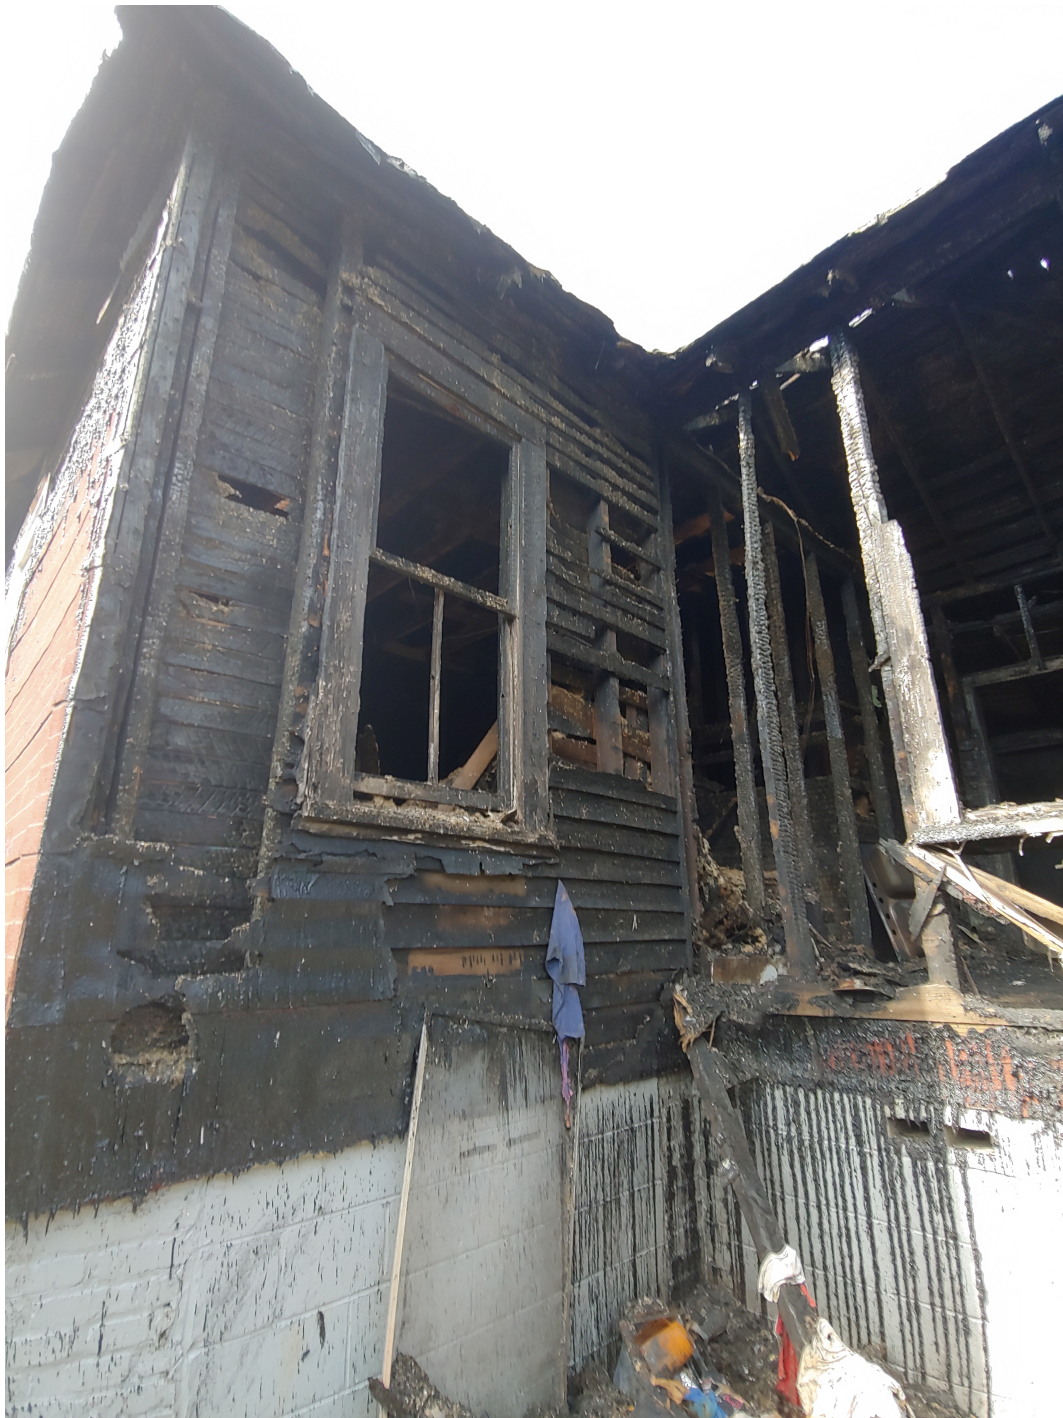
With the conclusion that the fire progressed from the kitchen to the exterior of the structure and subsequently through the side C bedroom window, it is evident that the uncontrolled exterior fire likely caused the bedroom to rapidly transition to flashover. This rapid transition prevented the Fire Control crew and the Search crew to exit the structure along the same path they took when they entered. As temperatures in the bedroom, the hallway, and the living room increased, none of the firefighters were able to access or operate the entry door in the bedroom or the bathroom of the structure, and they were forced to find paths of egress through the windows.

Figure 5.21: Photograph of the exterior of side C of the bedroom
