Analysis of Search and Rescue Tactics in Single-Story Single-Family Homes Part II: Kitchen and Living Room Fires

UL's Fire Safety Research Institute
Columbia, MD 21045

May 17, 2022

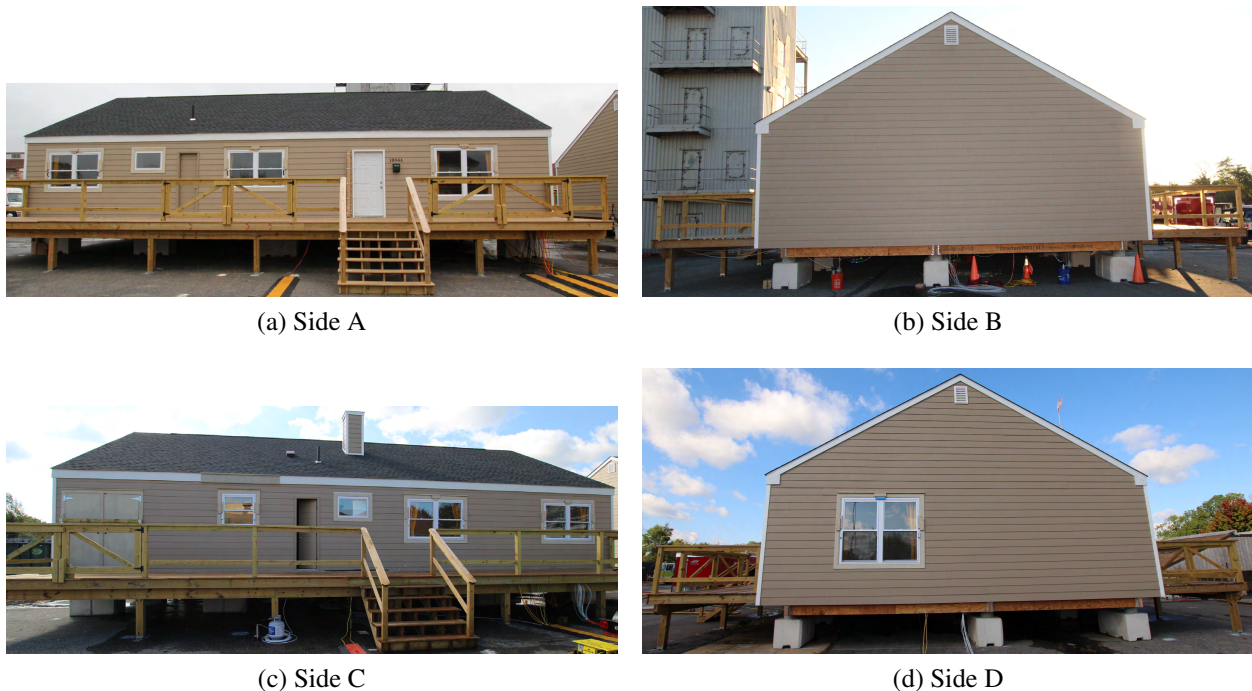
Figure 3.1: Representative exterior photographs of the four sides of the experimental structures.

Two identical, purpose-built, ranch-style, single-story residential structures were constructed on the grounds of the Delaware County Emergency Services Training Center in Sharon Hill, PA. The design of the structures, fuel loads, and set of experiments were planned during a workshop with the technical panel assembled for this study. Each structure had a footprint of approximately 1600 ft² with interior experimental area of approximately 1450 ft² and featured four bedrooms, two bathrooms, and an open concept kitchen/living room. Figure 3.1 shows representative photographs of the four sides of the structure with side A as the front.

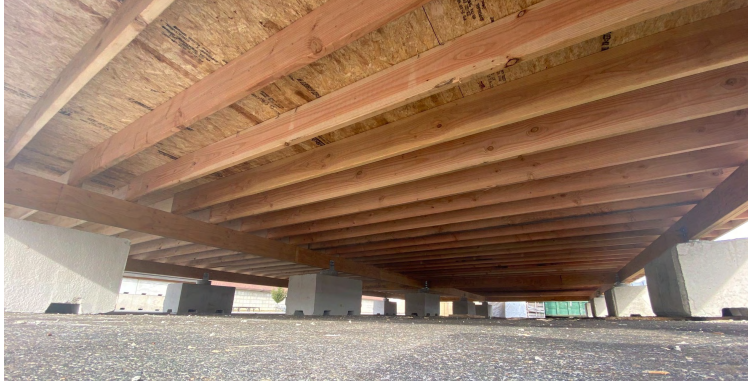
The subfloor of the structure was comprised of 0.72 in. tongue-and-groove, moisture-resistant, engineered wood sheeting. This sheeting was affixed to nominally 2.0 in. by 10.0 in. fir floor joists, spaced at 16.0 in. on center. The entire flooring system of the structure was supported through a series of laminated veneer lumber beams. Each beam location included a pair of 9.5 in. by 1.75 in. beams affixed together, which brought the total size to 9.5 in. by 3.5 in. The beam network supporting the structure was leveled using concrete piers with incorporated rebar connecting to each footing. Each footing was a 2.0 ft by 2.0 ft by 4.0 ft concrete block.

Figure 3.2: Photograph of support assembly for each structure. From the top down, this included the subfloor, floor joists, support beams, and concrete piers.

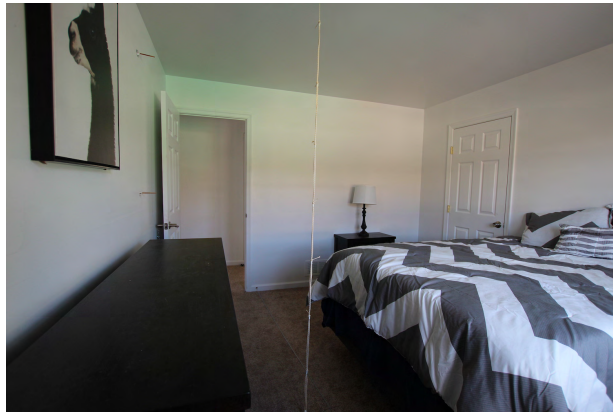
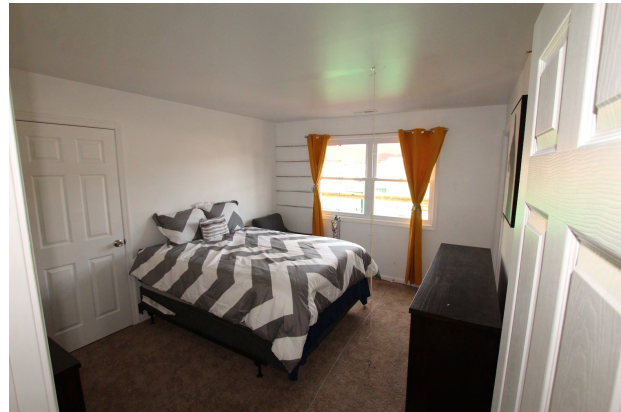
(a) View from Windows Toward Door

(b) View from Door Toward Windows

Figure 3.7: Example layout of fuels from bedroom 3.

Each bedroom’s fuel package consisted of a queen mattress set with a foam mattress topper and associated bedding, a dresser, a night stand, a chair, a lamp, window curtains, and a wall painting as shown in Figure 3.7. Additionally, each bedroom floor was lined with polyethylene terephthalate (PET) carpet, polyurethane (PU) foam padding, and an oriented strand board subfloor. Table 3.1 shows the size, material composition, and mass of each of the items that comprised a bedroom fuel load for each experiment. Note: The layout of the furniture was in one of three configurations based on the location of the respective hallway door, closet/bathroom door, and window, as shown in Figure 3.6.

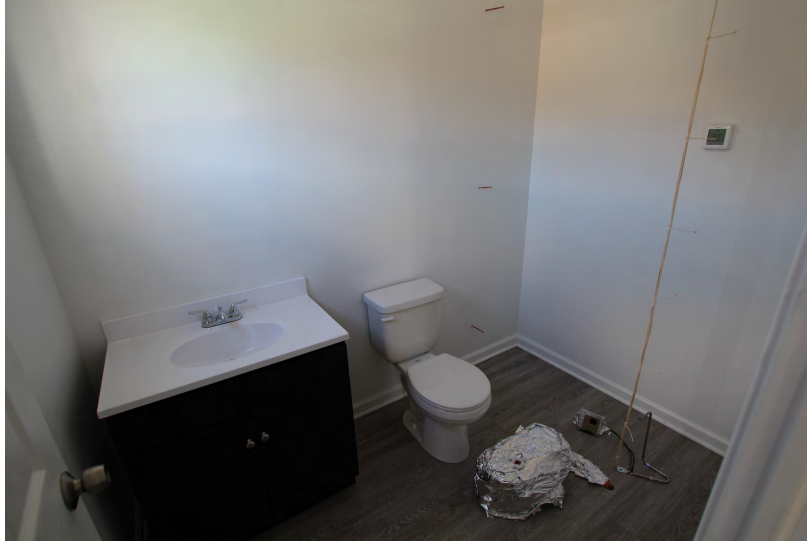
Figure 3.8: Photograph of bathroom fuel layout.

In addition to the fuel load in each of the bedrooms, the two bathrooms were also furnished with representative items (a vanity and toilet) as shown in Figure 3.8.

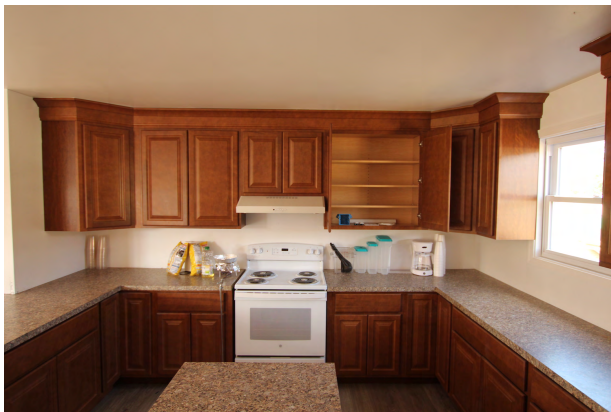
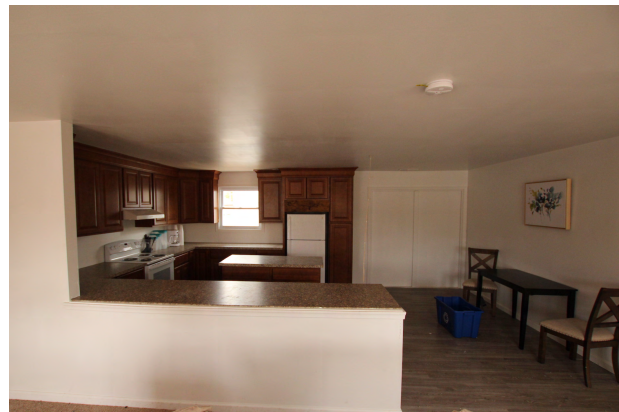
(a) View Toward Ignition Burner

(b) View of Full Kitchen

Figure 3.9: Example layout of kitchen fuels.

The open floor-plan kitchen featured both upper and lower cabinets, a range, a range hood, a refrigerator, and an island as well as a small table and two chairs along the wall opposite the cabinets. Figure 3.9 shows the layout of the kitchen fuels, and Table 3.2 shows the size, material composition, and mass of each of the items that comprised the primary kitchen fuel load for each experiment.

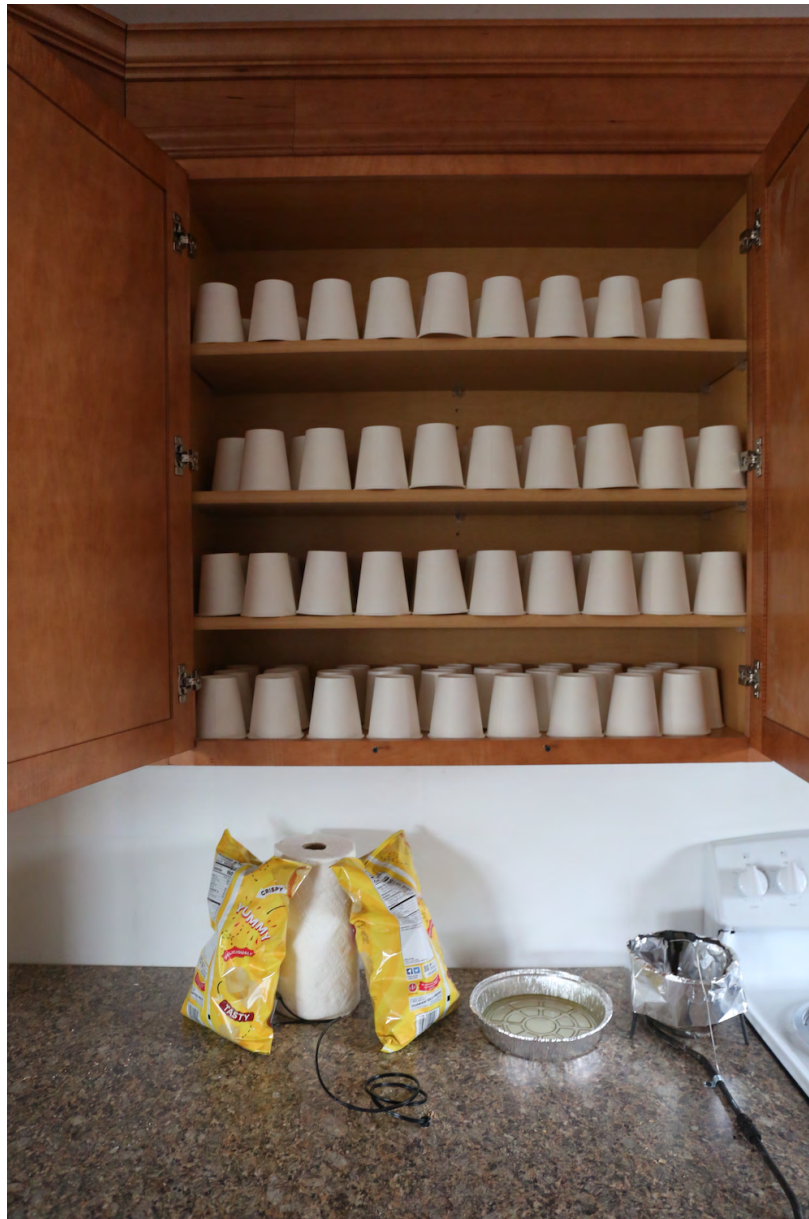
Figure 3.10: Photograph of ignition setup for kitchen fire. Prior to ignition of the pilot burner, the cabinet doors were closed. The pan of oil was placed on top of the stand above the burner after the burner is ignited.

The kitchen ignition was initiated from propane burner with 2.5 L/min flow rate that produced an approximate 4 kW pilot flame. The propane burner was lit by firefighters in full PPE who then placed a 7.5 in. diameter (at the bottom of the tray) aluminum cooking tray with 3/4 cup of canola oil on a stand 5 in. above the burner. After placing the canola oil, the firefighters left the structure. The pilot burner remained fixed at 4 kW until the oil reached its auto-ignition temperature. At this point the burner was shut down, and the flame produced by the oil spread to adjacent fuels on the counter and kitchen cabinets. A total of 111 paper cups were placed in the kitchen cabinets directly above the burner to help facilitate flame spread from the oil fire to the cabinets. Figure 3.10 shows the kitchen ignition configuration, but note however the cabinets were closed prior to ignition.

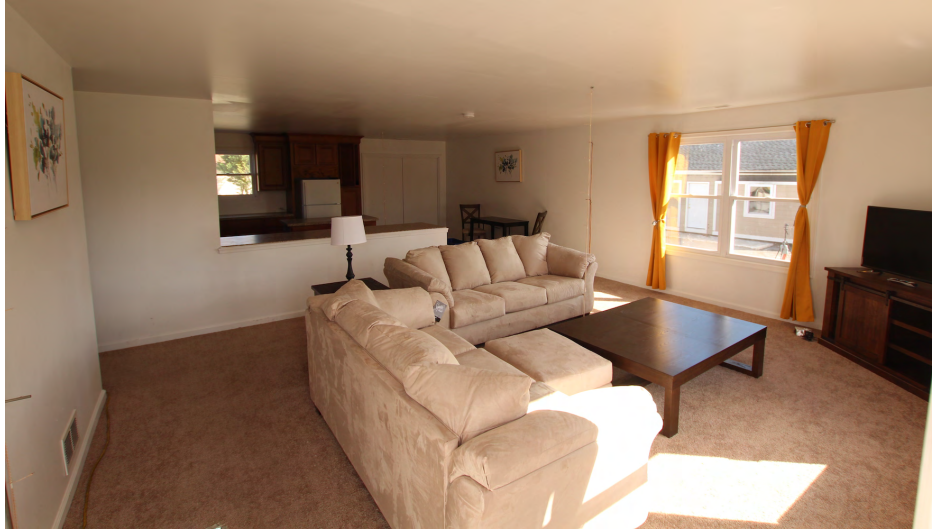
Figure 3.11: Photograph of fuels for a living room fire.

The living room contained two three-seat sofas, an ottoman, a coffee table, an end table, a TV stand, and a TV. The space was fully carpeted with padding and oriented strand board subfloor as shown in Figure 3.11. Table 3.4 shows the size, material composition, and mass of each of the items that comprised the living room fuel load for each experiment.

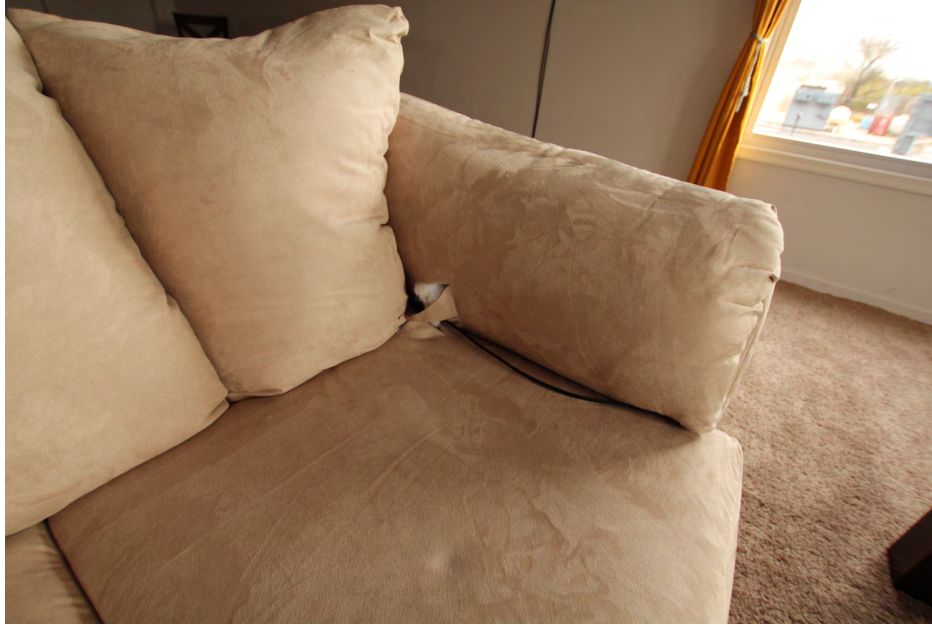
Figure 3.12: Photograph of ignition setup for a living room fire.

Living room fires were ignited with an electric match located in the corner of the upholstered sofa furthest from the front door where the seat cushion met the armrest. A slit was made in the fabric and a small amount of the polyester batting was pulled out. Figure 3.12 shows the ignition setup with the matchbook tucked into the corner underneath the batting.

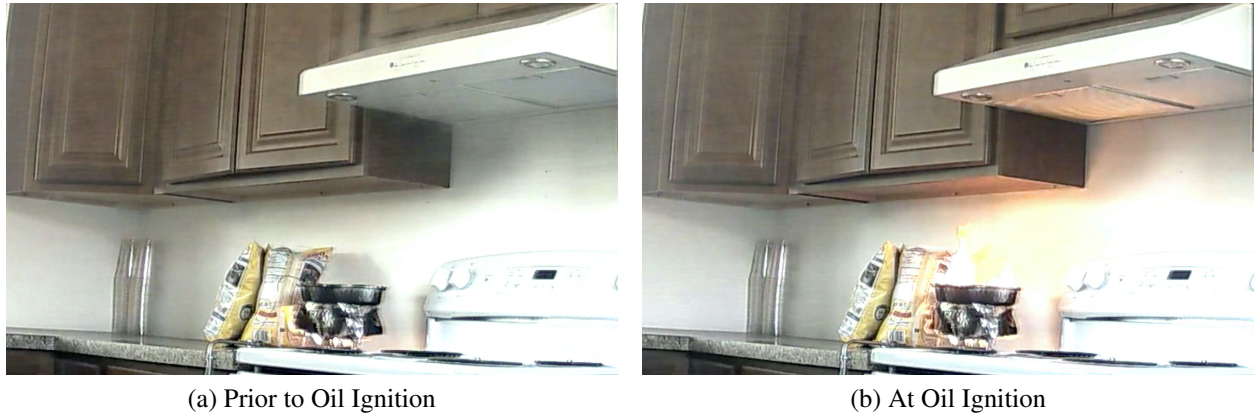
Figure 4.1: Still images from kitchen ignition video prior to and at ignition of cooking oil on kitchen counter.

Upon ignition of the propane burner ($t = 0$ s, Figure 4.1), the temperature of the oil in the pan began to increase, and it ignited after crossing its ignition temperature 370 s after pilot ignition of the burner. Across the eight kitchen experiments, the oil ignition occurred $355 (5:55) \pm 32$ s after pilot ignition of the gas burner. Figure 4.2 shows the kitchen and living room temperatures for Experiment 18. Prior to the ignition of the oil, no temperature increase was observed at the kitchen (Figure 4.2a) or living room (Figure 4.2b) measurement locations.

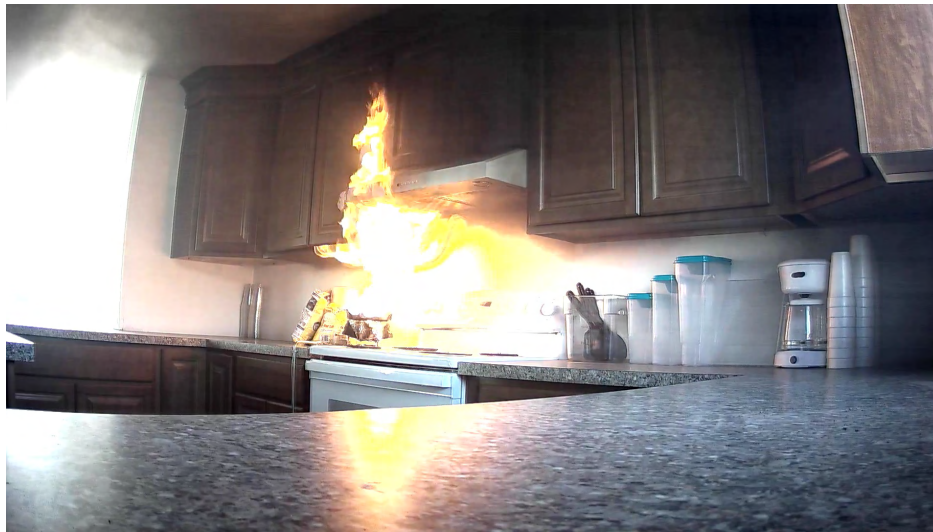
Figure 4.3: Camera view of fire beginning to spread from oil pan to kitchen cabinets at $t = 406$ s.

The ceiling temperature in the kitchen first began to increase 405 s after ignition, shortly after the oil ignition, and it continued to climb as flames began to extend to the cabinets, as shown in Figure 4.3. The temperature at other elevations in the kitchen increased more slowly, not rising until the hot gas layer in the kitchen began to develop. As the fire continued to spread to the cabinets, fire was observed out of the side C window 975 s after ignition.

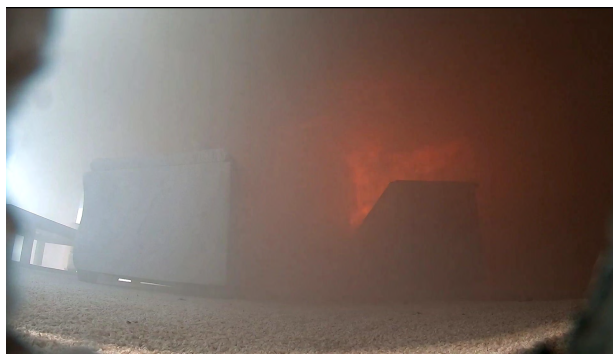
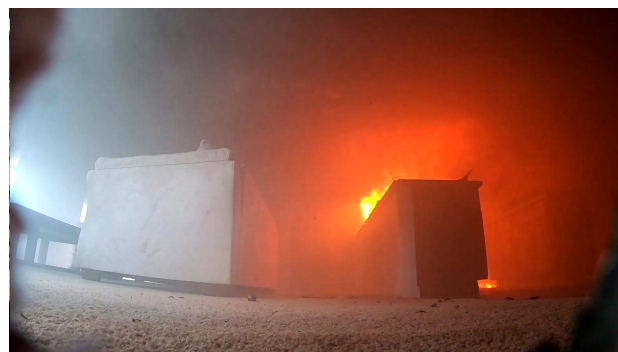
(a) Pre-Kitchen Counter Ignition ($t = 975$ s)

(b) Post-Kitchen Counter Ignition ($t = 1015$ s)

Figure 4.4: Camera view from side D living room wall toward kitchen before and after kitchen counter ignited during Experiment 18.

At 1000 s after ignition, temperatures 5 ft and above began to increase more rapidly, which corresponded to the time at which the kitchen counter was heated to the point of ignition, as shown in Figure 4.4. Following this increase, temperatures in the kitchen remained relatively steady until a final increase, which preceded the transition through flashover 1325 s after pilot ignition. The kitchen remained in a post-flashover state until suppression.

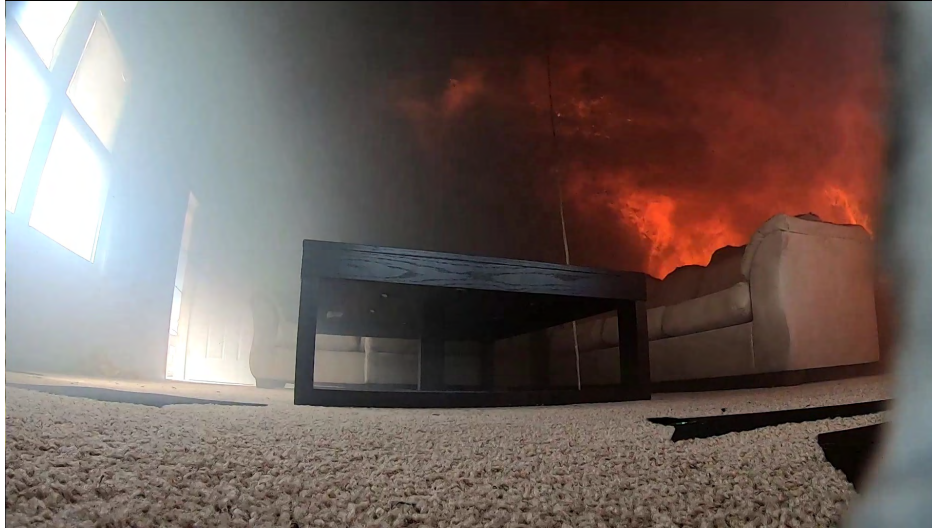
Figure 4.5: Camera view of rollover from kitchen to living room during Experiment 18.

temperature increases. Living room temperatures remained relatively steady until rollover was observed from the kitchen into the living room (Figure 4.5), 1240 s after pilot ignition. This rollover increased temperatures close to the ceiling and heated fuel surfaces, causing the living room to transition through flashover 1355 s after ignition. Fire was first observed out the side A living room windows 1300 s after ignition, and was observed out of both windows and the front door following flashover of the common space.

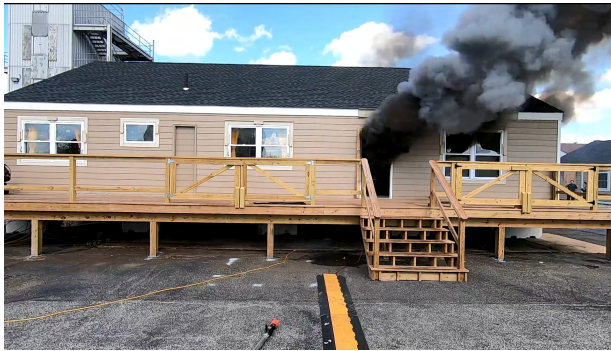
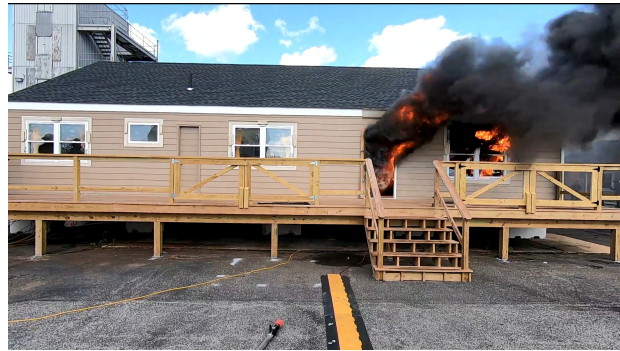
(a) Pre-Kitchen Counter Ignition ($t = 295$ s)

(b) Post-Kitchen Counter Ignition ($t = 1315$ s)

Figure 4.7: Camera view from side A exterior showing change from smoke exhaust to fire exhaust during Experiment 18.

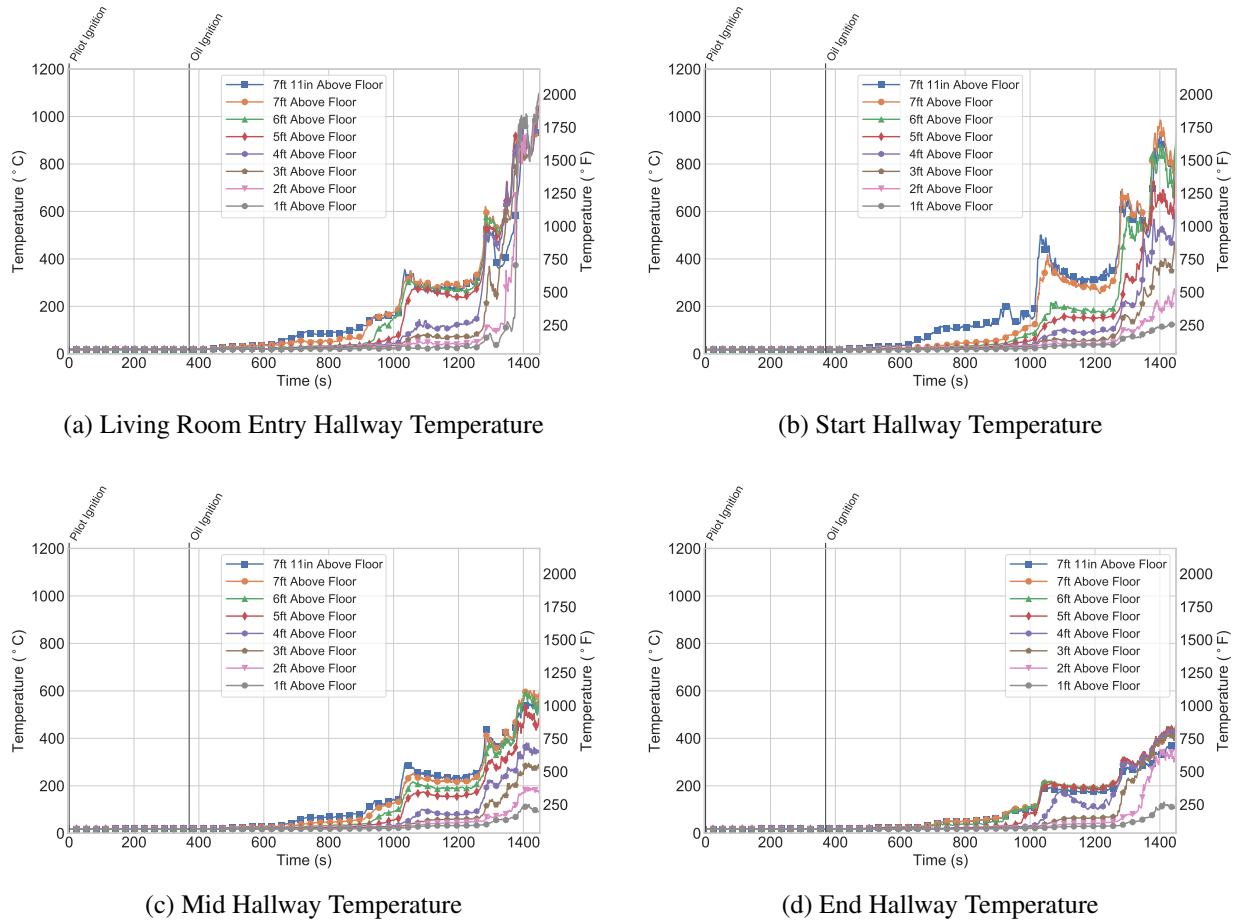
Figure 4.9: Temperature time histories in the hallway due to a fire in the kitchen from pilot ignition ($t = 0$ s) until firefighter intervention for Experiment 18.

combustion gases. At the time of intervention, peak temperatures ranged from 635 °C to 95 °C (1175 °F to 203 °F) at the mid hallway location and 450 °C to 100 °C (842 °F to 212 °F) at the end hallway location.

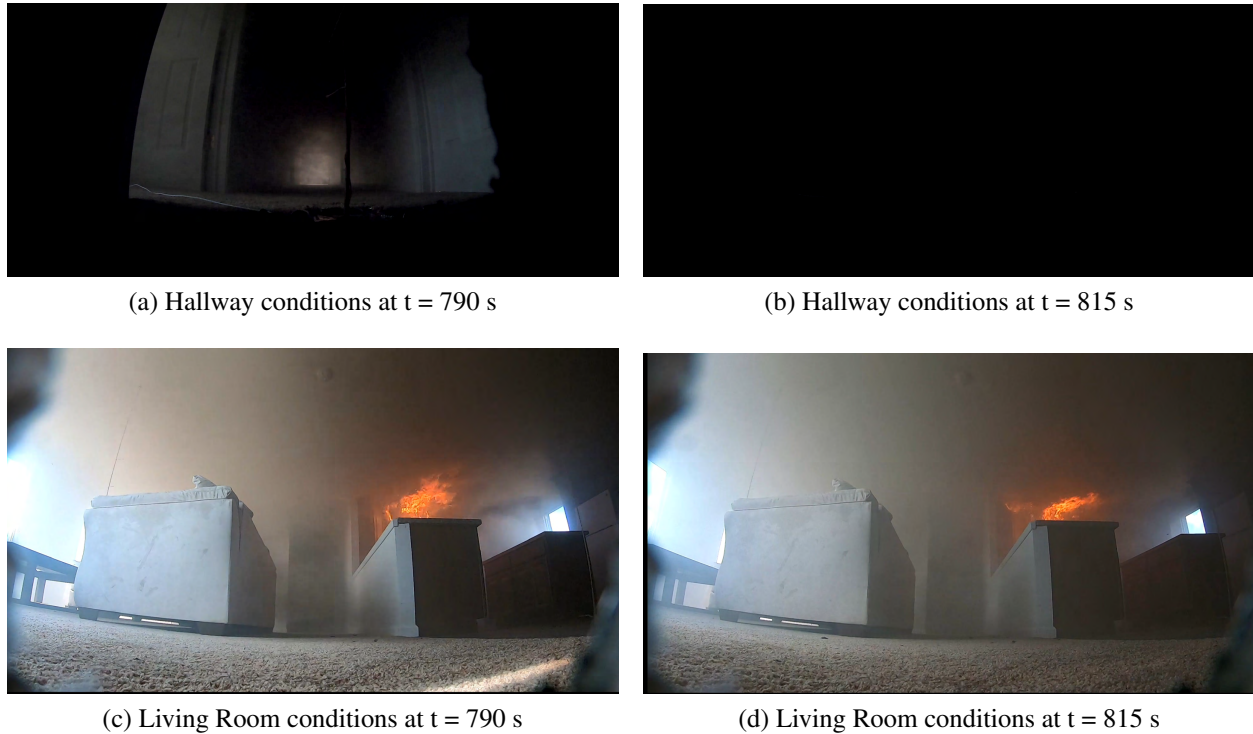
Figure 4.13: Loss of visibility at hallway camera location compared to living room camera location during Experiment 18.

of air in the common space up until the time of flashover. The hallway and remote bedrooms began to fill with products of combustion and optically dense smoke, which obscured visibility and increased toxic gas concentrations.

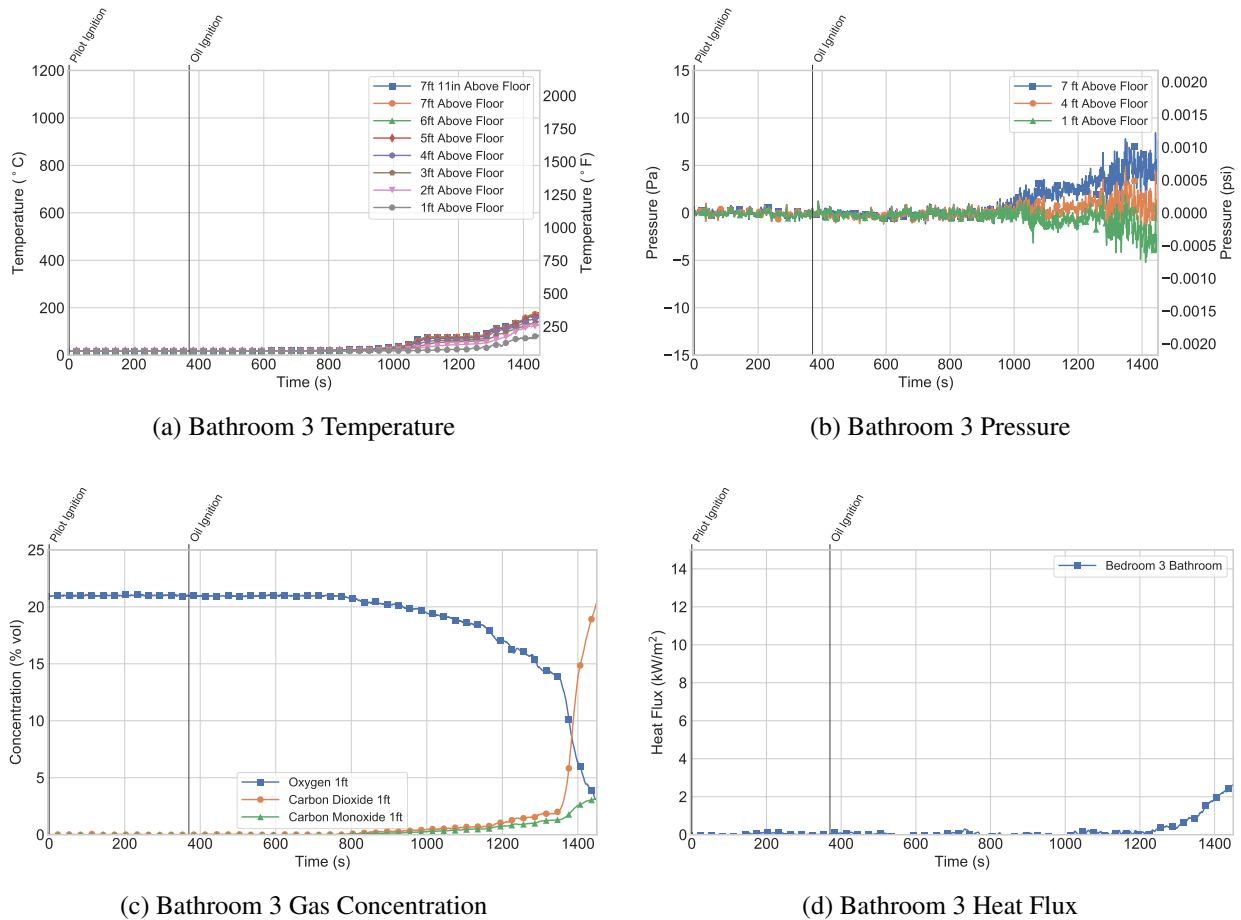
Figure 4.16: Bathroom 3 temperatures, pressure, gas concentrations, and heat flux time histories in the hallway due to a fire in kitchen from ignition ($t = 0$ s) until firefighter intervention for Experiment 18.

in the bathroom. The temperatures in bathroom 3 at the time of intervention were lower than those measured in both bedrooms 2 and 3, ranging from 178 °C to 77 °C (352 °F to 171 °F).

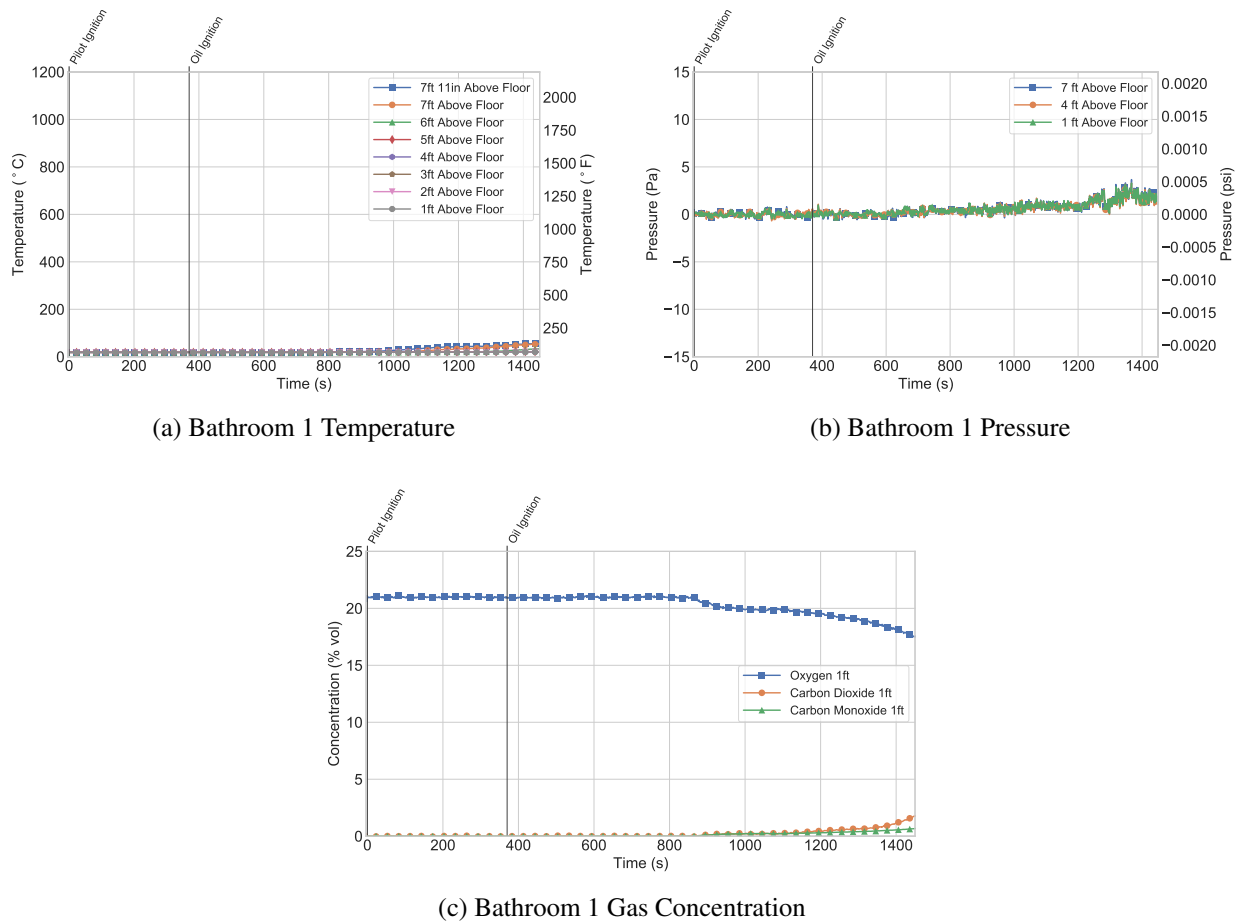
Figure 4.18: Bedroom 1 temperatures and pressure time histories in the hallway due to a fire in bedroom 4 from ignition ($t = 0$ s) until firefighter intervention for Experiment 18.

Bathroom 1 was immediately adjacent to bedroom 1, and was isolated from the bedroom by a closed door. The two closed doors between bathroom 1 and the hallway provided sufficient isolation, so the primary pathway for transport was through the HVAC supply in the ceiling. Only the temperatures from 6 ft above the floor to the ceiling exhibited any noticeable temperature increase (Figure 4.18a). This temperature increase started 830 s after ignition, and at the time of intervention, temperatures ranged from 55 °C (131 °F) at the ceiling to 20 °C (68 °F) 1 ft above the floor. The bathroom 1 pressure gradually increased at all three elevations, coinciding with the rise in temperature (Figure 4.18b). The uniform pressure behavior was driven by the absence of local vent either in the form of an open door or window or HVAC return.

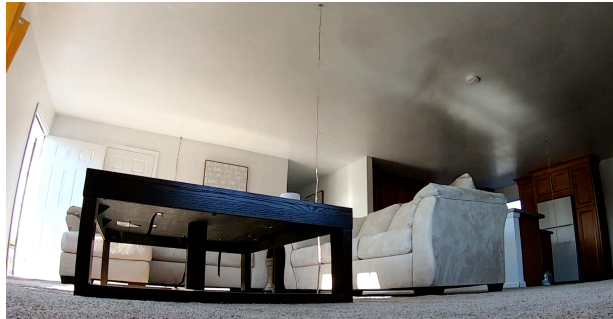
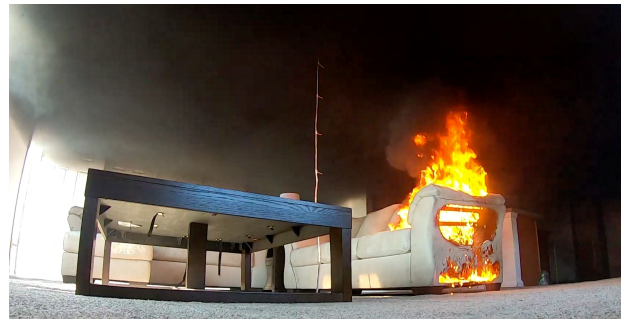
(a) Initial Ceiling Temperature Rise (40 s)

(b) Initial Floor to Ceiling Temperature Rise (145 s)

Figure 4.20: Interior views of fire growth at the time of initial temperature rise at the ceiling (40 s post ignition) and floor to ceiling temperature rise (145 s post ignition).

The fire was ignited in the side B corner of the upholstered sofa that was parallel to side A of the living room. Gas temperatures at the living room ceiling first began to rise 40 s after ignition (Figure 4.20a), and 10 s later temperatures rose in the kitchen. By 145 s, temperatures at all elevations within the living room had risen above pre-ignition values; at this point ceiling temperatures exceeded 170 °C (338 °F) (Figure 4.20b). At the time of Figure 4.20b, the smoke layer had filled the living room and kitchen to approximately 6 ft above the floor. At this point, the temperature rise below the smoke layer was driven by a combination of radiative heat transfer from the smoke layer and flames on the sofa.

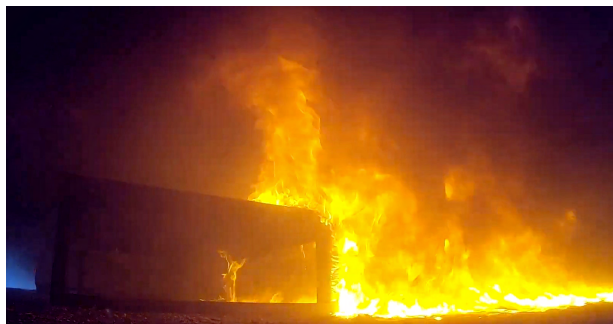
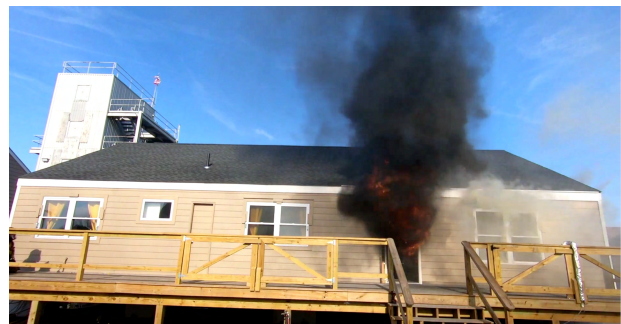
(a) Living Room At First Visible Exterior Flames (238 s)

(b) Side A Exterior At First Visible Exterior Flames (238 s)

Figure 4.21: Interior and exterior view at time (238 s post ignition) when flames were first visible on the exterior.

Flames were first visible from the front door 238 s (3:58) post ignition as the 1 ft elevation crossed 330 °C (626 °F). Figure 4.21 correspondingly shows the interior and exterior conditions. By 241 s, all temperatures exceeded 600 °C (1112 °F), an indication the living room had reached flashover. At 248 s, the living room temperatures reached their peak floor to ceiling magnitudes between 1000 °C and 1100 °C (1832 °F and 2012 °F).

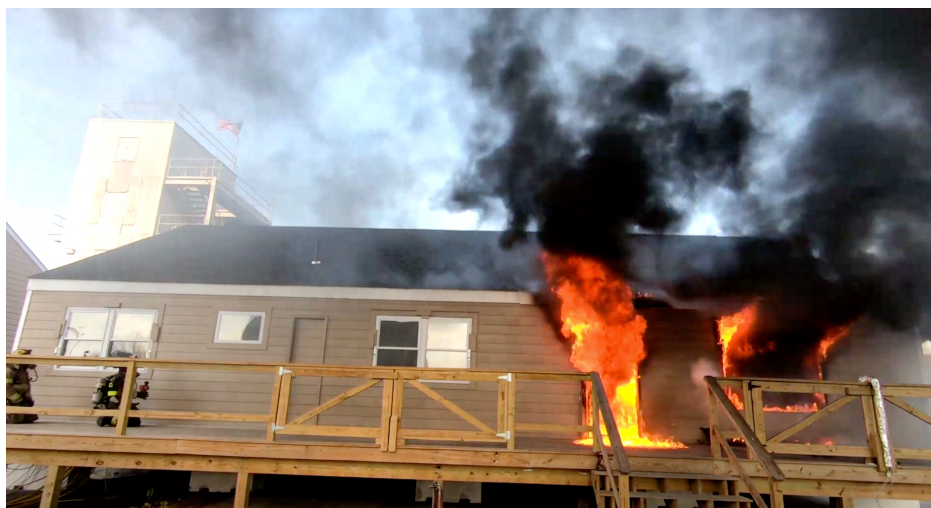
Figure 4.26: Side A exterior image of conditions at the front door and living room windows prior to first firefighter intervention for a living room fire (Experiment 19).

Measured temperatures at the 76 in. and 58 in. elevations in the doorway continued to rise until suppression, with peak values that exceeded 1000 °C (1832 °F). There were noticeable fluctuations at the 40 in. elevation temperature, which was tied to the gas velocity shifting between inlet and outlet conditions. Between 250 s and 300 s and again at 325 s to 350 s, inflow was recorded at the 40 in. probe, which corresponded to drops in measured temperature. The rise in inflow height was tied to living room window failure (approximately 275 s), which increased the exhaust vent area. At 22 in. and below there was consistent inflow in the living room. Figure 4.26 shows the exterior conditions on side A prior to first firefighter intervention.

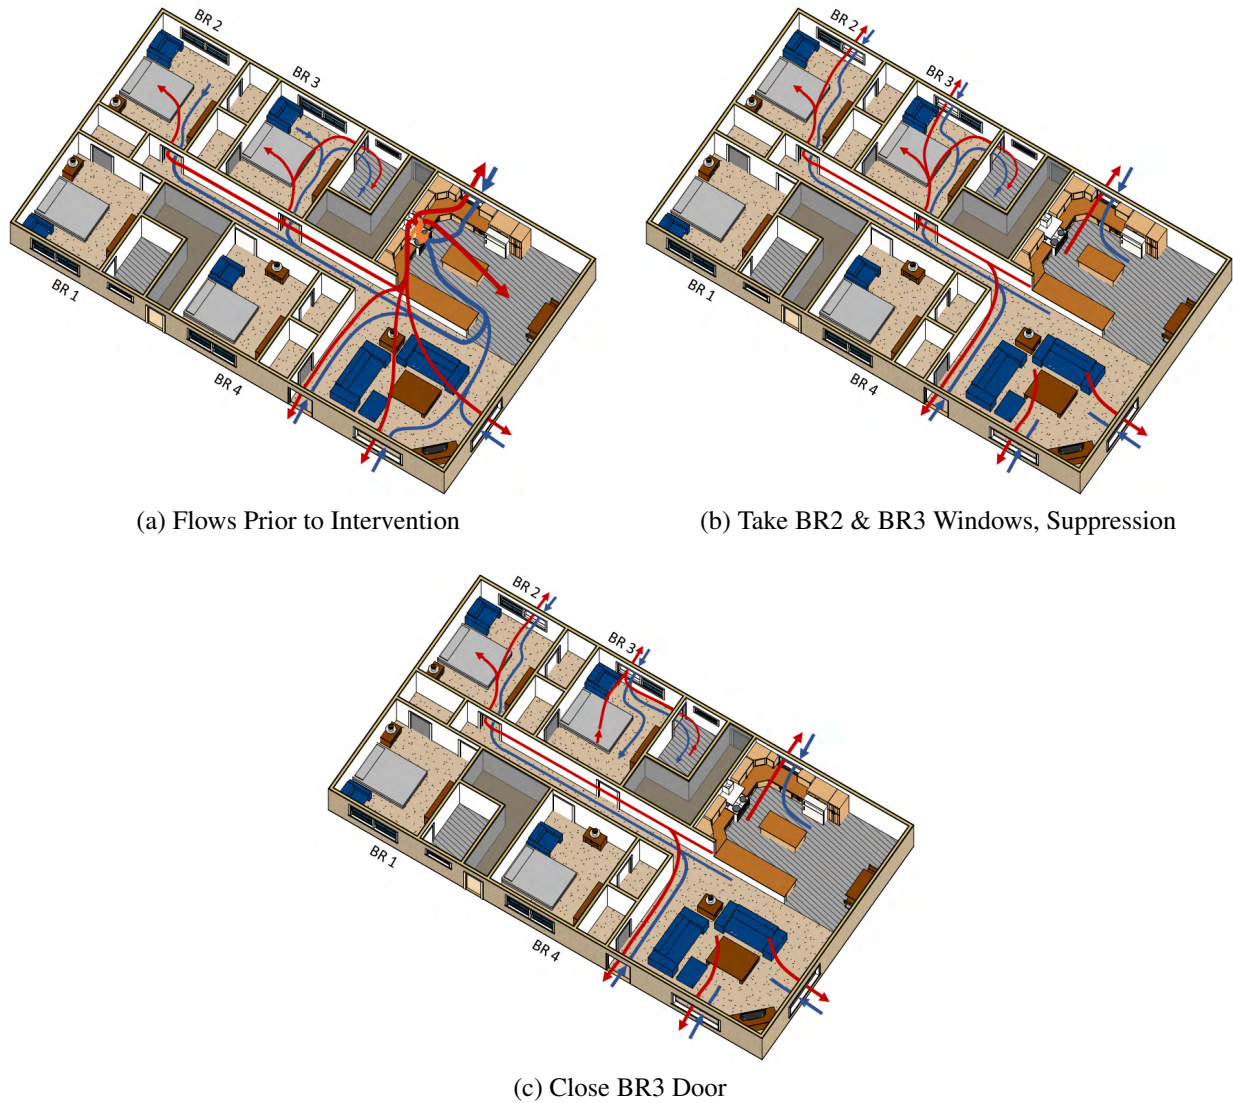
Figure 5.15: Changes in gas flows within the structure following fire department interventions in Experiment 12.

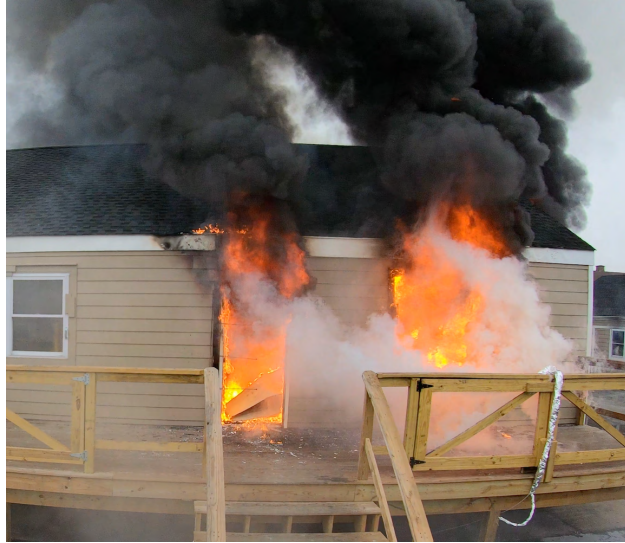
Figure 5.38: Photograph of front door panel fold over prior to suppression.

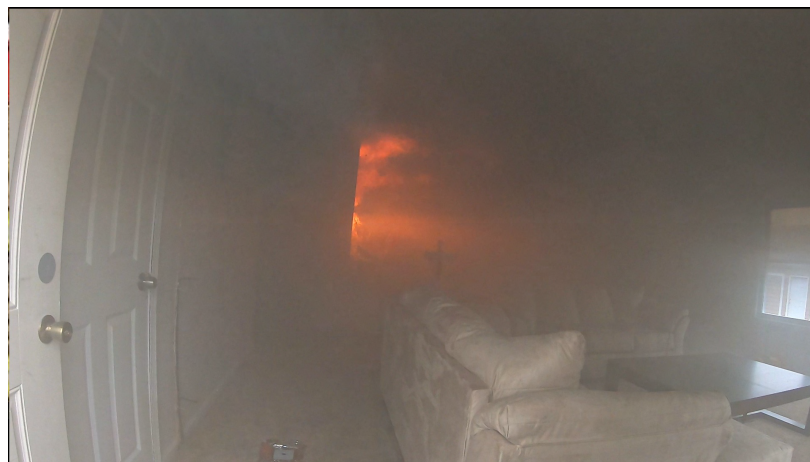
Figure 5.63: Fire conditions immediately prior to front door closing during Experiment 15.

At the time of intervention, the common space fire had not transitioned through flashover, as shown by the kitchen and living room temperature time histories shown in Figure 5.62. Prior to closure of the front door, the camera view from a suppression crew firefighter indicated that the fire was mostly confined to the kitchen (the countertop cabinets above the ignition location), as shown by the image in Figure 5.63. Immediately prior to the closing of the door, temperatures ranged from 510 °C (950 °F) to 71 °C (160 °F) in the kitchen and from 380 °C (716 °F) to 45 °C (113 °F) in the living room. Following the front door closure, the 4 ft and 5 ft temperatures in both spaces exhibited a short increase, as the smoke layer descended at the two measurement locations following the change in flow path. The closed front door eliminated the bidirectional vent at that location,

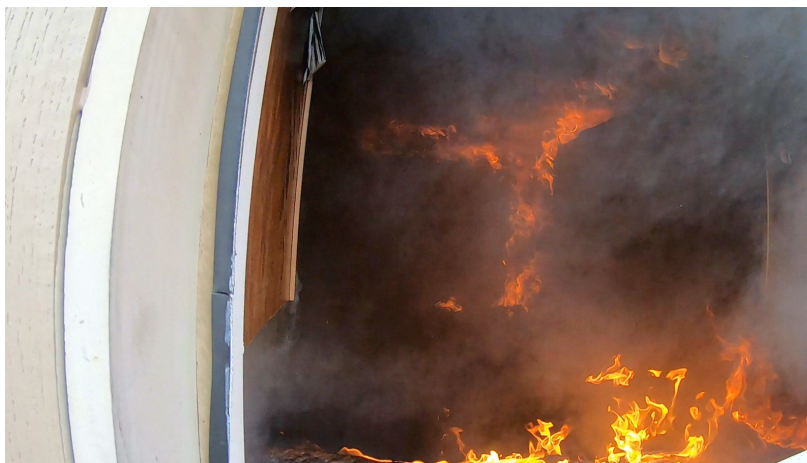
Figure 5.64: Looking through side C kitchen window, fire conditions immediately prior to suppression during Experiment 15.

The suppression crew opened the front door and advanced the line to the kitchen 181 s after the initial fire department intervention. Immediately prior to water flow, the fire conditions visible to the suppression crew were comparable to those when the front door was initially closed, with the majority of visible fire confined to the kitchen area, as shown in Figure 5.64. The suppression crew

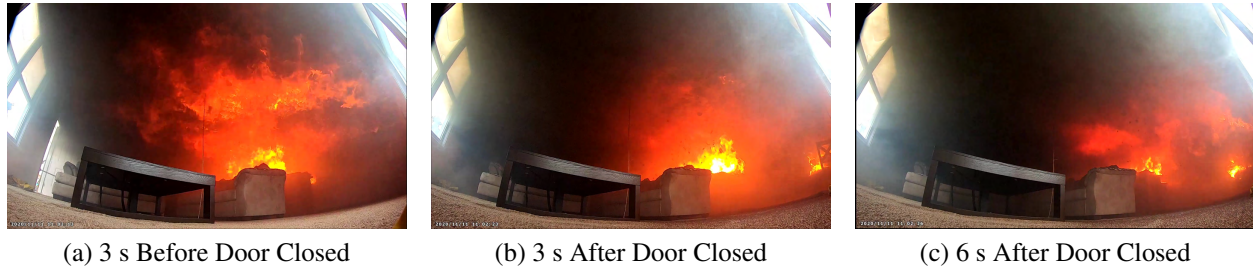
Figure 5.79: Fire conditions preceding and following front door closure during Experiment 16.

Figure 5.78 shows the temperatures in the kitchen and living room in the period following intervention during Experiment 16. Immediately prior to intervention, the kitchen fire was in a pre-flashover state, with temperatures stratified between 872 °C (1602 °F) at the ceiling and 158 °C (316 °F) 1 ft above the floor. Temperatures were increasing at all elevations in the kitchen at the time that the front door was closed. Temperatures were slightly lower in the living room, where they ranged from 785 °C (1445 °F) at the ceiling to 108 °C (226 °F) 1 ft above the floor at the time of intervention. At the time that the front door was closed, rollover was observed along the ceiling of the kitchen and living room, as shown in Figure 5.79a. Temperatures 6 ft and above in both the living room and the kitchen were in excess of 600 °C (1112 °F). Bidirectional flows existed from the kitchen to living room through the front door, which allowed hot gases from the kitchen to exhaust through the upper portion of the front door and air to be entrained through lower portion of the front door toward the kitchen. When the front door was closed, this flow path was eliminated, causing temperatures to begin to decrease. Interior camera views indicated that this decrease in temperatures was coupled with a reduction in visible flaming in the living room following front door closure, as shown in Figures 5.79b and 5.79c.

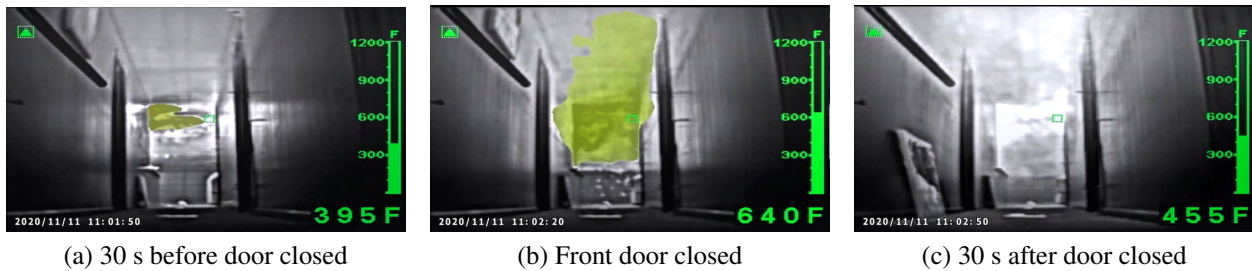
Figure 5.81: Hallway IR view in period preceding and following front door closure in Experiment 16.

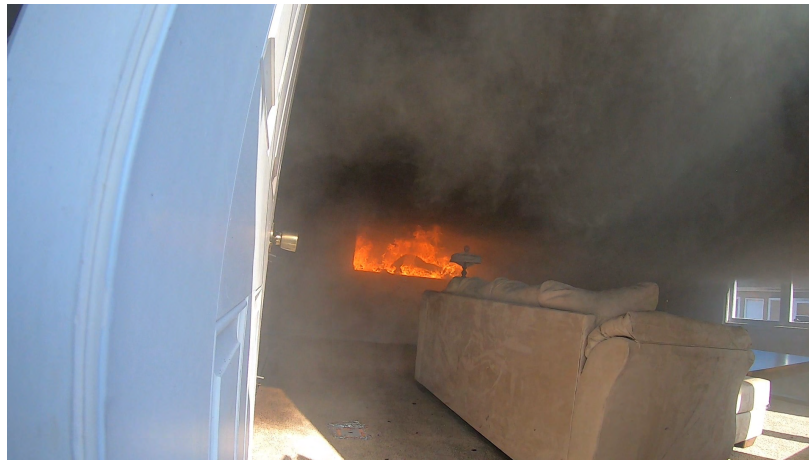
contained to the kitchen area which is shown in Figure 5.96. Following search team entry, temperatures in the kitchen and living room continued to increase as the air flow through the front door facilitated further fire growth. The kitchen fire transitioned through flashover 60 s after intervention (1190 s after ignition), which led to flashover of the living room 12 s later at 72 s after intervention (1202 s after ignition). The post-flashover conditions in the living room caused the side A and D living room windows to fail, resulting in fire showing through the front door and both living room windows. Temperatures in the living room were consistent with post-flashover conditions up until suppression was initiated. After flashover was observed in the common space, the only air available for combustion in the kitchen was what could be entrained by the kitchen window. The small opening and high sill height limited the supply of oxygen which resulted in lower, post-flashover temperature that were stratified between 825 °C and 425 °C (1517 °F and 797 °F).

Figure 5.96: Fire conditions immediately prior to search crew entering structure during Experiment 17.

In contrast to Experiment 15, the front door remained open in Experiment 17. Although crews entered the structure while the fire was still contained to the kitchen (recall Figure 5.96), conditions 3 ft above the floor at the living room entry had reached the ordinary exposure class. The crews continued to the start hallway location and then toward the mid hallway location, where they

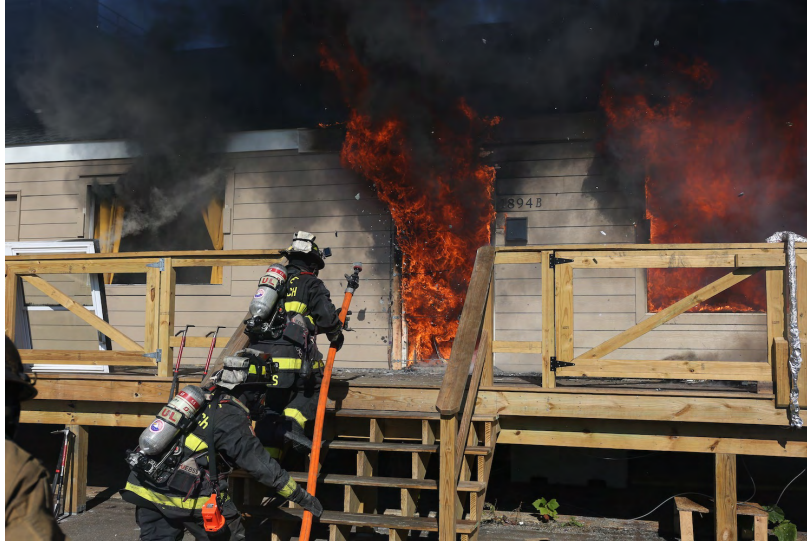
Temperature and velocity measurements in the front door showed that the exhaust from the front door transitioned from smoke to flames approximately 120 s after intervention (1250 s after ignition). Immediately afterward, the side A living room failed, resulting in flames showing from both the front door and the side A living room window.

Figure 5.97: Side A fire conditions immediately prior to suppression during Experiment 17.

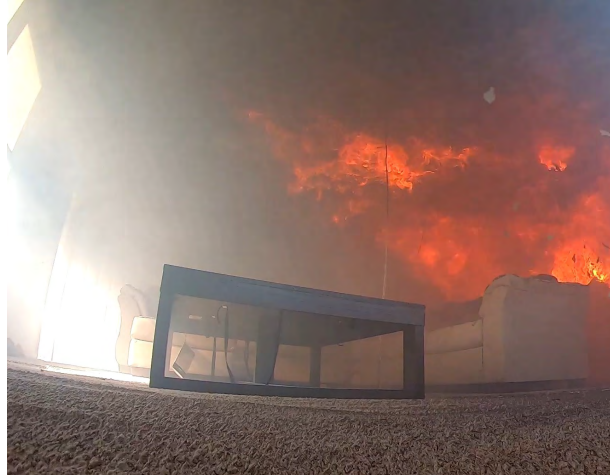
Figure 5.99: Fire conditions 30 s after intervention in Experiment 17.
