Analysis of Search and Rescue Tactics in Single-Story Single-Family Homes Part II: Kitchen and Living Room Fires

UL's Fire Safety Research Institute
Columbia, MD 21045

May 17, 2022

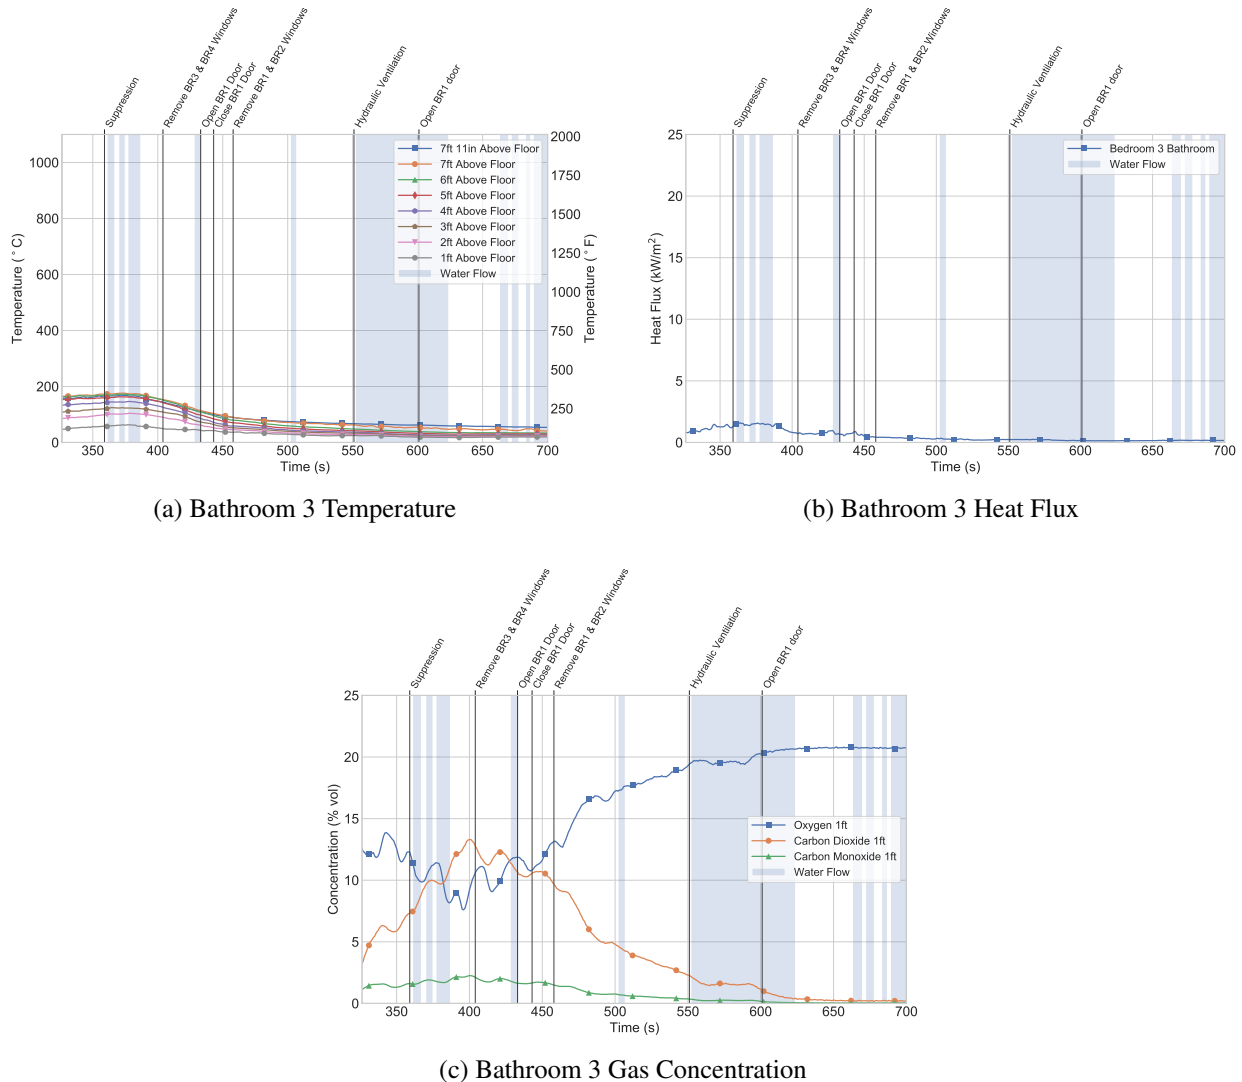
Figure 5.146: Post-intervention temperatures, heat flux, and gas concentrations in bathroom 3 during Experiment 20.

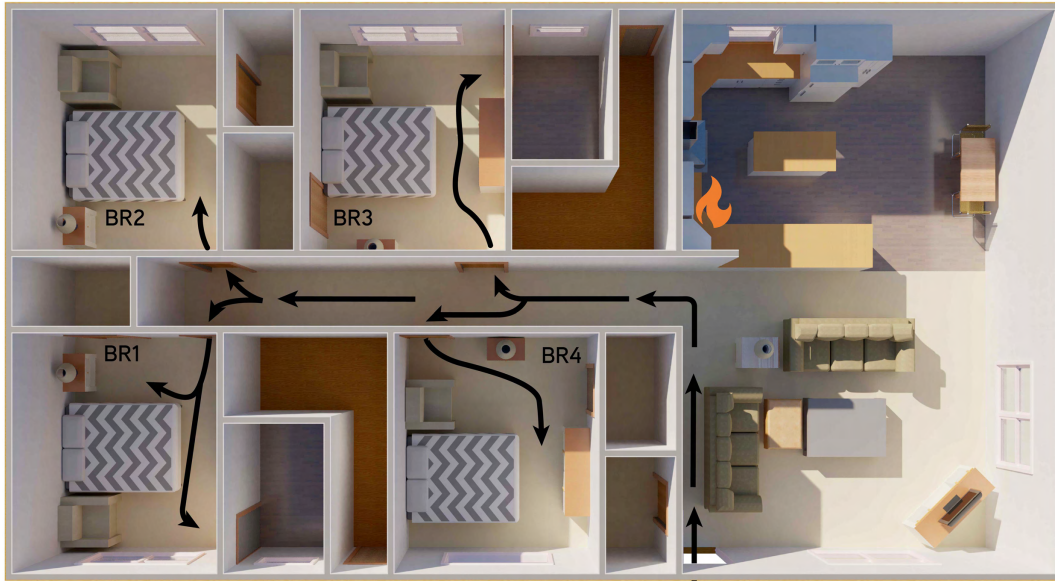
Three kitchen experiments and one living room experiment included door initiated search. In these experiments, the crews entered the open front and traveled down the hallway to search bedrooms 3 and 4, then re-entered the hallway to search bedrooms 1 and 2. The variables changed were timing of suppression relative to search (Experiments 14, 17, 20) and isolation of the front door (Experiment 15). Figure 6.2 shows the routes taken for the crews for these four experiments.

Experiment	Details
14	Post suppression
15	Isolation of front door post entry
17	Pre-suppression
20 *	During suppression

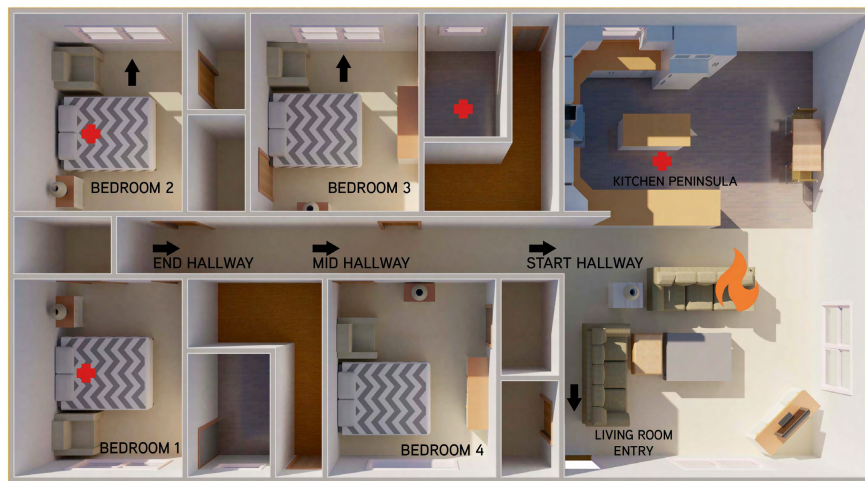
The limited number of living room experiments, prevented a statistical analysis of toxic FED data, but there were still several key takeaways. Figure 6.5 shows the locations for exposure measurements of potentially trapped occupants and the data presented in Table 6.2 shows the cumulative toxic FED at the time of earliest intervention for the living room experiments (359 s). In both Experiments 19 and 20, the living room was in a post-flashover state prior to intervention.

Figure 6.5: Toxic gas exposure measurement locations. The red plus signs are locations of potentially trapped occupants and the black arrows are measurement locations along potential egress pathways.

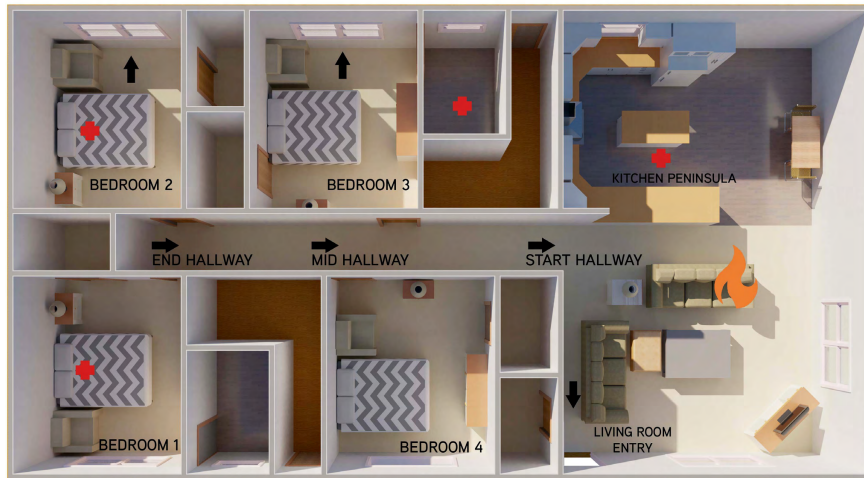
The limited number of living room experiments, prevented a statistical analysis of thermal FED data, but there were still several key takeaways. Figure 6.7 shows the locations for exposure measurements of potentially trapped occupants and the data presented in Table 6.4 shows the cumulative thermal FED at the time of earliest intervention for the living room experiments (359 s), Experiments 19 and 20. In both experiments, the living room was in a post-flashover state prior to intervention compared to the pre-flashover state for the earliest intervention time for the kitchen experiments.

Figure 6.7: Thermal exposure measurement locations. The red plus signs are locations of potentially trapped occupants and the black arrows are measurement locations along potential egress pathways.

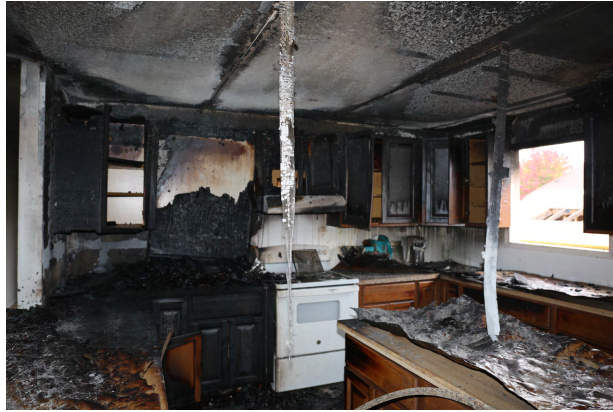
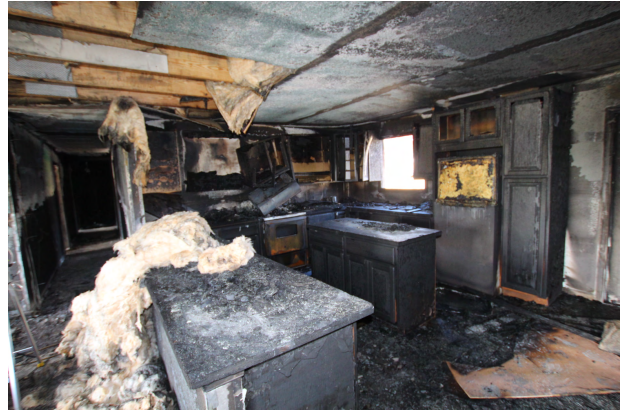
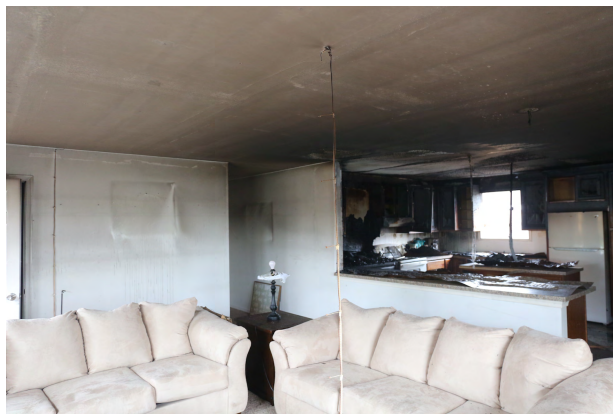
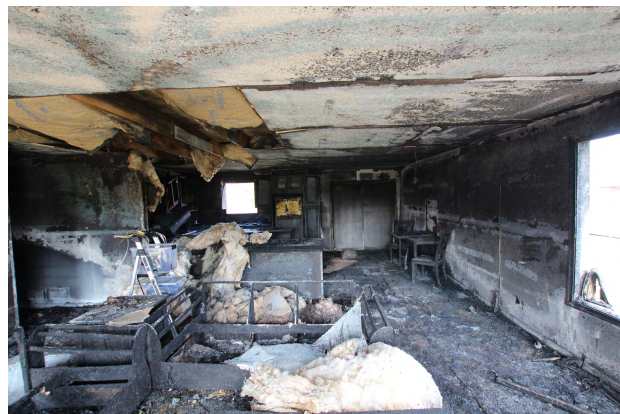
Experiments 15 and 17 examined a door initiated search that occurred prior to suppression. The primary difference between the two experiments was that in Experiment 15 the initial action was closing the front door after entry compared to Experiment 17 where the front door was open for the duration of the experiment. In Experiment 15, closure of the front door limited the ventilation in the structure to only the kitchen window, which was an inefficient vent for air supply due to the high sill height. As a result, the fire remained contained to the kitchen compared to Experiment 17 where the open door provided sufficient oxygen for the fire to spread from kitchen to living room and to support a transition to flashover over the space. To visualize the impact of the front door closure, Figure 6.16 shows post-experiment photographs of the kitchen and living room for Experiments 15 and 17. The most striking difference between the set of photographs is the comparison of living rooms.

Figure 6.16: Post experiment photographs of the kitchen and living room Experiments 15 and 17.

shows post-experiment photographs of the kitchen and living room for Experiment 16. The most noticeable difference between Figures 6.16c and 6.17b is the damage to the living room sofas. Although the fire produced sufficient heat to begin to pyrolyze the sofas, there was insufficient heat and available oxygen to support flame spread into the living room.

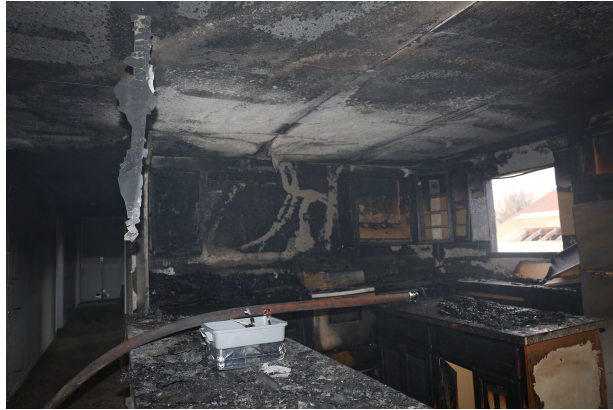
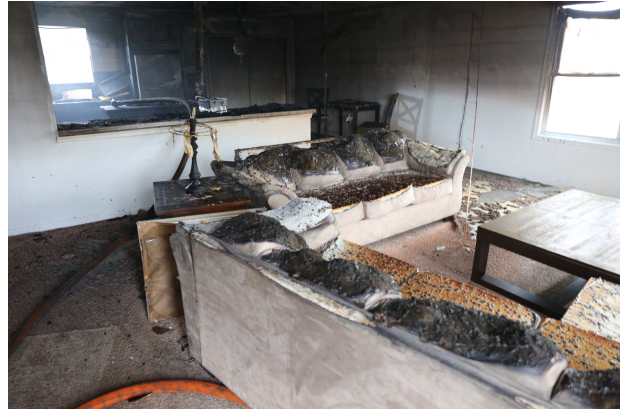
Figure 6.17: Post experiment photographs of the kitchen and living room Experiment 16.

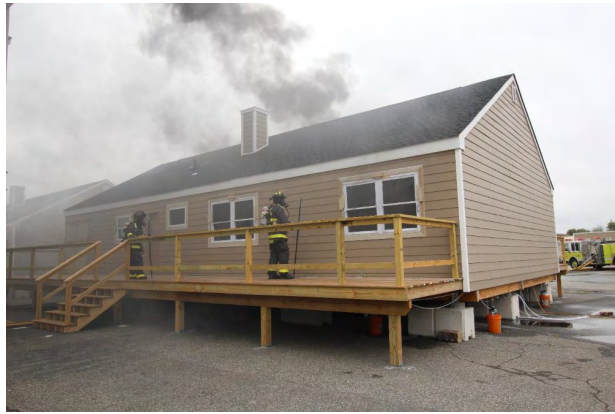
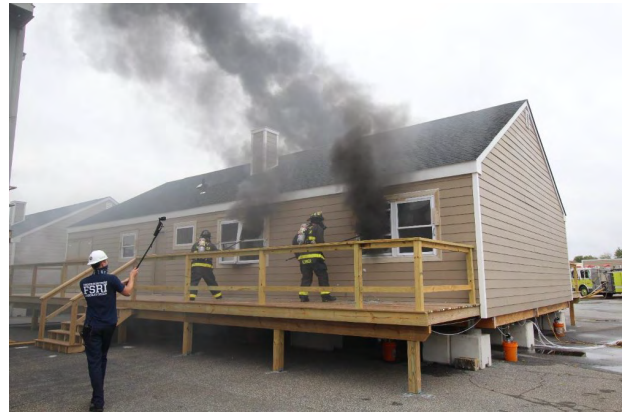
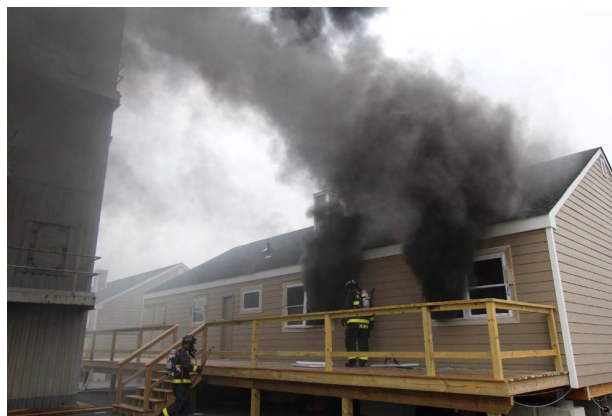
To begin window initiated search operations, exterior crews used pike poles to break one of two double-hung, dual-pane bedroom windows. The area of the opening created was 3 ft x 4 ft. This action was designed to replicate the action that search crews would take to make an exterior entry point to search the interior of the structure. Figure [A.1](#) shows a series of images of firefighters taking one-half of the bedroom 2 and bedroom 3 windows during Experiment 1. After this was completed, one side of the window remained intact (Figure [A.1c](#)).

Figure A.1: Firefighters taking a window during Experiment 1.

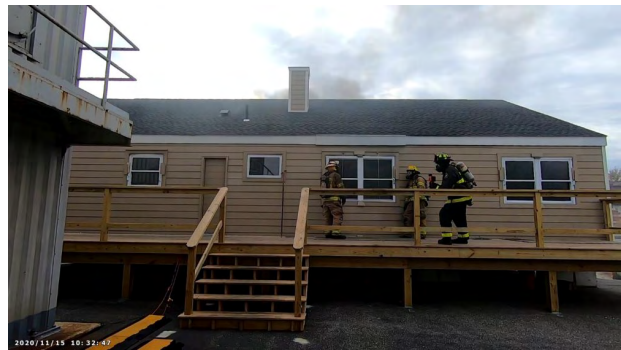
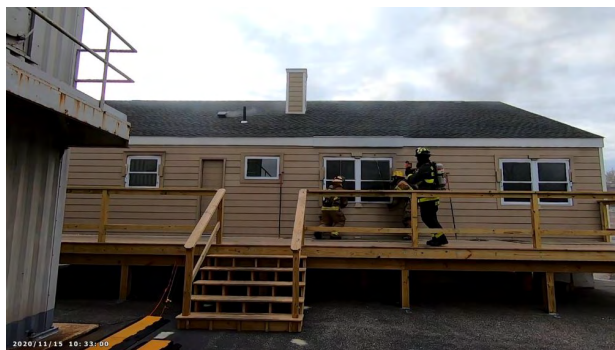
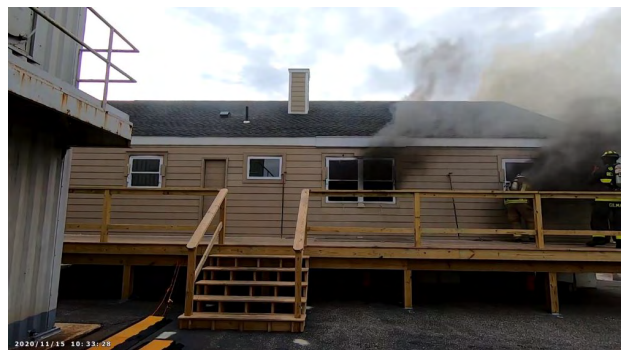
Figure A.2: Firefighters opening a window during Experiment 9.

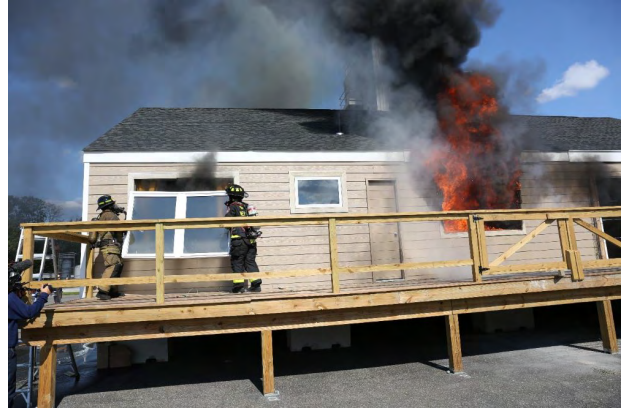
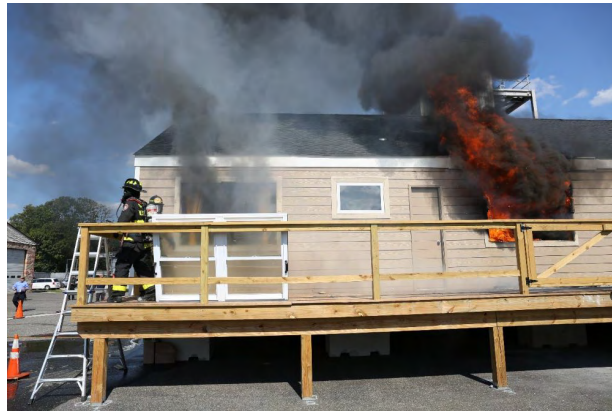
The removal of the two double-hung, dual-pane windows from bedrooms occurred during window initiated search and door initiated search experiments. The window install was designed as a plug. Once the shims, that were installed to ensure an air tight seal, were pulled, the entire two-window assembly could be removed. This action was designed to simulate the search crew breaking all of the glass and clearing the window frame to maximize the area of the vent (6 ft by 4 ft). This occurred either after isolation of the space or after suppression. For the window initiated search experiments that included isolation, the window removal reflected the crew taking the second of the two windows.

Firefighters removed a window by pulling the entire window assembly out of the structure. This action is shown in Figure A.3, where firefighters are seen removing a window during Experiment 4.

Figure A.3: Firefighters removing a window during Experiment 4.
