Analysis of Search and Rescue Tactics in Single-Story Single-Family Homes Part I: Bedroom Fires

UL's Fire Safety Research Institute
Columbia, MD 21045

May 17, 2022

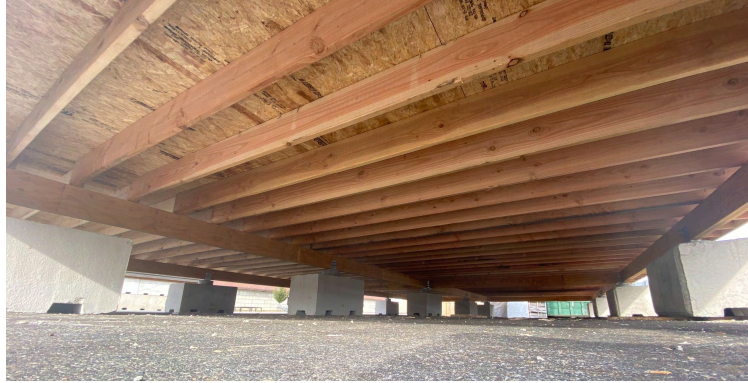
Figure 3.2: Photograph of support assembly for each structure. From the top down, this included the subfloor, floor joists, support beams, and concrete piers.

The subfloor of the structure was comprised of 0.72 in. tongue-and-groove, moisture-resistant, engineered wood sheeting. This sheeting was affixed to nominally 2.0 in. by 10.0 in. fir floor joists, spaced at 16.0 in. on center. The entire flooring system of the structure was supported through a series of laminated veneer lumber beams. Each beam location included a pair of 9.5 in. by 1.75 in. beams affixed together, which brought the total size to 9.5 in. by 3.5 in. The beam network supporting the structure was leveled using concrete piers with incorporated rebar connecting to each footing. Each footing was a 2.0 ft by 2.0 ft by 4.0 ft concrete block.

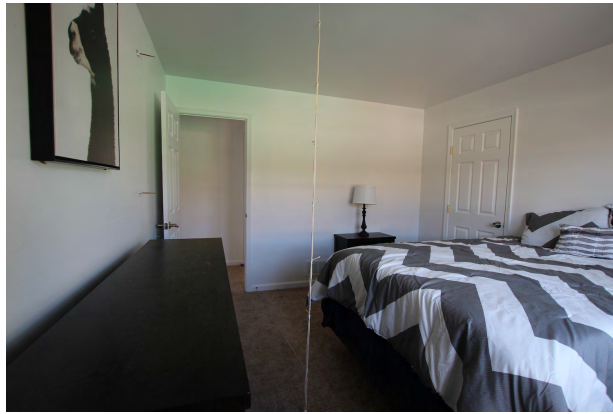
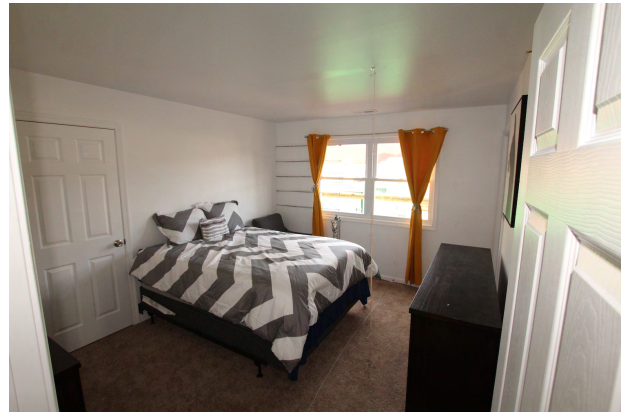
(a) View from Windows Toward Door

(b) View from Door Toward Windows

Figure 3.7: Example layout of fuels from bedroom 3.

Each bedroom’s fuel package consisted of a queen mattress set with a foam mattress topper and associated bedding, a dresser, a night stand, a chair, a lamp, window curtains, and a wall painting as shown in Figure 3.7. Additionally, each bedroom floor was lined with polyethylene terephthalate (PET) carpet, polyurethane (PU) foam padding, and an oriented strand board subfloor. Table 3.1 shows the size, material composition, and mass of each of the items that comprised a bedroom fuel load for each experiment. Note: The layout of the furniture was in one of three configurations based on the location of the respective hallway door, closet/bathroom door, and window, as shown in Figure 3.6.

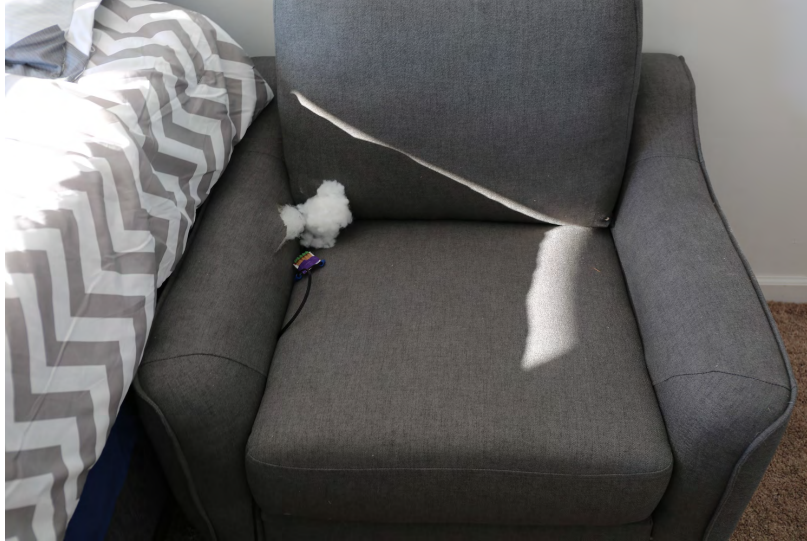
Figure 3.8: Photograph of ignition setup for a bedroom fire.

Bedroom fires were ignited with an electric match located in the corner of the upholstered chair where the seat cushion met the armrest nearest the mattress. A slit was made in the fabric and a small amount of the polyester batting was pulled out. Figure 3.8 shows the ignition setup prior to the matchbook being set underneath the batting.

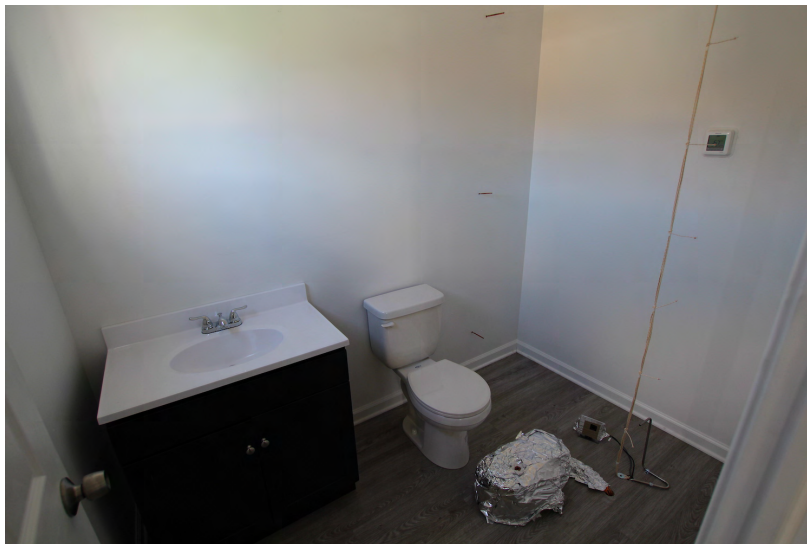
Figure 3.9: Photograph of bathroom fuel layout.

In addition to the fuel load in each of the bedrooms, the two bathrooms were also furnished with representative items (a vanity and toilet) as shown in Figure 3.9.

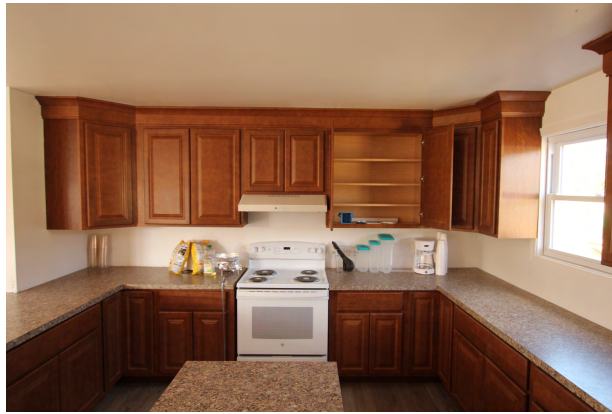
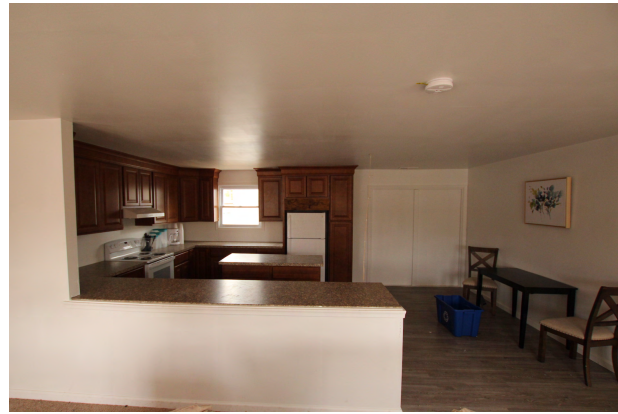
(a) View Toward Ignition Burner

(b) View of Full Kitchen

Figure 3.10: Example layout of kitchen fuels.

The open floor-plan kitchen contained both upper and lower cabinets, a range, a range hood, a refrigerator, an island, a small table, and two chairs. Figure 3.10 shows the layout of the kitchen fuels, and Table 3.2 shows the size, material composition, and mass of each of the items that comprised the primary kitchen fuel load for each experiment.

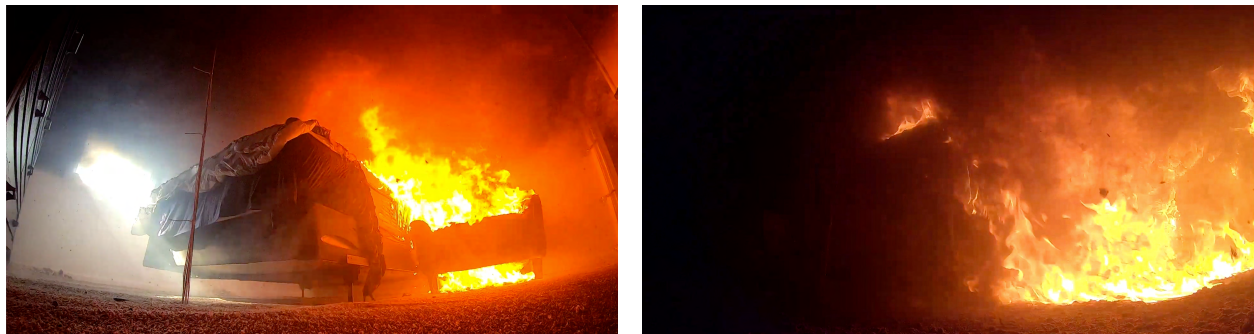
(a) Flames First Visible Out Window

(b) Transition Through Flashover

For the bedroom ignition, consider Experiment 10. Prior to ignition, the lower windows of the fire room were removed and the fire room door and front door were open. The door to bedroom 1 and bathroom 1 were closed while the doors to bedroom 2, bedroom 3, and bathroom 3 were open. The fire was ignited in the upholstered chair next to the bed. Flames were first visible from the bedroom 4 window at 172 s (2:52) post ignition, and Figure 4.1a correspondingly shows the interior conditions. Across the 11 bedroom ignition experiments (Table 3.5), flames were visible out of the window at 176 s (2:56) \pm 25 s. The fire continued to grow and reached flashover at 197 s (3:17) post ignition as floor-to-ceiling temperatures crossed 600 °F (1100 °F) (Figure 4.1b). Post-flashover, flames extended out of the bedroom 4 windows until suppression.

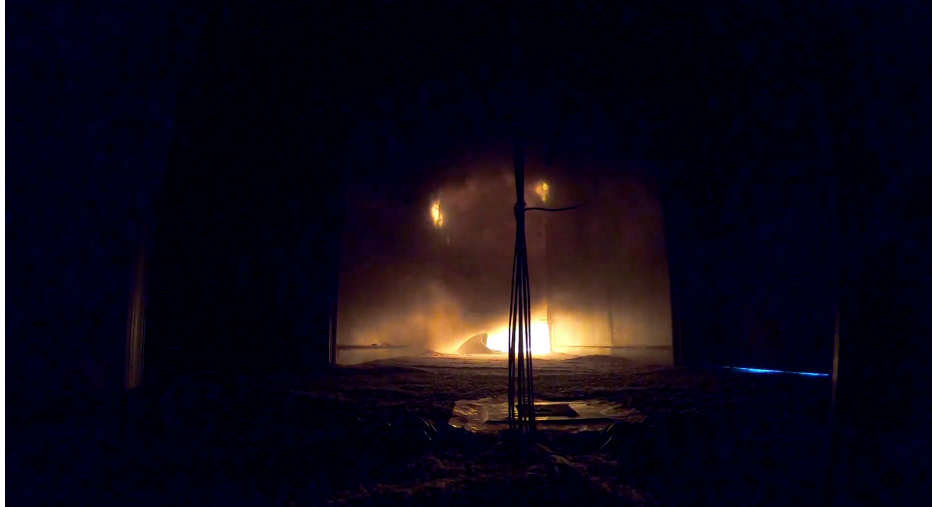
Figure 4.3: Ignition of hallway carpet outside of bedroom 4 just prior to flashover looking from the end hallway location toward the start hallway location.

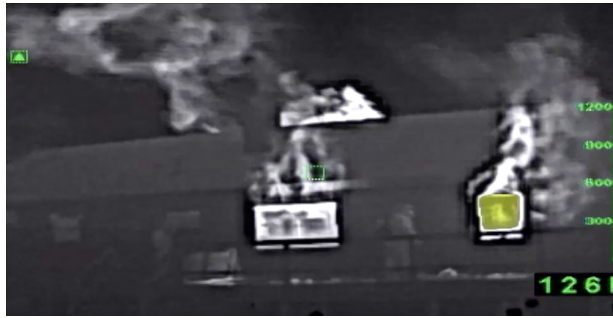
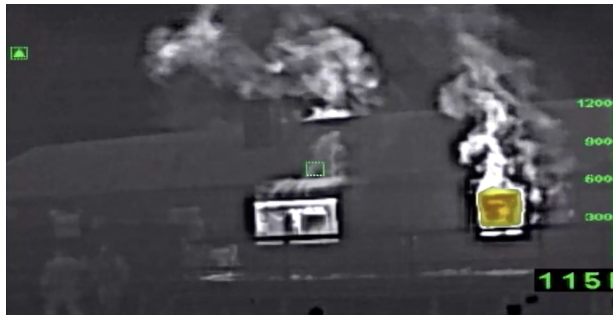
Figure 5.9: Post-intervention, side C view of bedroom 2 (right window) and view of bedroom 2 doorway showing change in conditions following bedroom 1 door open/close in Experiment 1.

Opening and closing the bedroom 1 door increased the available oxygen for combustion within the hallway. As a result, flaming combustion occurred in the hallway and at the bedroom 2 doorway. Heat and flames traveled along the flow path between the fire room and the exterior of the structure through bedroom 2. Figure 5.9 shows the changes in visual conditions in bedroom 2 following the

opening of the bedroom 1 door. Temperatures increased from 380 °C to 516 °C (716 °F to 961 °F) at the top of the window and from 80 °C to 250 °C (176 °F to 482 °F) at the bottom of the window.

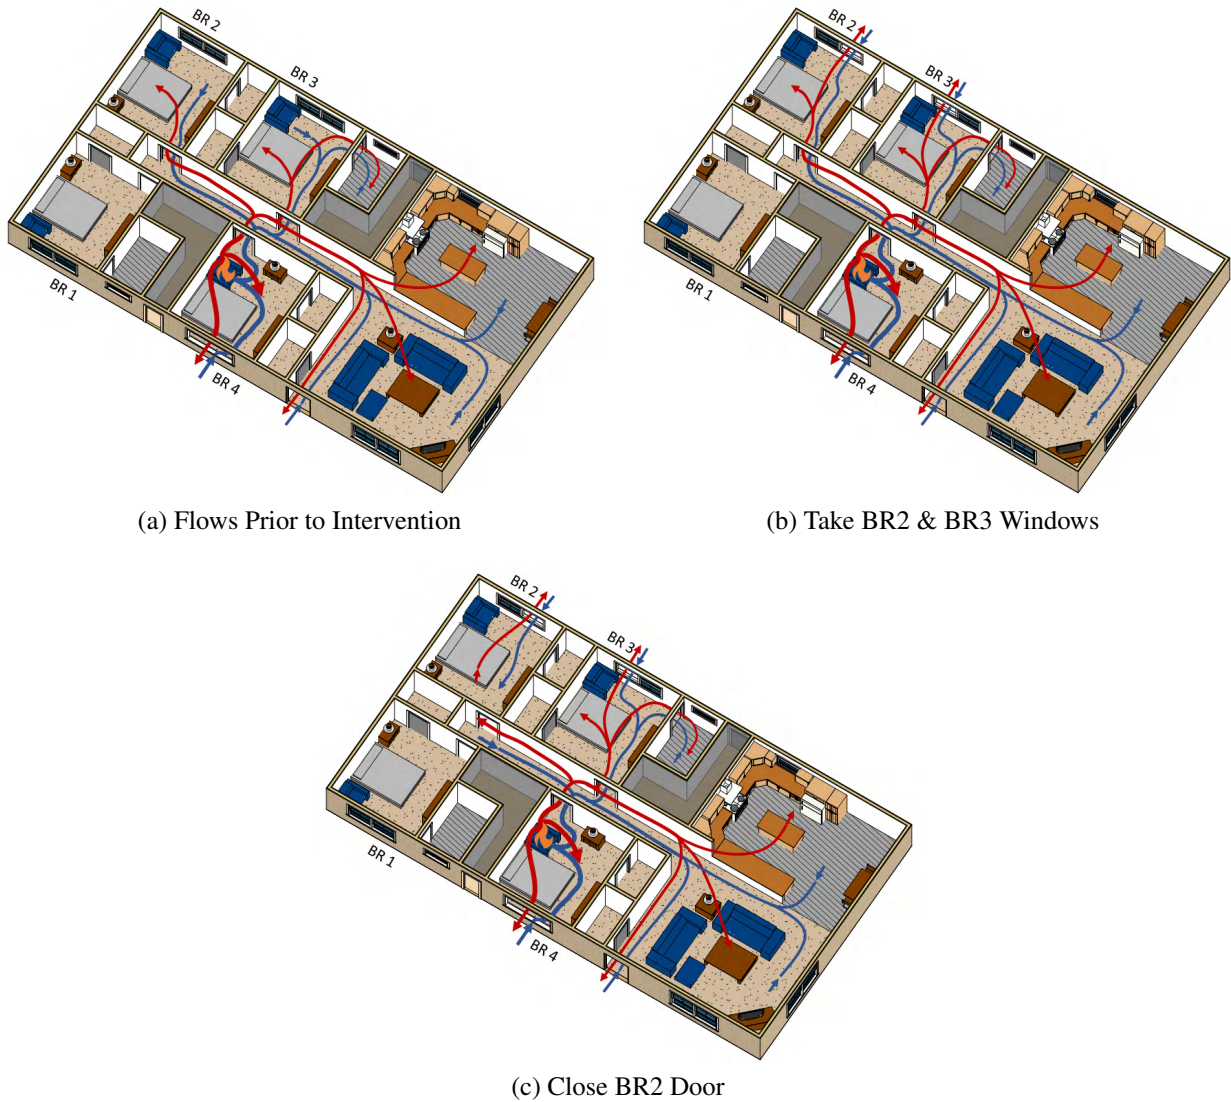
Figure 5.49: Changes in flow in structure following fire department interventions in Experiment 4.

Figures 5.49, 5.50, and 5.51 show the changes in gas flow within the structure caused by each fire department intervention during Experiment 4. Prior to intervention, the bedroom 4 fire was entraining air and exhausting combustion gases, which generated bidirectional flow through the open bedroom 4 vents, as shown in Figure 5.49a. Flow paths were established between the higher-pressure fire room and lower-pressure open volumes of the structure and the exterior.

path established between the higher-pressure fire room and the lower-pressure exterior through each bedroom, as shown in Figure 5.49b. Bidirectional flow through each window exhausted combustion gases and entrained air to each bedroom.

Closure of the bedroom 2 door stopped the flow of combustion gases from the fire room to the bedroom, which limited further accumulation of combustion gases in bedroom 2 (Figure 5.49c). Bidirectional flow through the window exhausted previously accumulated combustion gases.

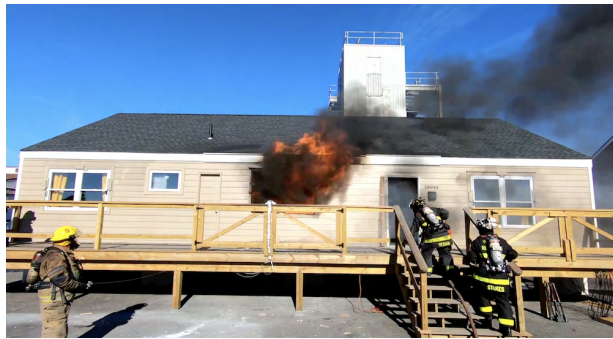
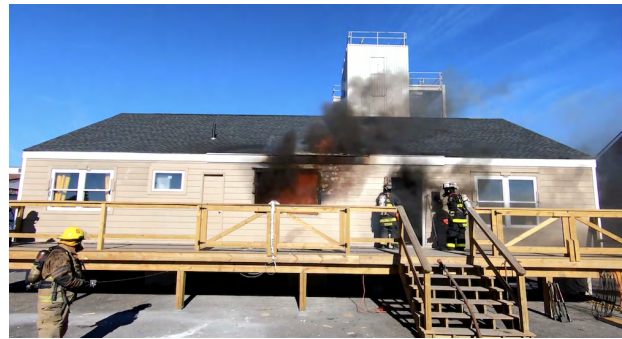
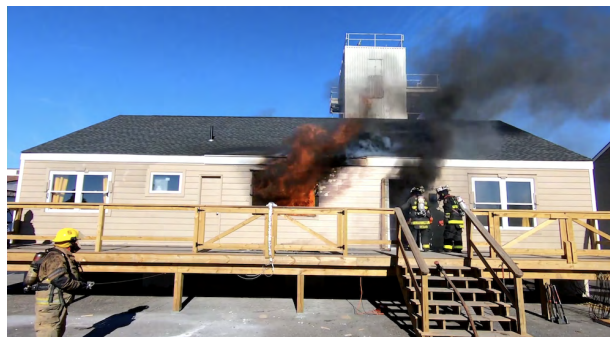
Figure 5.117: Changes in flow through the bedroom 4 window following ventilation of bedroom 3 window in Experiment 8.

to become unidirectional intake and flow through the bedroom 3 window to become unidirectional exhaust. Inflow through the bedroom 4 window was indicated by retreating window flames in Figures 5.117a through 5.117b. The available oxygen for combustion in the fire room increased, which increased the heat release rate of the bedroom 4 fire. Bedroom 4 temperatures exceeded 1010 °C (1850 °F).

As wind velocities slowed, bidirectional flow through the bedrooms 3 and 4 windows established, as indicated by exhaust flow from the bedroom 4 window (Figure 5.117c). The available oxygen for combustion in the fire room decreased, which decreased the heat release rate of the bedroom 4 fire. Bedroom 4 temperatures decreased to to approximately 830 °C (1526 °F).

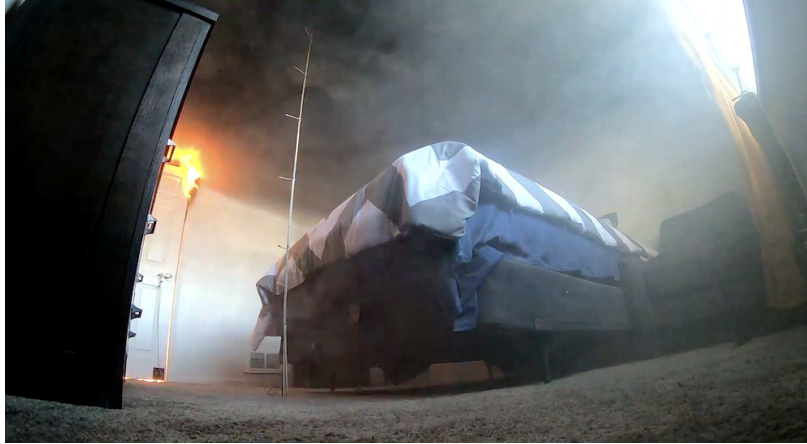
Figure 5.135: Pre-intervention Bedroom 3 Door Combustion

The bedroom 3 door was closed prior to ignition, which isolated the bedroom from the bulk flow of combustion gases. Higher-pressure combustion gases in the hallway still flowed through the leakage area around the closed door and through the HVAC vents. Combustion gases that flowed into the bedroom around the top corner of the closed door auto-ignited approximately 201 s post-ignition. Flaming combustion was sustained at the corner of the doorway (Figure 5.135). The smoke layer in the bedroom had descended approximately 1 ft to 2 ft from the ceiling, generally independent of the flaming combustion at the door.

Prior to intervention, temperatures at the top two measurement elevations in the center of the bedroom were increasing due to the accumulation of combustion gases (Figure 5.138). Recall from Figure 5.135, the smoke layer had descended approximately 1 ft from the ceiling and the corner of door had ignited. Bedroom 3 temperatures ranged from 230 °C (446 °F) at the ceiling to 15 °C (59 °F) 1 ft above the floor. Flow through the ventilated bedroom 3 window limited the temperature increase in the bedroom from flaming combustion around the door frame.

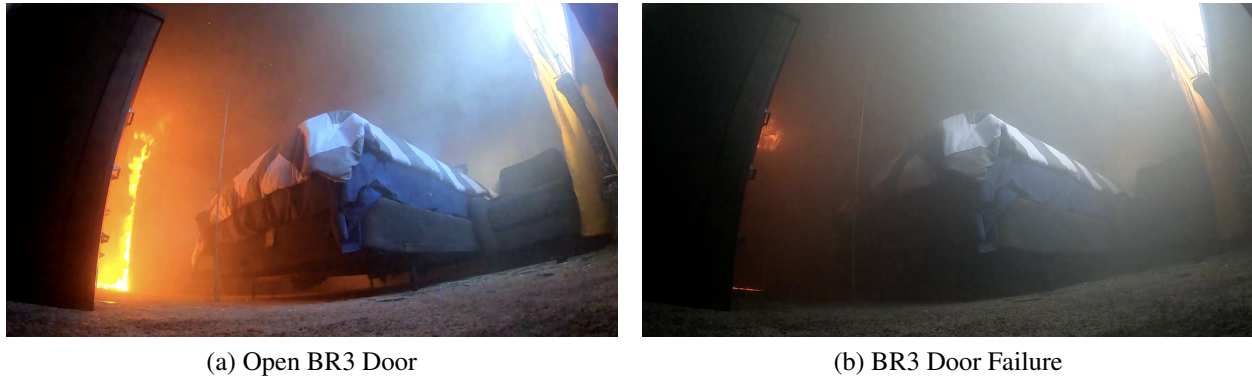
Figure 5.137: Post-intervention Bedroom 8b conditions.

The bedroom 3 door was opened 30 s after the window was ventilated. There was an initial outflow of gases at the top two probes between 0.5 m/s and 1.0 m/s (1.1 mph at 2.2 mph), which increased temperatures 44 in. above the sill to 115 °C (239 °F) and 34 in. above the sill to 52 °C (126 °F). Within 4 s, unidirectional inflow was established through the bedroom 3 window with peak velocities of -5.8 m/s (-13.0 mph) driven by the fire that had spread through hallway, as shown in Figure 5.137a. Due to the increased inflow, temperatures at the window decreased, until the bedroom 3 door was closed 12 seconds later.

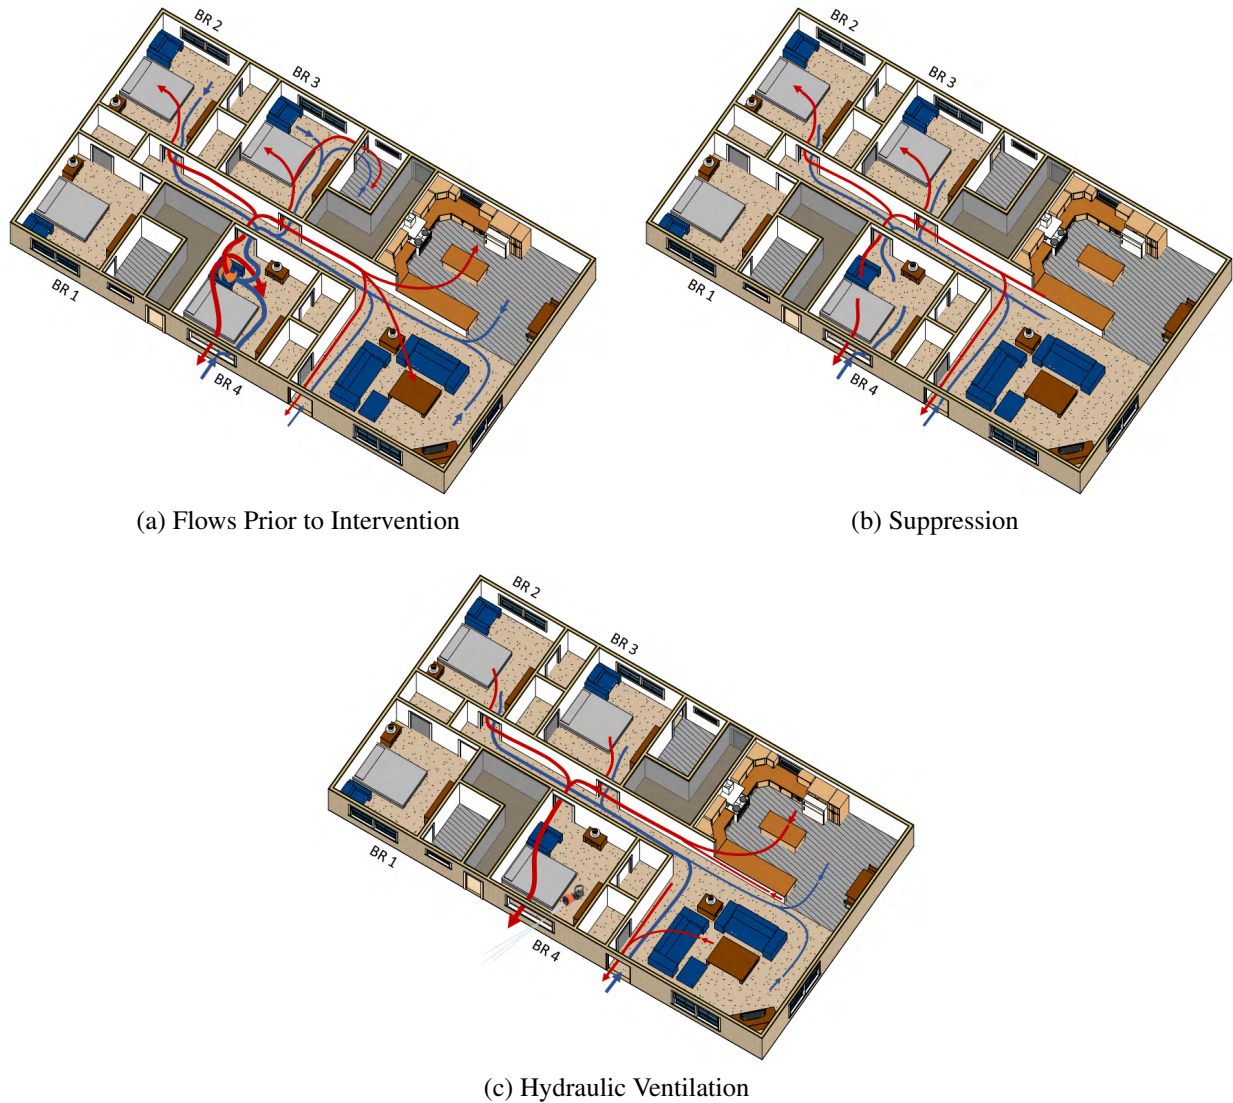
Figure 5.163: Changes in flow in structure following fire department interventions in Experiment 10.

The suppression crew entered the structure through the front door and advanced to the bedroom 4 door with a combination nozzle set to flow a straight stream at 150 gpm with a nominal nozzle pressure of 50 psi, connected to an 1 3/4 in. hoseline. The bedroom 4 door was opened and water was flown immediately. Suppression reduced the heat release rate of the fire and reduced the production of higher-pressure, higher-temperature combustion gases, limiting the flow through the bedroom 4 door to open volumes of the structure (Figure 5.163b).

Hydraulic ventilation occurred out of the failed double-wide bedroom 4 window with a narrow fog in an O-pattern. As water flowing from the room created an area of low pressure, the bedroom 4 vents became unidirectional, exhausting combustion gases from open volumes of the structure (Figure 5.163c).

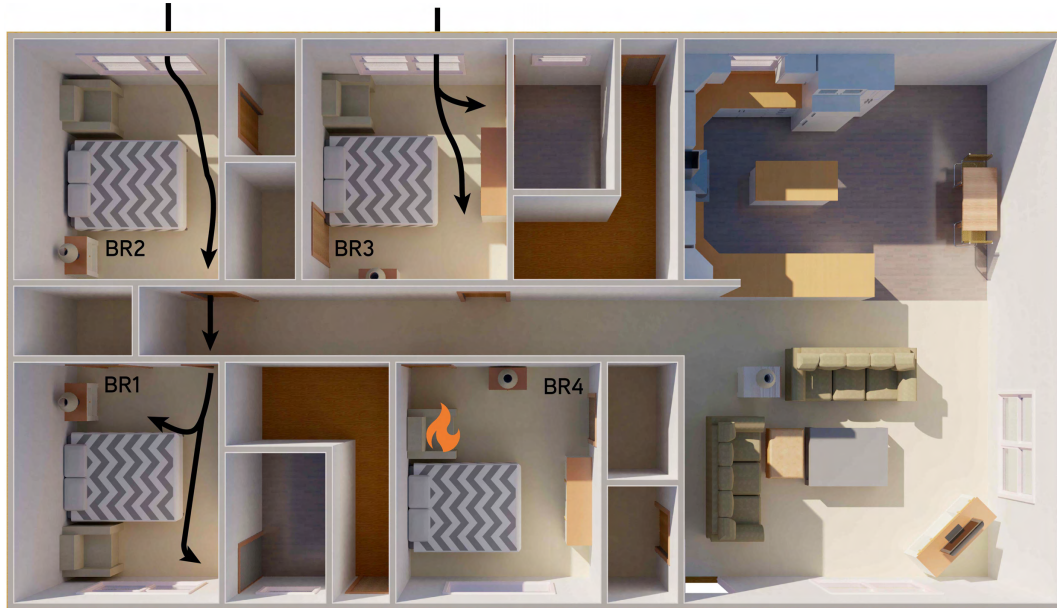
Experiment	Details
1, 2, 3	Isolation of bedroom 3 post entry, varied suppression timing
4, 5	Isolation of bedroom 2 post entry, varied suppression timing

Figure 6.1: Window initiated search pathways that originated simultaneously from bedrooms 2 and 3 for a bedroom 4 fire. Black lines represent pathways the search crews took.

In Figures 6.1 – 6.3, the arrows represent the overall path of travel for the search crew(s) within the structure and are not intended to be representative of the physical footsteps taken within each compartment. The first pathway was simultaneous window initiated search into bedrooms 2 and 3. Crews entered the structure by taking the bedroom windows, and the firefighters that entered into

bedroom 2 proceeded to search beyond the room of entry by entering a previously isolated bedroom 1. Experiments 1–5 utilized this approach. The key variables that changed were if the bedroom of entry was isolated after entry and the timing of suppression relative to the start of search operations. Figure 6.1 shows the routes taken for the crews for these 5 experiments.

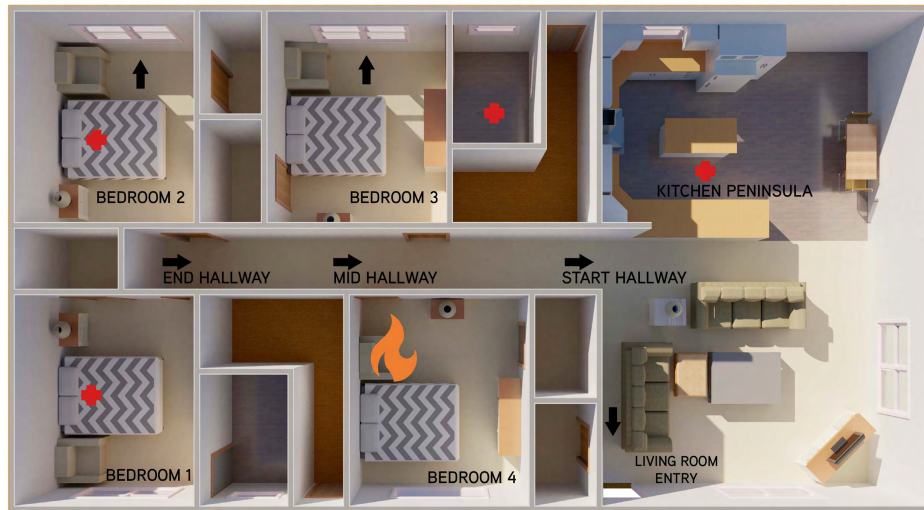
Figure 6.5: Thermal exposure measurement locations. The red plus signs are locations of potentially trapped occupants and the black arrows are measurement locations along potential egress pathways.

Temperatures and heat fluxes and the combined resultant FEDs can vary considerably prior to fire department intervention, due to differences in ignition location, initial fire growth, and time of intervention. To control for the time of intervention, the analysis will focus on the cumulative FED at the time of earliest intervention across the bedroom experiments, which occurred during Experiment 4 at 270 s post-ignition of the upholstered chair in bedroom 4. At this point, for all bedroom experiments, bedroom 4 was in post-flashover state. Figure 6.5 shows the locations for exposure measurements of potentially trapped occupants and Table 6.1 presents the median and range of cumulative thermal FED at all temperature and heat flux measurement locations within the structure for the 11 bedroom experiments.

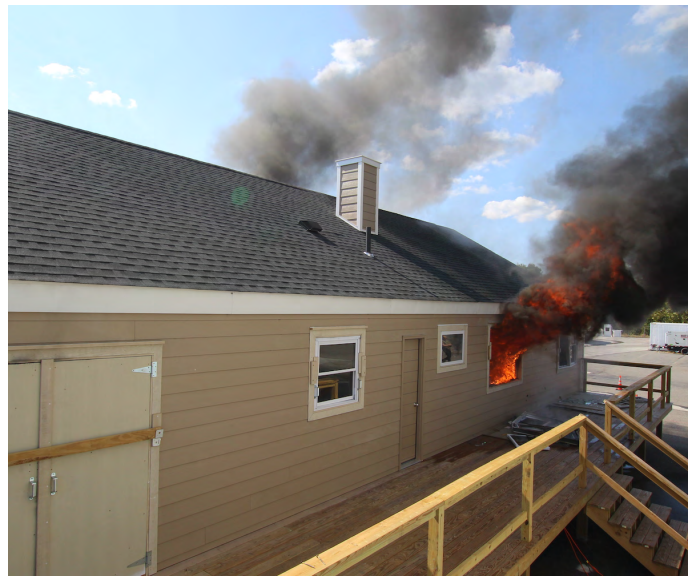
Figure 6.11: Photograph of side C exterior fire conditions at bedroom 3 window 90 s after window ventilation during Experiment 4.

In Experiment 4, where bedroom 3 was not isolated, 3 ft temperatures in bedroom 3 steadily rose from 146 °C (295 °F) to 200 °C (392 °F) in the 30 s following window ventilation, which increased the operating class from ordinary to emergency. Over the next 30 s, the lack of isolation, presence of an exterior vent, and close proximity to the fire compartment resulted in flame spread across the hallway and into bedroom 3. Within 90 s of window ventilation, the 3 ft temperatures crossed 800 °C (1472 °F) and the room transitioned through flashover as shown in Figure 6.11. Bedroom 3 remained in the emergency operating class until suppression, with 3 ft temperatures peaking at 935 °C (1715 °F). Additionally, bathroom 3, which was also not isolated, reached the emergency operating class 98 s after initial intervention. The 3 ft temperatures peaked at 330 °C (626 °F) and 10 kW/m². Bathroom 3 was adjacent to, but not part of the flow path created between the fire room and the bedroom 3 window, which both delayed and dampened the temperature and heat flux rise in the space relative to the bedroom.

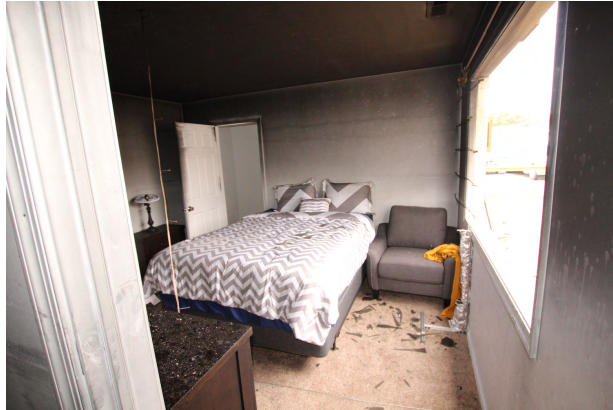
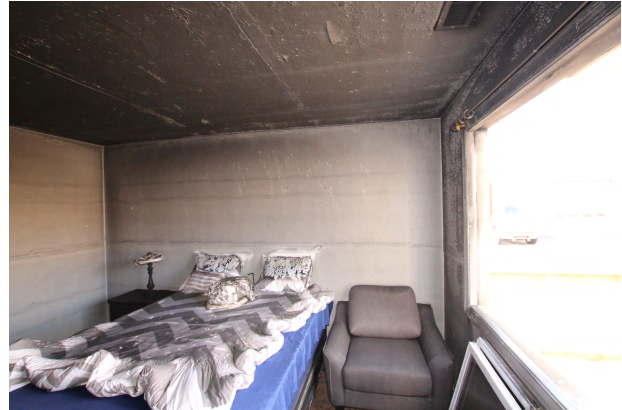
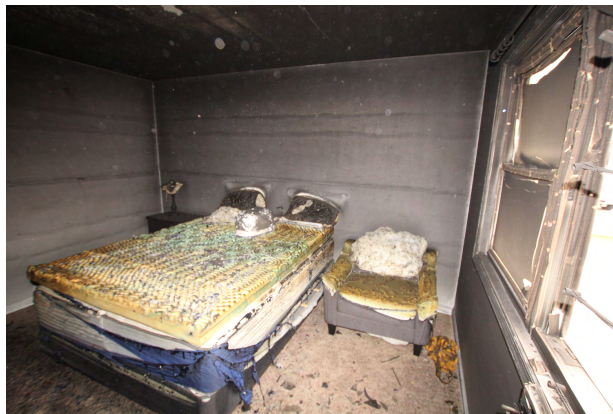
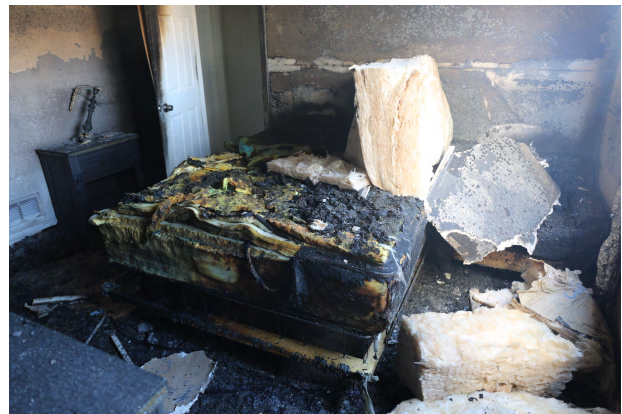
respective experiments. Note the distinct differences in thermal damage between Figures 6.12a and 6.12b where the rooms were isolated and Figures 6.12c and 6.12d where the rooms were not isolated.

(a) Experiment 1 Bedroom 3 (Isolated)

(b) Experiment 4 Bedroom 2 (Isolated)

(c) Experiment 1 Bedroom 2 (Not Isolated)

(d) Experiment 4 Bedroom 3 (Not Isolated)

Figure 6.12: Post experiment photographs of bedrooms 2 and 3 for Experiments 1 and 4.

In both Experiments 1 and 4, the bedrooms which were isolated after ventilation transitioned back to the routine operating class prior to suppression due to the combination of the closed door and local exterior vent. In Experiment 1, 3 ft bedroom 3 temperatures peaked at 145 °C (293 °F) and in Experiment 4, 3 ft bedroom 2 temperatures peaked at 256 °C (493 °F). In both experiments, the peak temperatures in these rooms occurred immediately prior to closure of the respective bedroom doors, further quantifying the thermal protection provided by a closed door due to the isolation from the flow path. Figure 6.12 shows post-experiments photographs of both bedrooms for the

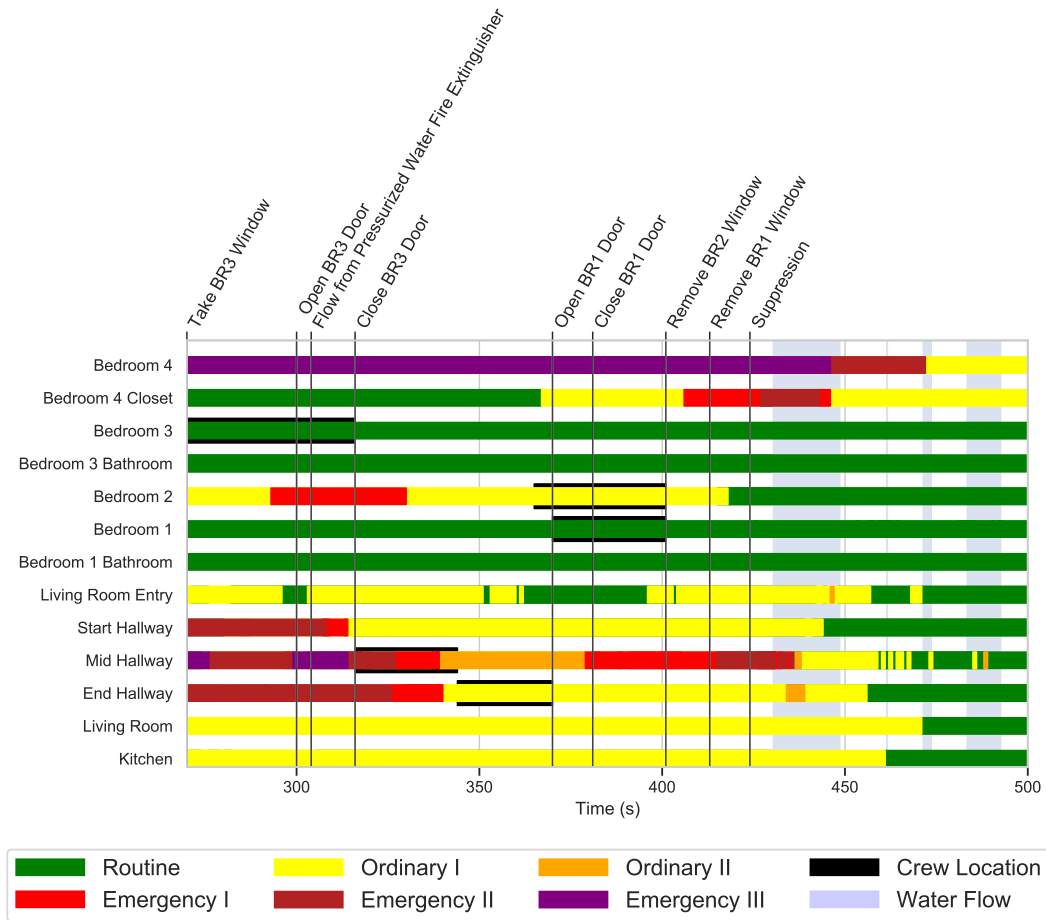
Figure 6.13: Comparison of thermal operating conditions based upon 3 ft elevation temperatures and heat fluxes during post-intervention period for pre-suppression window initiated search tactics into an isolated room (Experiment 8b).

In Experiment 8b a window initiated search ahead of suppression was performed into a room, in this case bedroom 3, that was isolated prior to ignition. Figure 6.13 shows the thermal conditions, expressed as the thermal operating class, corresponding to both the 3 ft temperature and heat flux (where available) in the period following the initial intervention for Experiment 8b. The black bars on the charts correspond to the relative locations of the search crews during the events sequence.

As shown in Figure 6.13, bedroom 3 remained in the routine operating class for the duration experiment. Prior to the window ventilation, there was intermittent flaming combustion at the top of the door frame due to the 1000 °C (1832 °F) temperatures at the ceiling in the hallway (Figure 6.14a). Although sustained combustion on the bedroom 3 side of the door did not occur (Figure 6.14b, the intermittent burning is an indication that a closed door may not provide infinite protection. The 3 ft temperature in the bedroom was at 20 °C (68 °F) prior to the ventilation of the window and remained nominally steady in the 30 s until the door was opened. Despite the exterior vent created in bedroom 3, the closed door provide sufficient flow resistance to prevent the higher temperature, higher pressure fire gases from filling the bedroom as shown by the hallway conditions following the door being opened in Figure 6.14c. Additionally, because the door was only opened for 16 s and there was water flow from a pressurized water fire extinguisher immediately following the bedroom door being opened, flaming combustion local to the mid hallway location was temporarily controlled and the 3 ft temperatures in bedroom 3 peaked at 38 °C (100 °F) shortly after the door was closed.

Recall Figure 6.13 from Section 6.3.1, the closed door prior to the window initiated search kept bedroom 3 in the routine operating class for firefighters for the duration of the experiment. This was similar to bedroom 1, which was also isolated but did not have a vented window. In contrast, bedroom 2 which had an open interior door reached the ordinary operating class. The FER data shows similar results for the toxic and thermal exposures to potentially trapped occupants. The rate of toxic and thermal FED increase in bedroom 3 was of similar magnitude to bedroom 1 compared to bedroom 2. In particular the rate of toxic FED increase was between 2 to 3 orders of magnitude higher in the open bedroom. This further shows the impact of the closed door in reducing exposure and that ventilation into an isolated space does not drastically change the conditions of the space.

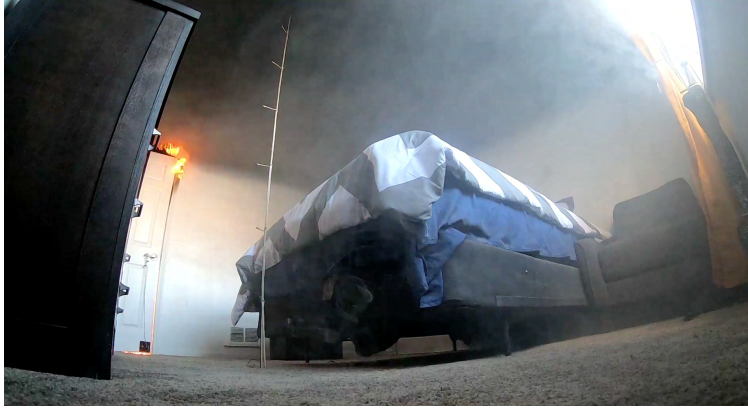
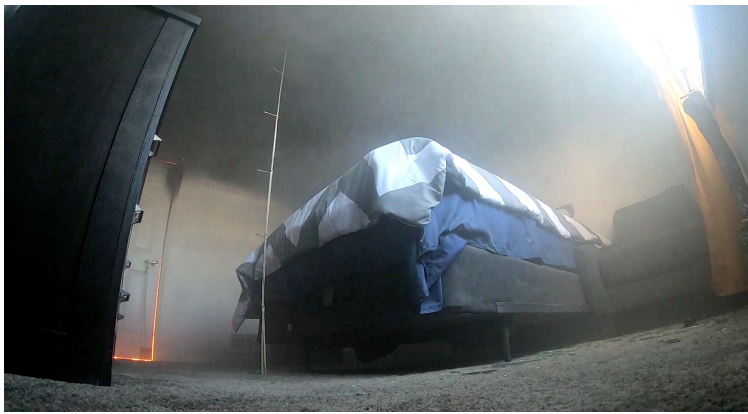
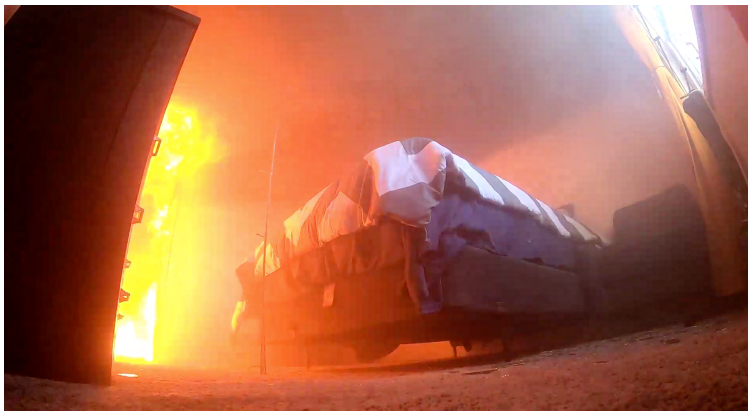
(a) 10 s Prior to Window Ventilation

(b) Immediately Prior to Hallway Door Open (30 s Post Window Ventilation)

(c) Immediately Following Hallway Door Open

Figure 6.14: Images of bedroom 3 from Experiment 8b prior to window ventilation and before and after opening the interior hallway door.

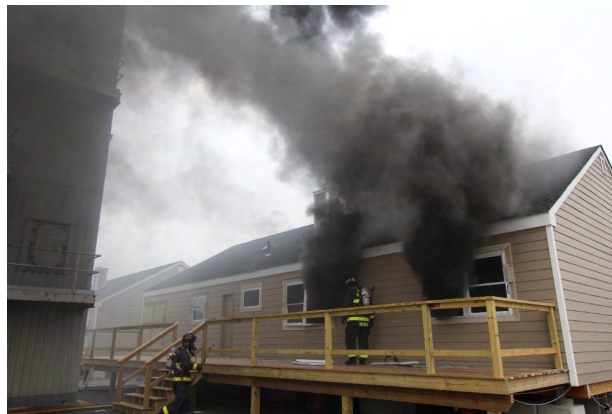
(a) Take Window (Before)

(b) Take Window (During)

(c) Take Window (After)

Figure A.1: Firefighters taking a window during Experiment 1.

To begin window initiated search operations, exterior crews used pike poles to break one of two double-hung, dual-pane bedroom windows. The area of the opening created was 3 ft x 4 ft. This action was designed to replicate the action that search crews would take to make an exterior entry point to search the interior of the structure. Figure [A.1](#) shows a series of images of firefighters taking one-half of the bedroom 2 and bedroom 3 windows during Experiment 1. After this was completed, one side of the window remained intact (Figure [A.1c](#)).

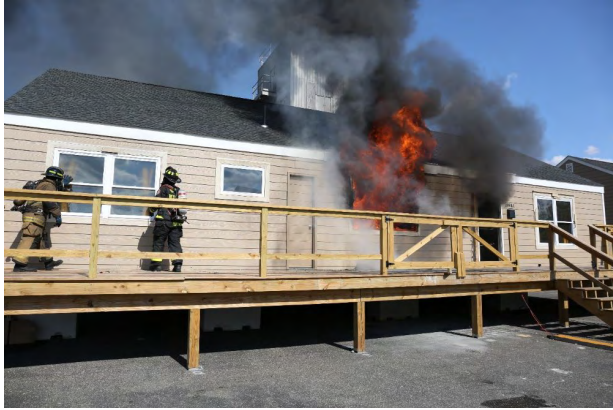
(a) Remove Window (Before)

(b) Remove Window (During)

(c) Remove Window (After)

Figure A.3: Firefighters removing a window during Experiment 4.

The removal of the two double-hung, dual-pane windows from bedrooms occurred during window initiated search and door initiated search experiments. The window install was designed as a plug. Once the shims, that were installed to ensure an air tight seal, were pulled, the entire two-window assembly could be removed. This action was designed to simulate the search crew breaking all of the glass and clearing the window frame to maximize the area of the vent (6 ft by 4 ft). This occurred either after isolation of the space or after suppression. For the window initiated search experiments that included isolation, the window removal reflected the crew taking the second of the two windows.

Firefighters removed a window by pulling the entire window assembly out of the structure. This action is shown in Figure A.3, where firefighters are seen removing a window during Experiment 4.
