# Evaluation of Ventilation-Controlled Fires in L-Shaped Training Props

Joseph Willi  
Keith Stakes  
John Regan  
Robin Zevotek

UL Firefighter Safety Research Institute  
Columbia, MD 21045

October 16, 2018

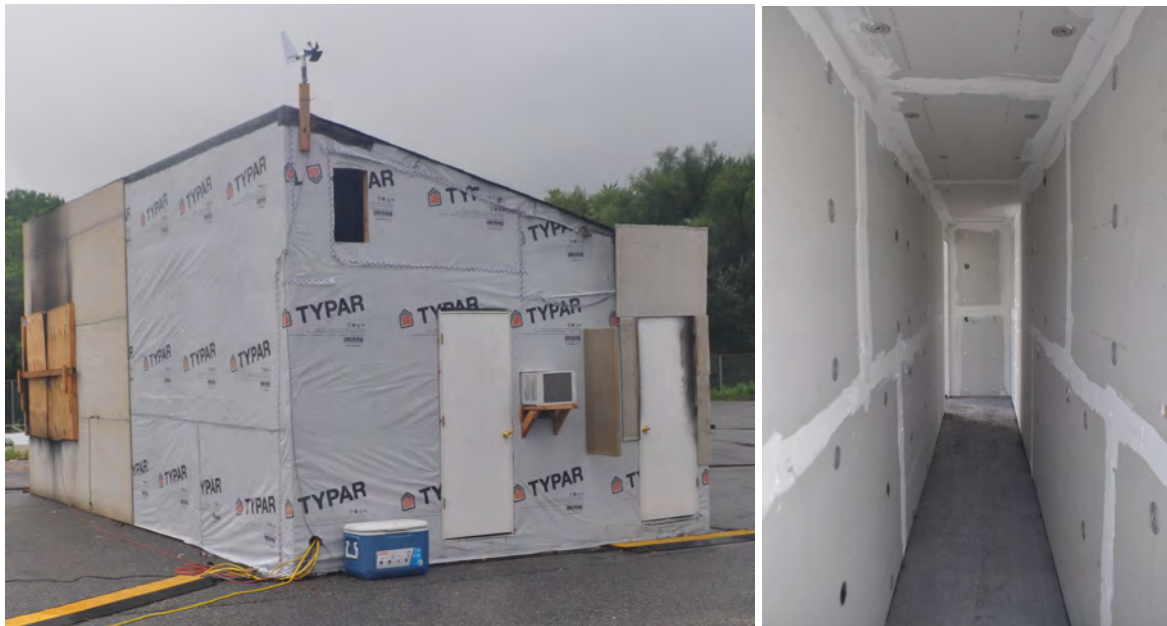
Figure 3.1: Images of the Gypsum Prop exterior (left) and interior (right). The exterior view is from the AB corner of the Gypsum Prop, and the interior view is looking down the hallway towards the fire room.

The Gypsum Prop was constructed to replicate a typical hallway and room of a single-family dwelling that utilizes modern construction practices. The size and layout of the Gypsum Prop were selected to resemble the metal container props, which were constrained by the fixed sizes of steel shipping containers. Additionally, the hallway size was similar to that of the ranch structure used for full-scale fire experiments during a previous research project that focused on studying fire attack with interior and exterior streams [27]. Figure 3.1 contains pictures of the exterior and interior of the Gypsum Prop.

The walls of the Gypsum Prop were composed of nominally 2.0 in. (5.1 cm) by 4.0 in. (10.2 cm) wooden studs, actual dimensions 1.5 in. (3.8 cm) by 3.5 in. (8.9 cm), with 16.0 in. (40.6 cm) on-center spacing. Fiberglass insulation (R-13 value) was placed in the spaces between studs, as is typical in residential structures. The insulation, commonly referred to as “batt” insulation, contained a paper face and was pre-cut into sections that filled the entire volume between studs. The exterior sides of the walls were lined with a layer of 0.5 in. (13 mm) thick plywood covered by plastic home wrap to provide weather-proofing. The interior side was lined with a layer of 0.5 in. (13 mm) thick lightweight gypsum board. Normal weight drywall compound, screws, and joint tape were utilized during the installation. The floor of the structure was comprised of nominally 2.0 in. (5.1 cm) by 6.0 in. (15.2 cm) boards, actual dimensions 1.5 in. (3.8 cm) by 5.5 (14.0 cm), arranged on edge with 16.0 in. (40.6 cm) on-center spacing. A base layer of 0.75 in. (19 mm) thick plywood formed the subfloor and was covered by a top layer of 0.5 in. (13 mm) thick cement board. The hallway door was a hollow core interior door, commonly used for interior doors of residential structures, and the window contained two plywood panels covered by Kaowool insulation that

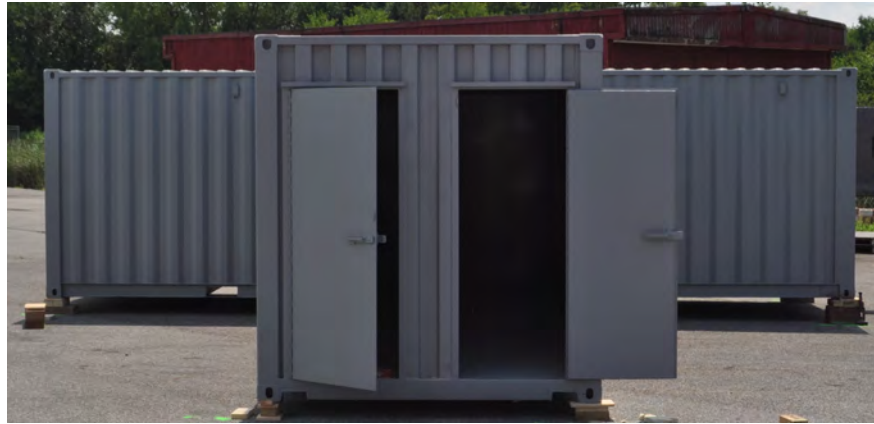
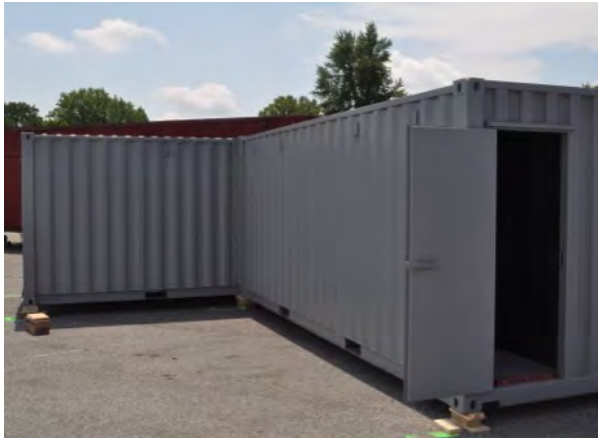
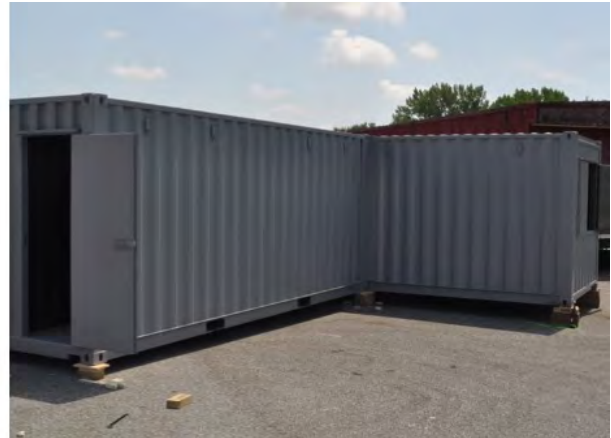
Figure 3.4: Exterior views of the Insulated Metal Prop. The top image is of the front, and the bottom images are of the left and right sides.

L-shaped sides that were mirror images of one another. Dividing the T-shape into two L-shaped props with identical dimensions provided the ability to conduct two experiments with the same wall configuration in rapid succession. The layout was formed by two steel shipping containers — a 30.0 ft (9.1 m) long by 8.0 ft (2.4 m) wide shipping container formed the two burn rooms, or the top part of the “T”, and a 20.0 ft (6.1 m) long by 8.0 ft (2.4 m) wide container formed both hallways, or the bottom portion of the “T”. Exterior views of the Insulated Metal Prop are shown in Figure 3.4.

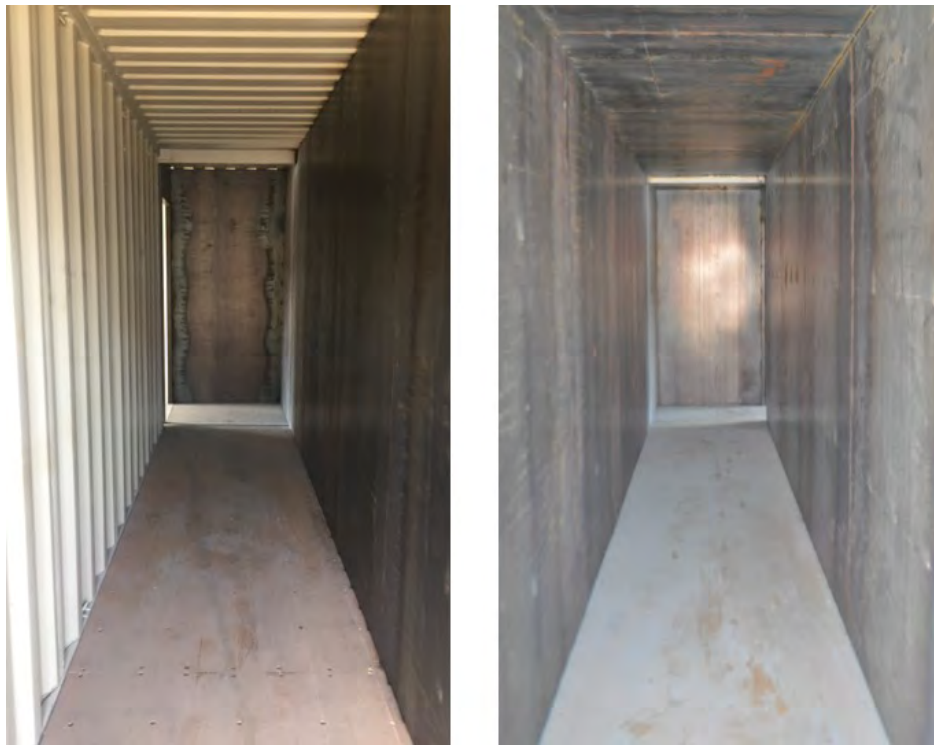
Figure 3.5: Images of interior wall linings of the Metal Prop (left) and Insulated Metal Prop (right). Both views are looking down the hallway towards the fire room.

The interior wall linings of the Metal Prop and Insulated Metal Prop are pictured in Figure 3.5. Dimensioned floor plans of the Metal Prop and Insulated Metal Prop are presented in Figures 3.6 and 3.7, respectively. Additionally, isometric views of a CAD model of the Metal Prop are shown in Figure 3.8. Note that because the interior wall lining was the only differentiating factor between the Metal Prop and Insulated Metal Prop, the exterior views of their CAD models are identical.

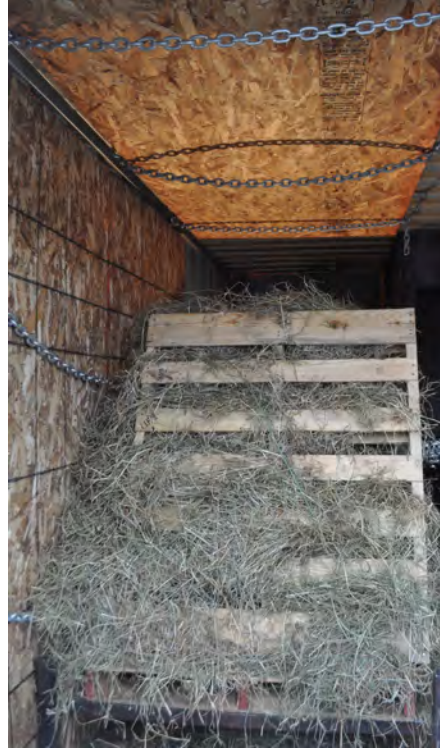
Figure 3.11: Image of the pallets & OSB fuel load.

Some fire training academies incorporate the use of OSB in addition to pallets and straw with the expectation that adding OSB in varying configurations creates a more realistic experience for students. The variation studied for this project, referred to as the “pallets and OSB” fuel package throughout this report, contained three pallets and one bale of straw configured on a steel platform like the pallets fuel load. Three 0.625 in. (16 mm) thick sheets of OSB were positioned around the pallets and straw setup as shown in Figure 3.11. Two of the sheets, each measuring 7.5 ft (2.3 m) by 4.0 ft (1.2 m) with an average weight of 36.2 lbs  $\pm$  5.3 lbs (16.4 kg  $\pm$  2.4 kg), were centered behind the steel platform and held against the wall by steel chains. The third sheet, measuring 8.0 ft (2.4 m) by 4.0 ft (1.2 m) with an average weight of 37.0 lbs  $\pm$  4.6 lbs (16.8 kg  $\pm$  2.1 kg), was centered above the pallets and straw fuel load and supported by steel chains. The location of the steel platform in the fire room was the same as in the pallets fuel load configuration, shown in Figure 3.10. Remote ignition for this fuel load occurred via an electronic matchbook located within the straw in the center of the pallet formation.

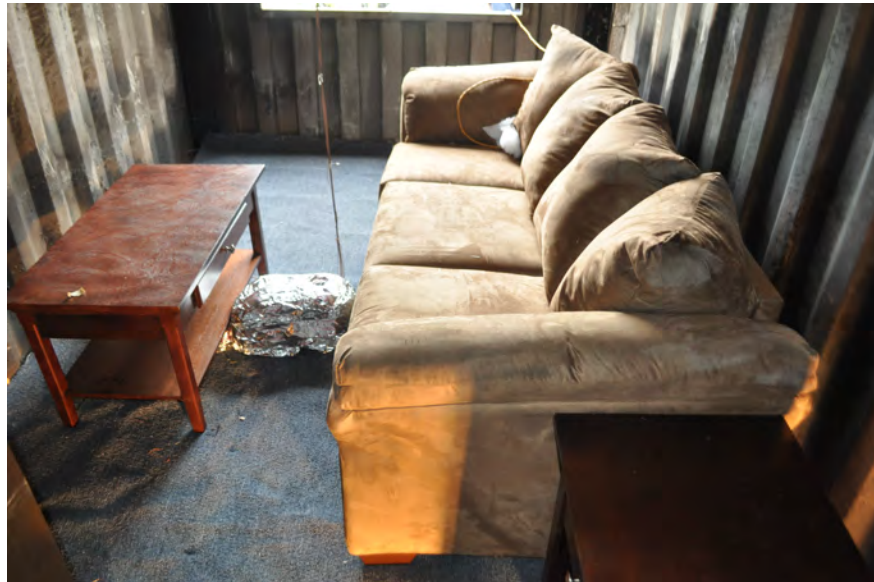
Figure 3.12: Furniture fuel load consisting of a couch, coffee table, end table, and carpet on top of padding and OSB.

To provide a real-world comparison to the wood-based fuel packages, a fuel load with residential furnishings was also utilized during experiments. This fuel package, referred to as the “furniture” fuel load, is pictured in Figure 3.12. It contained six components: a couch with polyurethane cushions, coffee table, end table, and polyolefin carpet on top of a layer of polyurethane padding and OSB. The average weight of each item is listed in Table 3.1, and their locations within the fire room are shown in Figure 3.13. Remote ignition for this fuel load occurred via an electronic matchbook resting on the couch corner closest to the fire room window.

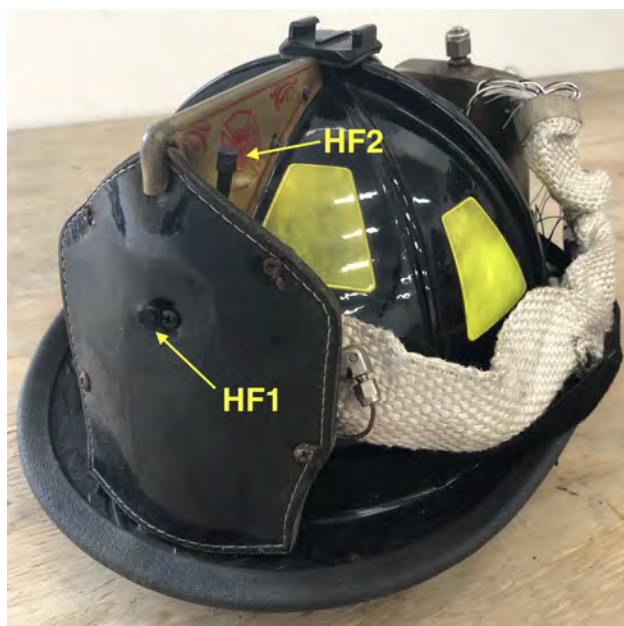
Figure 3.15: Image of the helmet worn by the firefighter at the nozzle during experiments involving interior suppression. Two heat flux gauges mounted on the helmet, labeled “HF1” and “HF2” measured the incident heat flux exposure to the firefighter in the horizontal and vertical directions, respectively.

Aspects of the typical instrumentation layout pictured in Figure 3.14 were modified to reduce potential obstructions and create more space for the firefighters to advance down the hall during experiments that involved interior suppression. First, the two thermocouple arrays in the hall were moved from being centered between the walls to being mounted against the longer wall. Also, the five BDPs in the door opening were moved approximately 8 in. (20 cm) away from the center of the opening. Lastly, the two heat flux gauges in the hallway were removed entirely and replaced by Schmidt-Boelter heat flux gauges mounted on the helmet of the firefighter at the nozzle. To measure the incident heat flux from conditions in front of and above the firefighter, one gauge was positioned to “look” horizontally in front of the firefighter, and the other was positioned to “look” vertically above the firefighter. The sensors, labeled “HF1” and “HF2”, respectively, are pictured in Figure 3.15. Data from the two gauges were recorded by a microcontroller (Arduino Yun) that was also mounted to the helmet.

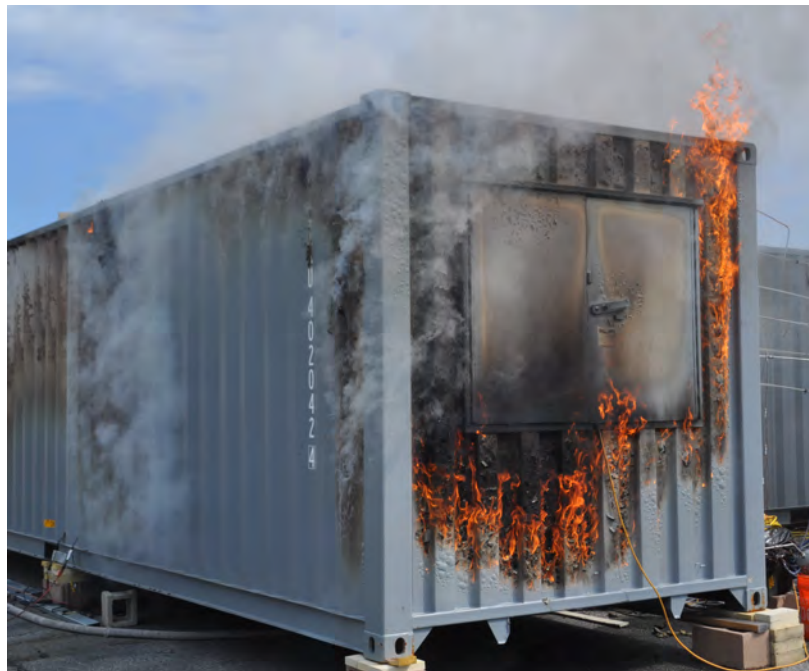
Figure 4.1: Example of fire spread to the exterior surface of the Metal Prop during the initial experiment. This phenomenon was caused by the exterior paint reaching its autoignition temperature and igniting.

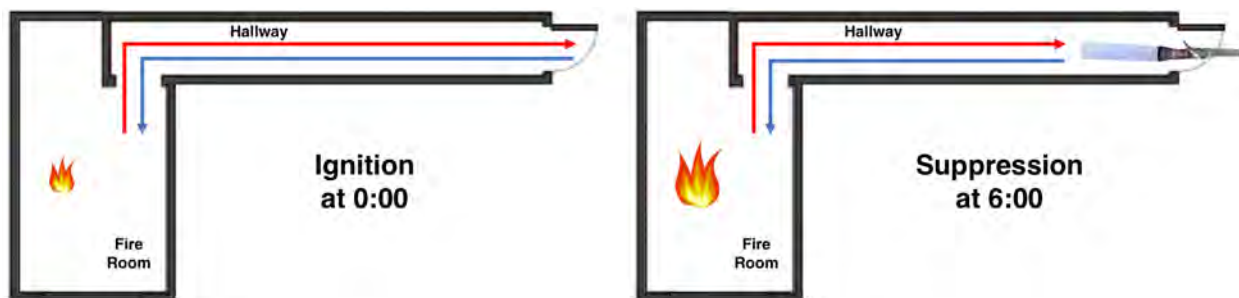
Figure 4.5: Floor plans highlighting the flow path created during suppression effects tests. The red arrows show the direction in which the hot exhaust gases flowed, and the blue arrows show the direction in which the cool inlet air flowed to the fire for combustion.

Three experiments were completed to evaluate and compare the effect of suppression on the thermal environment, specifically the immediate thermal exposure encountered by the firefighter at the nozzle, between the three different wall constructions. Each experiment used the pallets and OSB fuel load and followed the procedure outlined in Table 4.5 and Figure 4.5.

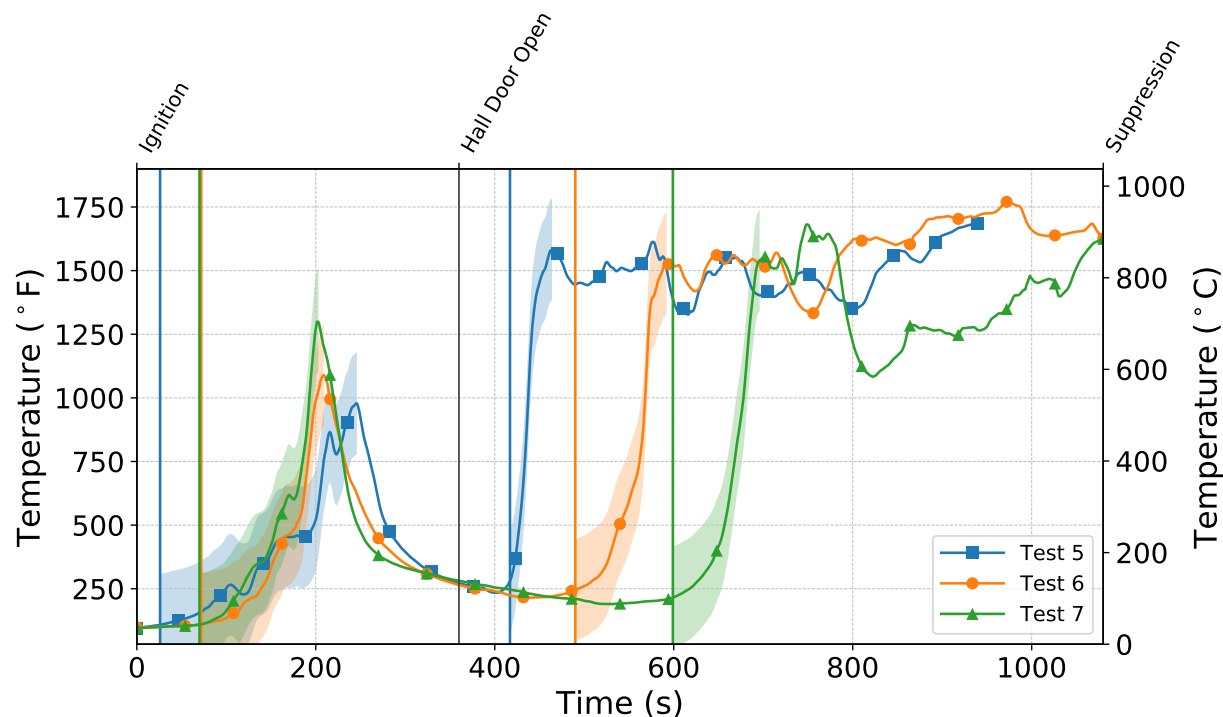
Figure 5.1: Plots of temperature data measured 1.0 in. (25 mm) below the fire room ceiling during the three repeatability tests conducted in the Gypsum Prop with the furniture fuel load. Vertical lines mark the growth and regrowth times for the identically colored plot, and shaded areas represent the duration over which growth and regrowth rates were calculated for the plot of similar color. Note, the fire in Test 5 (blue plot) was suppressed early to prevent the structural members of the prop from being permanently damaged.

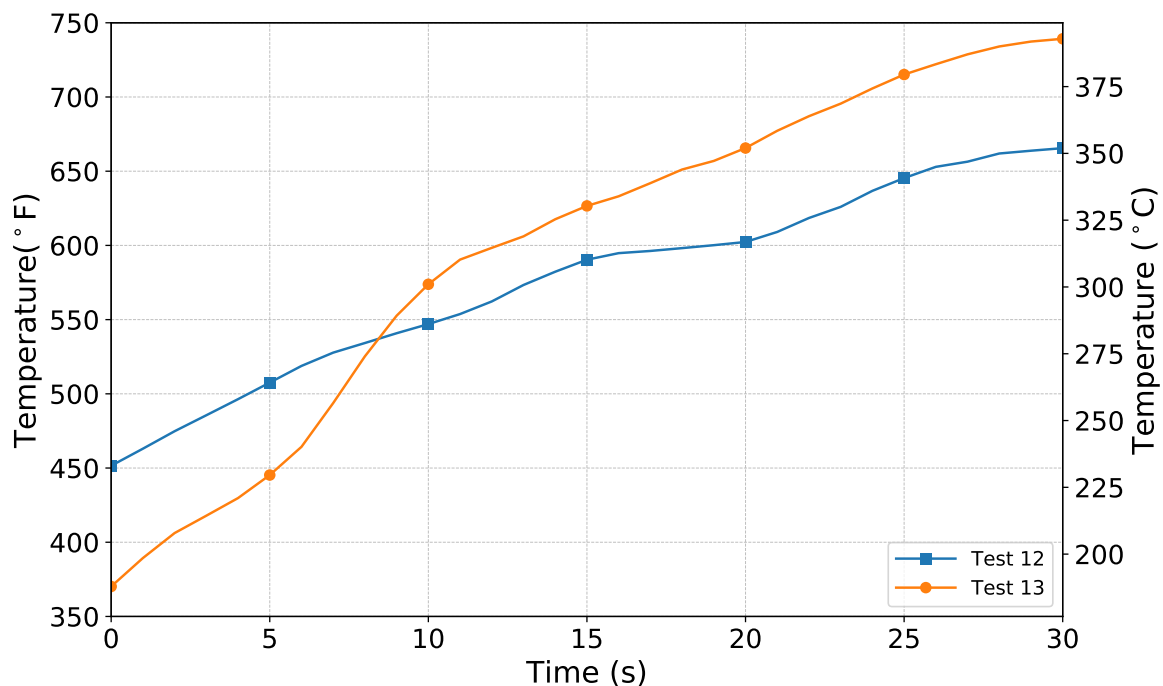
Figure 5.3: Temperature data measured by the thermocouple 2 ft (0.6 m) below the fire room ceiling during the initial growth period of Tests 12 and 13. These data sets are used as an example to outline the method used to quantify overall agreeableness of fire conditions between experiments.

Figure 5.4: Scatter plot of measurement pairs (blue circles) formed by the Test 12 and Test 13 temperature data plotted in Figure 5.3. The black line is the line of perfect agreement, the gray area represents the region on each side of the line within estimated measurement uncertainty, and the red, dashed line corresponds to the linear regression line fitted over the data pairs.

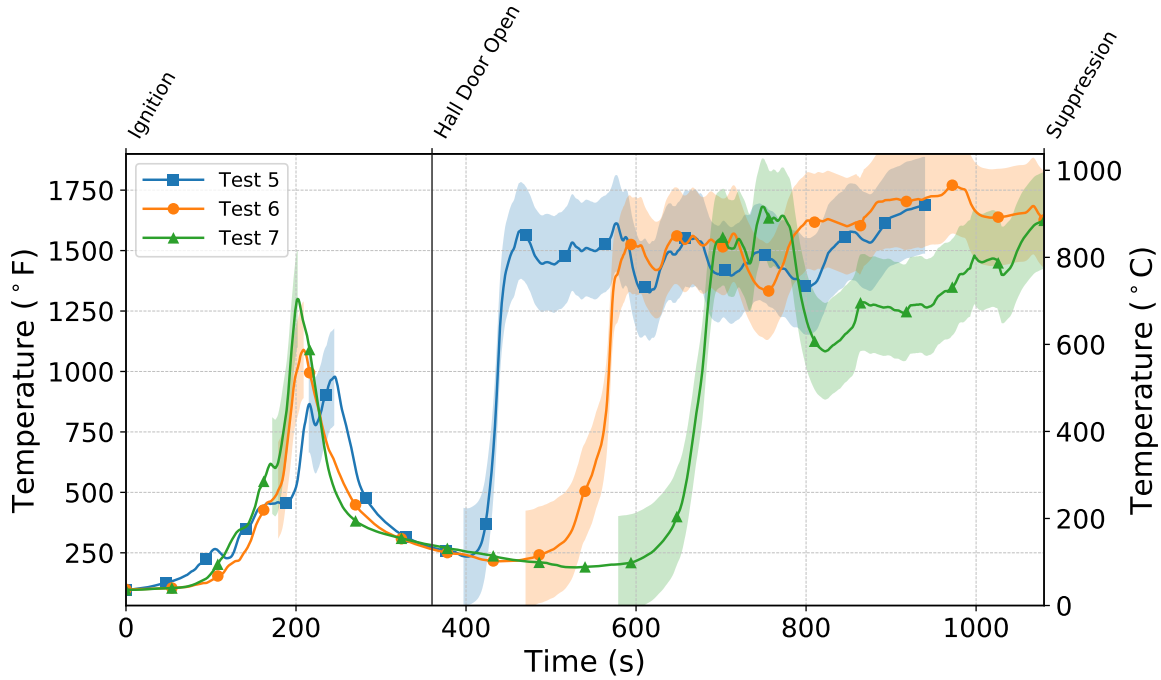
Figure 5.5: Plots of temperature data measured 1.0 in. (25 mm) below the fire room ceiling during the three repeatability tests conducted in the Gypsum Prop with the furniture fuel load. The shaded area represents the span of the data sample sets for the plot of similar color. Note, the fire during Test 5 (blue line) was suppressed at an earlier time to prevent the structural members of the prop from being permanently damaged.

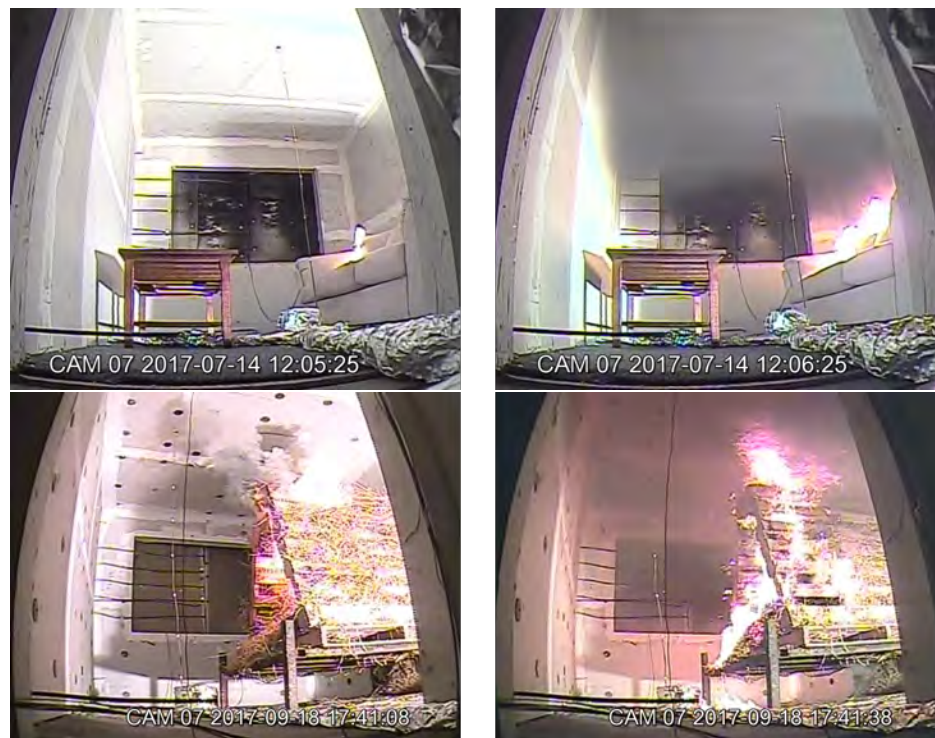
Figure 5.7: Still images obtained from recorded video of fire growth after ignition of the furniture fuel load (top images) and pallets fuel load (bottom images) in the Gypsum Prop. The images on the left side are of times shortly after visible flames were seen in the video, and the images on the right are from 30 seconds later for the pallets and one minute later for the furniture.

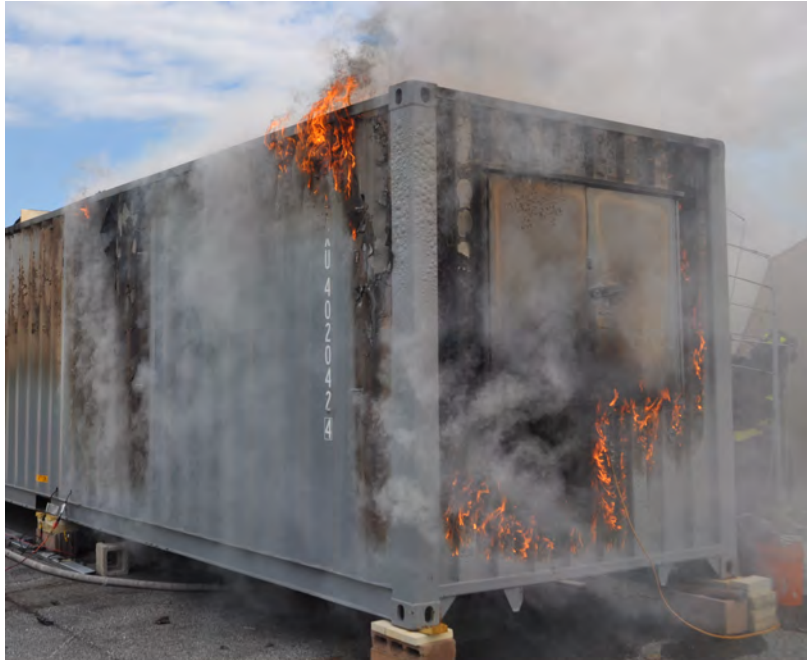
Figure 5.8: Photo of the paint burning on the exterior side of the Metal Prop during the Burn In experiment.

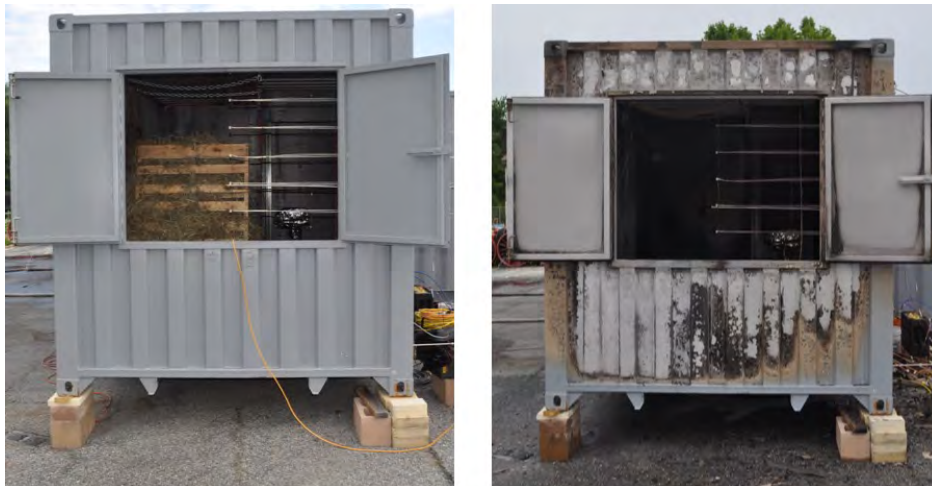
Figure 5.9: Exterior photos of the Metal Prop before (left) and after (right) the Burn In experiment.

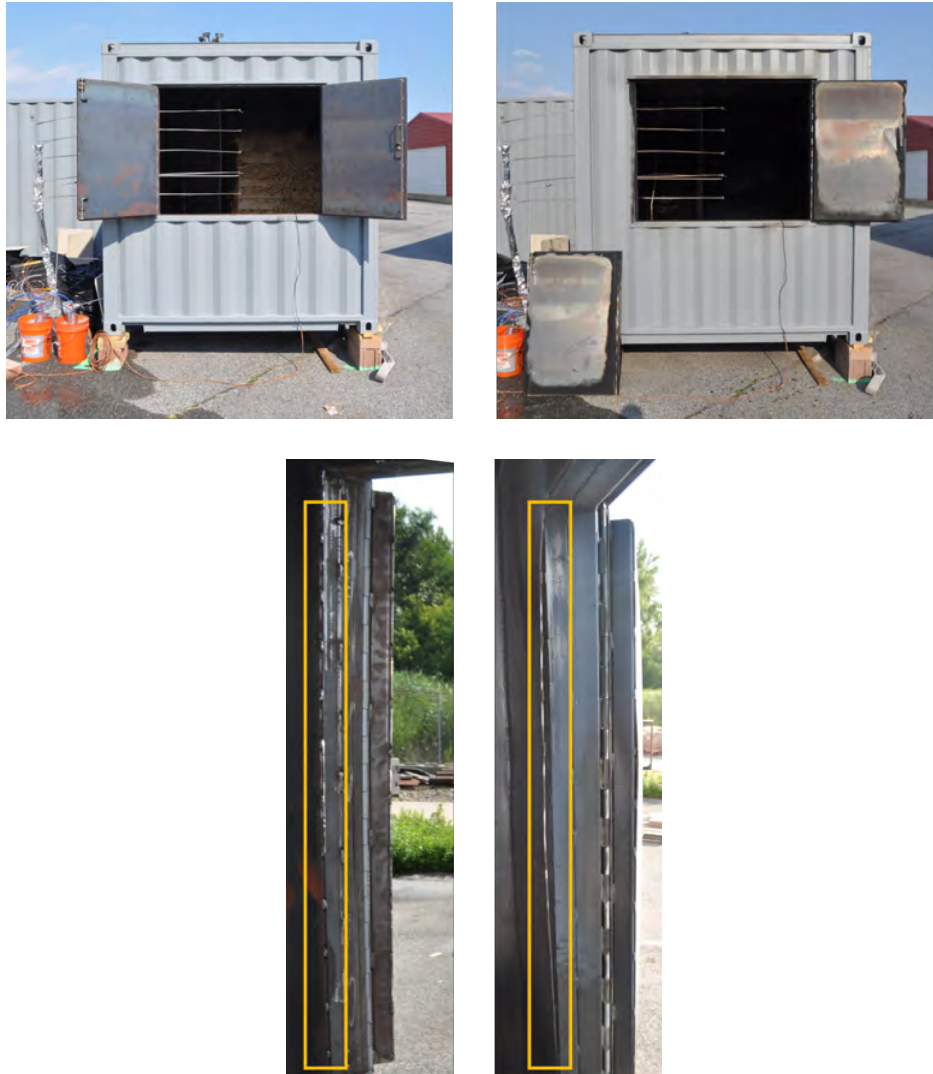
Figure 5.10: Images of the Insulated Metal Prop before (left side) and after (right side) the Burn In experiment. The top images are of the exterior side of the fire room window, and the bottom images are looking at welds along the edge of a steel sheet on the interior side near the window. The left window shutter became detached from the prop, and multiple interior welds were broken as a result of the Burn In experiment.

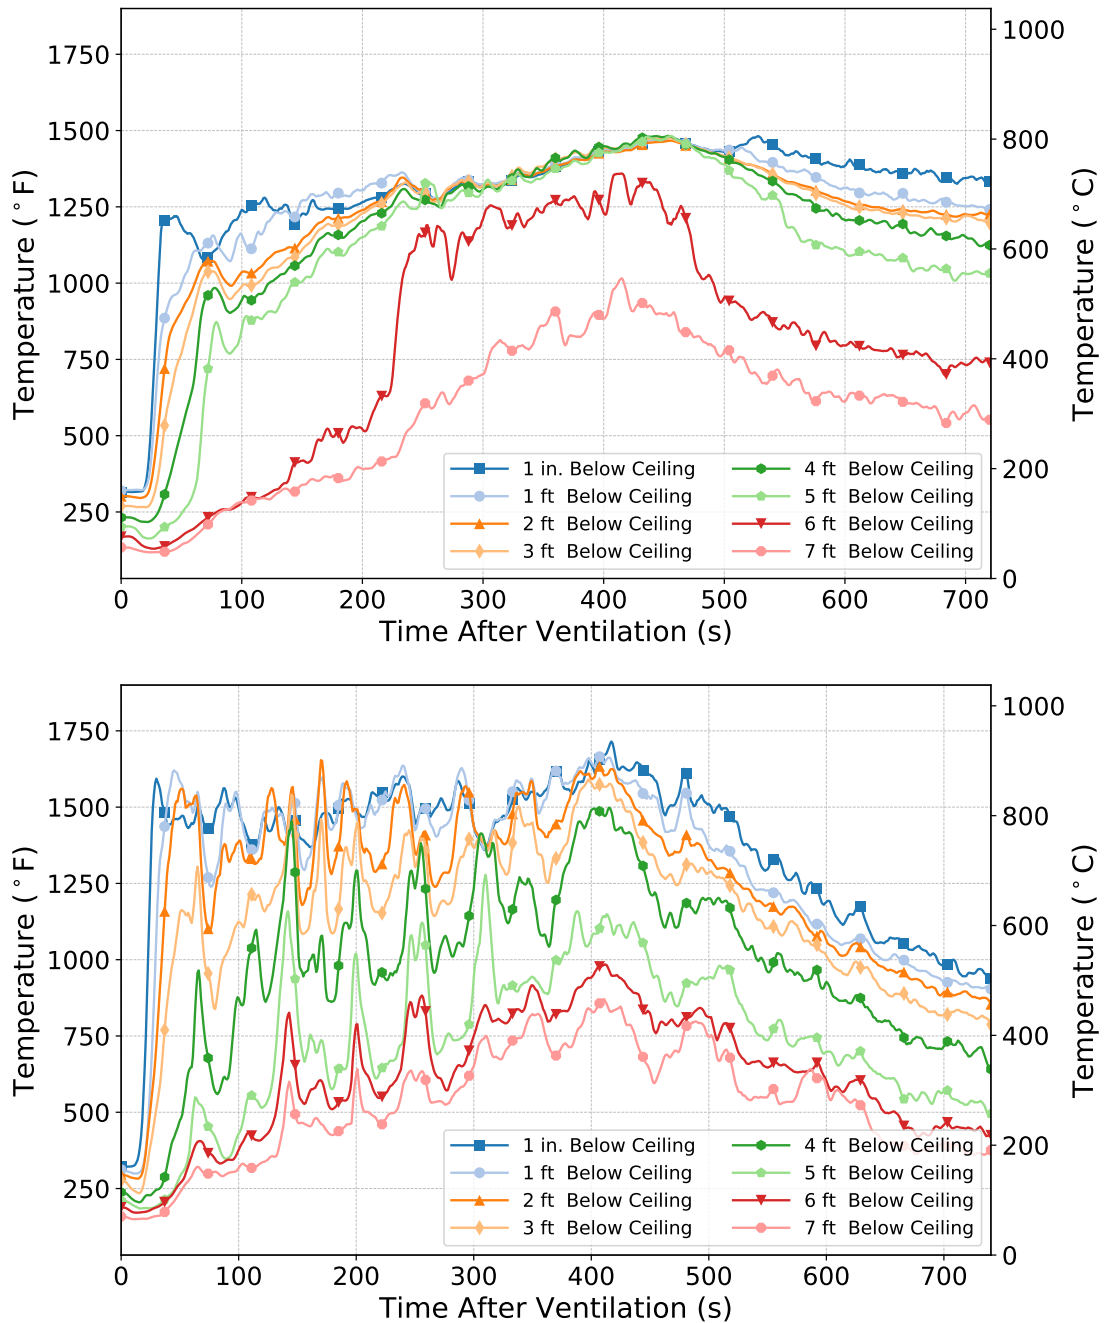
Figure 5.14: Plot of temperatures measured by thermocouples in the fire room array during the post-vent period of the vent door (top) and vent window (bottom) tests with the pallets and OSB fuel load in the Gypsum Prop.

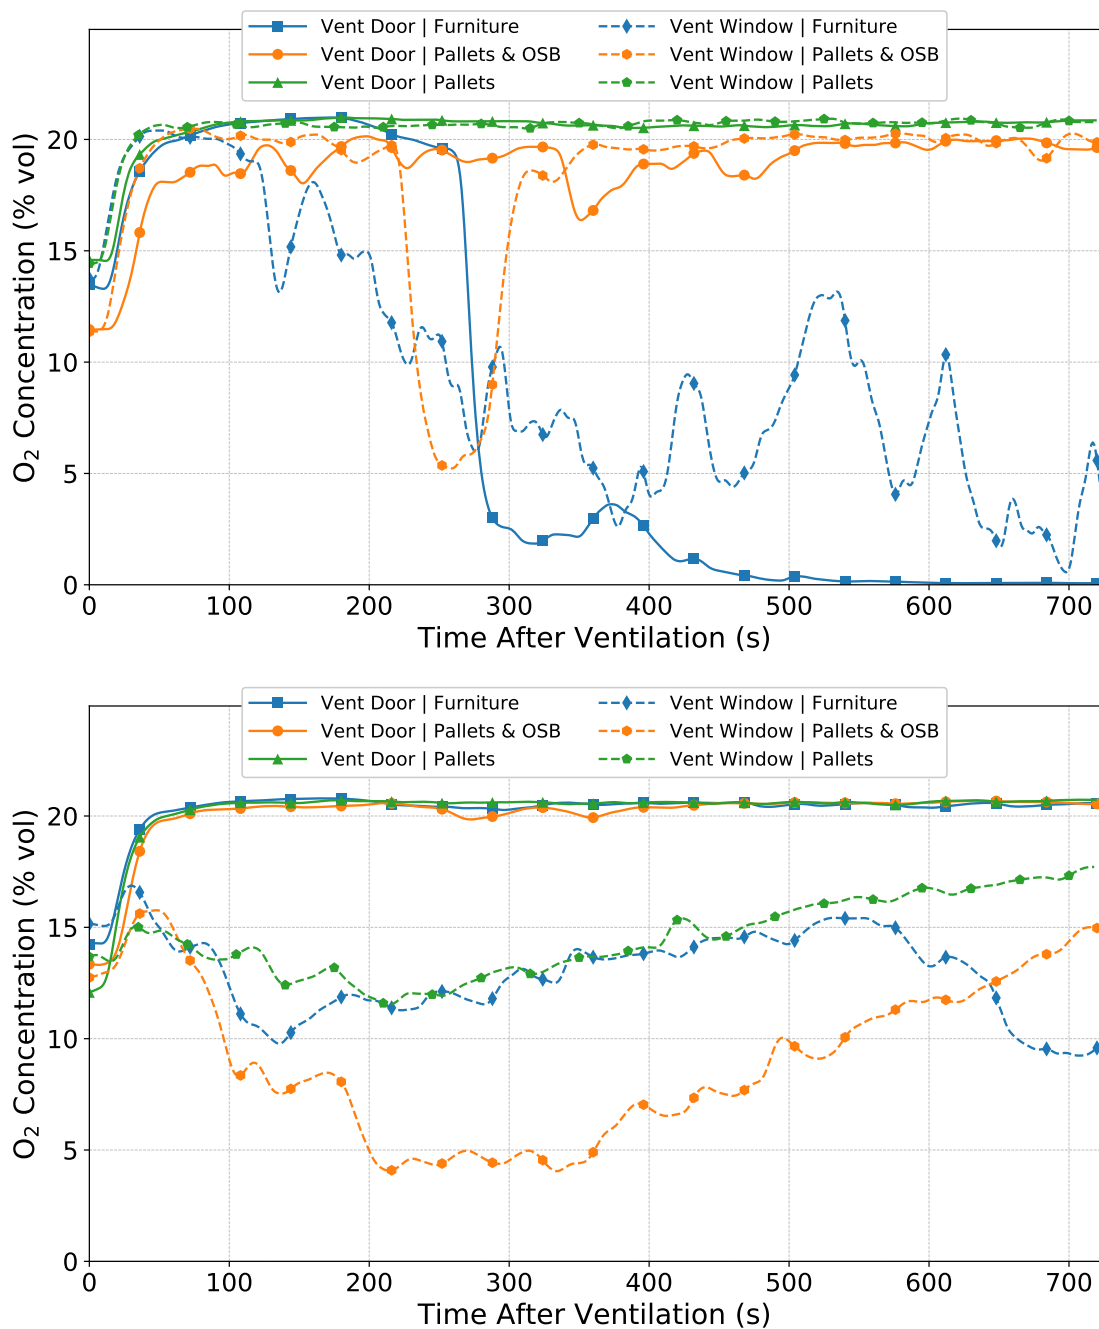
Figure 5.15: O<sub>2</sub> concentrations measured 4.0 in. (10.2 cm) above the floor near the window (top) and doorway (bottom) of the fire room plotted over the duration of the post-vent period of the vent door and vent window tests in the Insulated Metal Prop. Data from vent door tests are plotted as solid lines, and data from vent window tests are plotted as dashed lines.

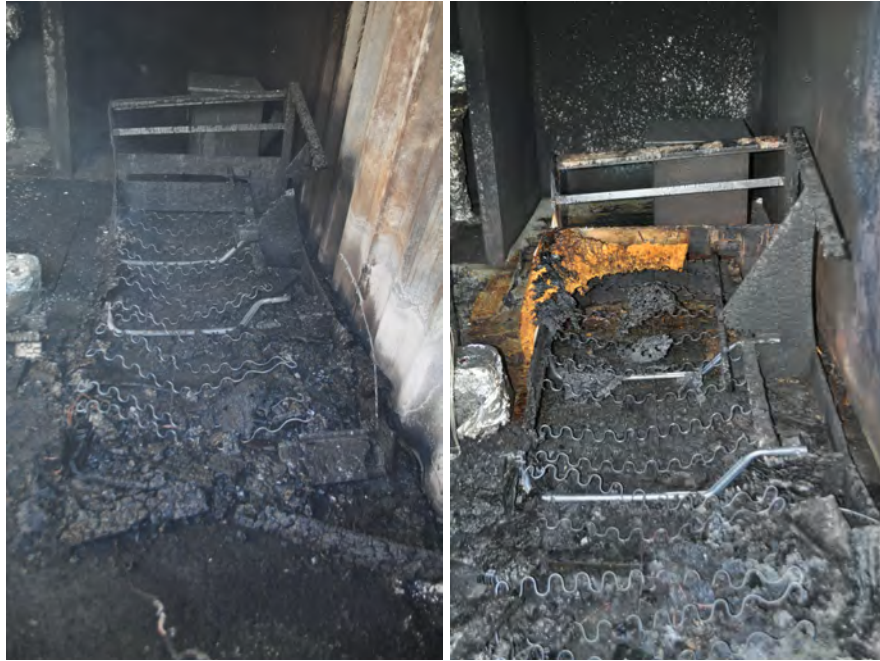
Figure 5.16: Images of the furniture fuel package after suppression from the tests with the vent door (left) and vent window (right) configurations. More fuel (end of the couch, carpet and padding near doorway, etc.) remained after the test with the vent window configuration than after the test with the vent door configuration.

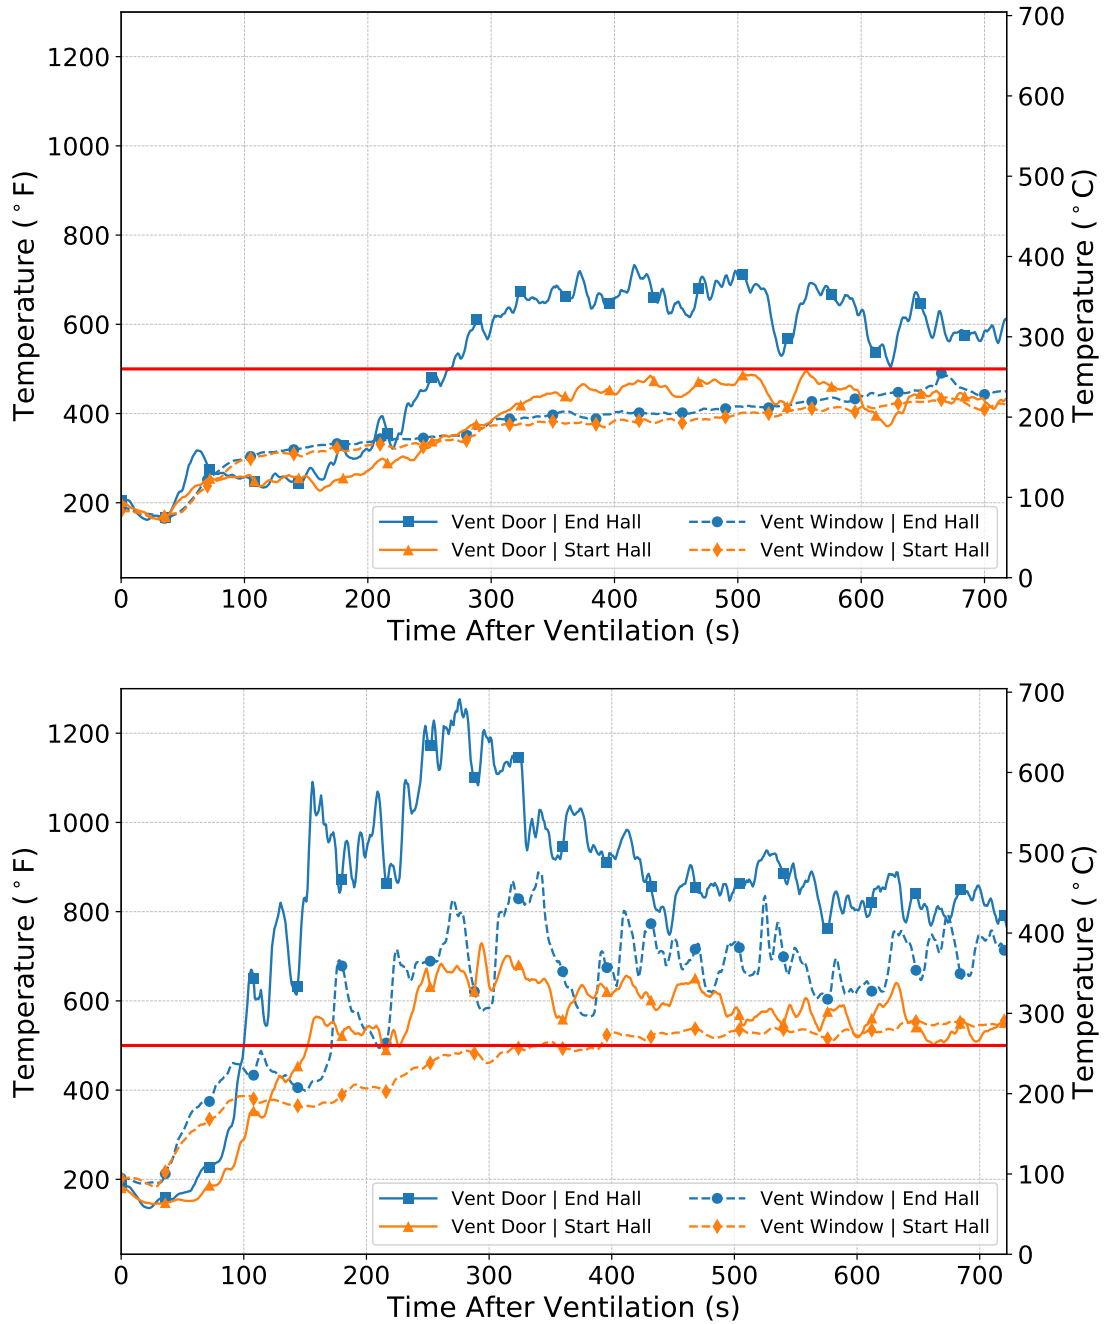
Figure 5.17: Temperatures measured 3.7 ft (1.1 m) above the floor at the end hall (blue lines) and start hall (orange lines) locations after ventilation during the vent door (solid lines) and vent window (dashed lines) experiments in the Insulated Metal Prop. The top graph is from experiments with the pallets fuel load, and the bottom graph is from experiments with the pallets and OSB fuel load. The red line at 500 °F (260 °C) highlights the firefighter PPE temperature threshold listed in Table 5.1.

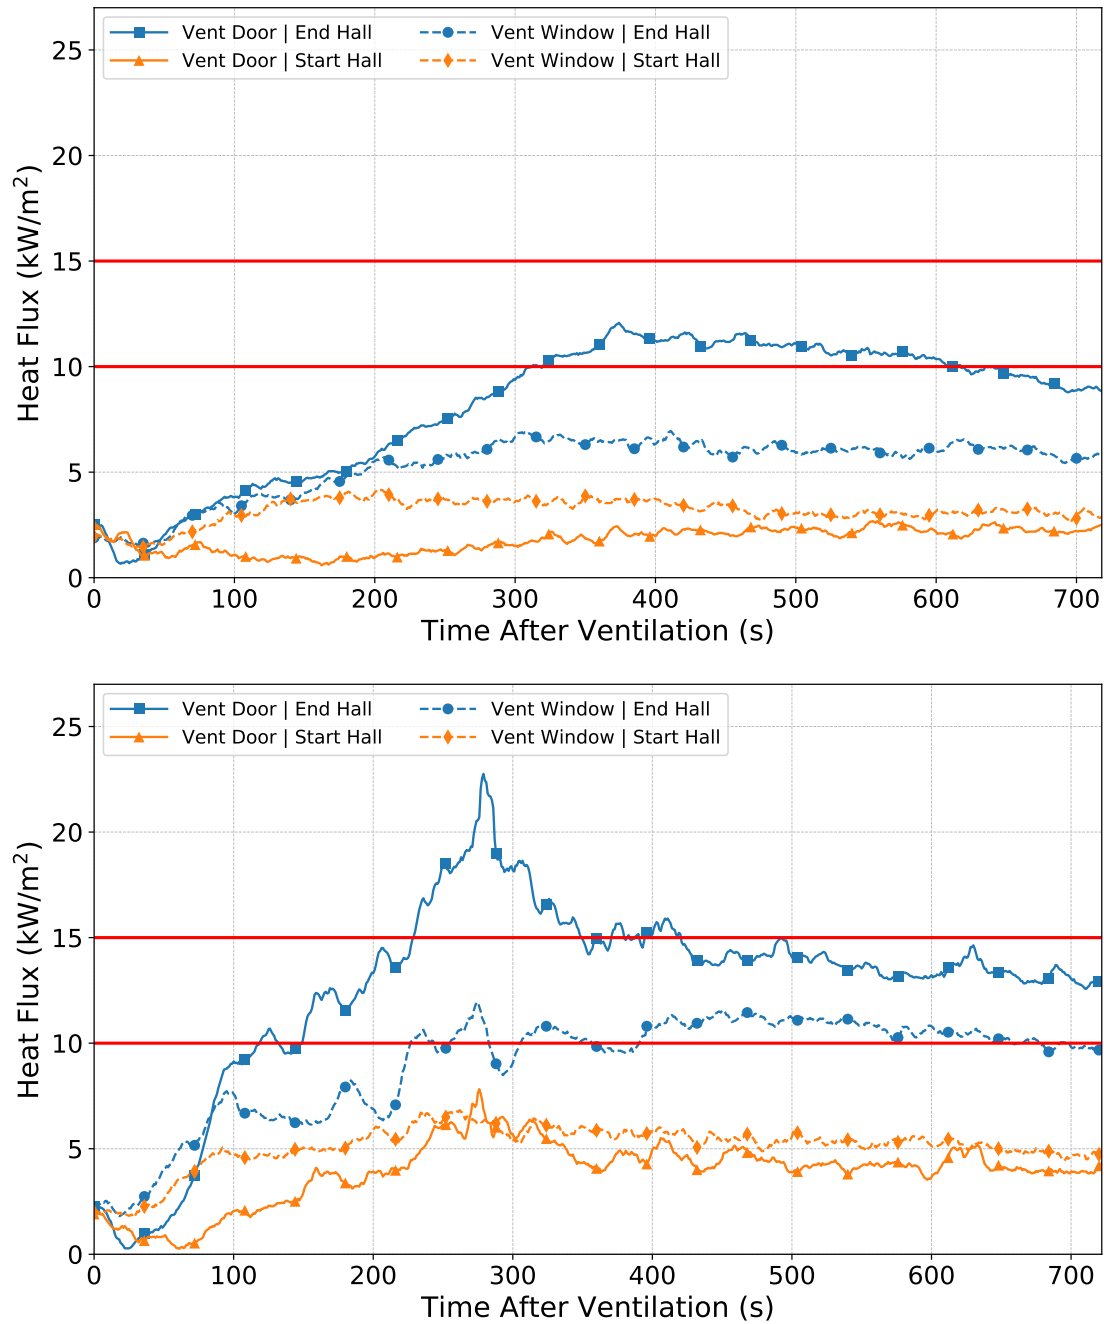
Figure 5.18: Heat flux in the horizontal direction measured at 3.0 ft (0.9 m) above the floor at the end hall (blue lines) and start hall (orange lines) after ventilation during the vent door (solid lines) and vent window (dashed lines) experiments in the Insulated Metal Prop. The top graph is from experiments with the pallets fuel load, and the bottom graph is from experiments with the pallets and OSB fuel load. The red lines at 10 kW/m² and 15 kW/m² highlight the firefighter PPE heat flux exposure thresholds listed in Table 5.1.

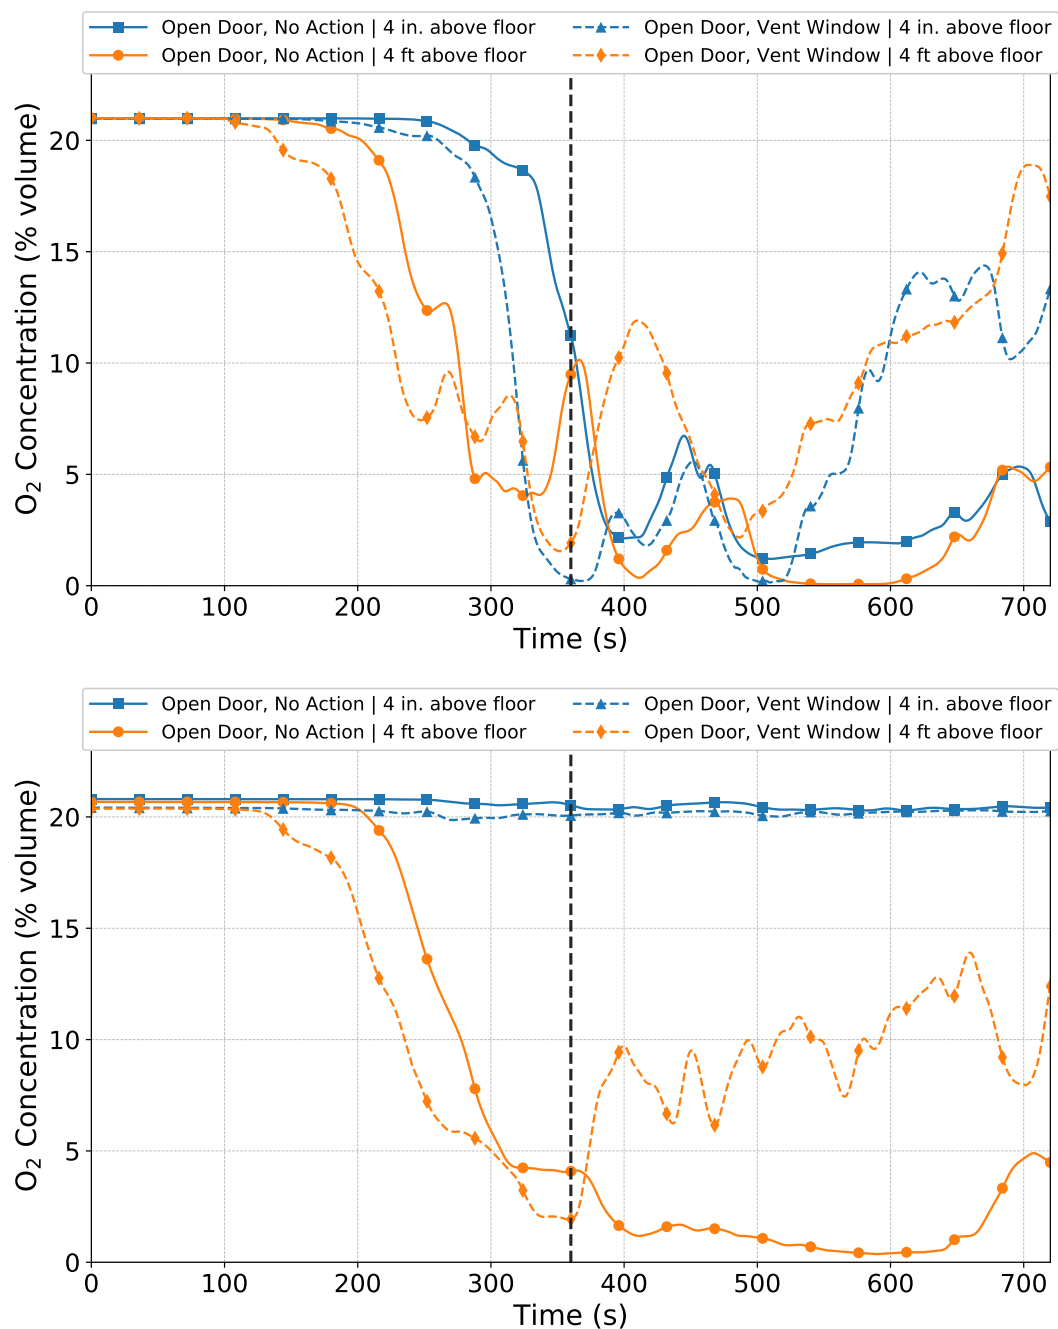
Figure 5.19: Plots of the O<sub>2</sub> concentrations from the open door, no action and open door, vent window tests with the furniture fuel load. The top graph is of the data collected near the fire room window, and the bottom graph is of the data collected near the fire room doorway. Data from 4.0 in. (10.2 cm) above the floor are plotted with solid lines, and data from 4.0 ft (1.2 m) above the floor are plotted with dashed lines. The black dashed line marks the time at which the window was opened during the open door, vent window test.

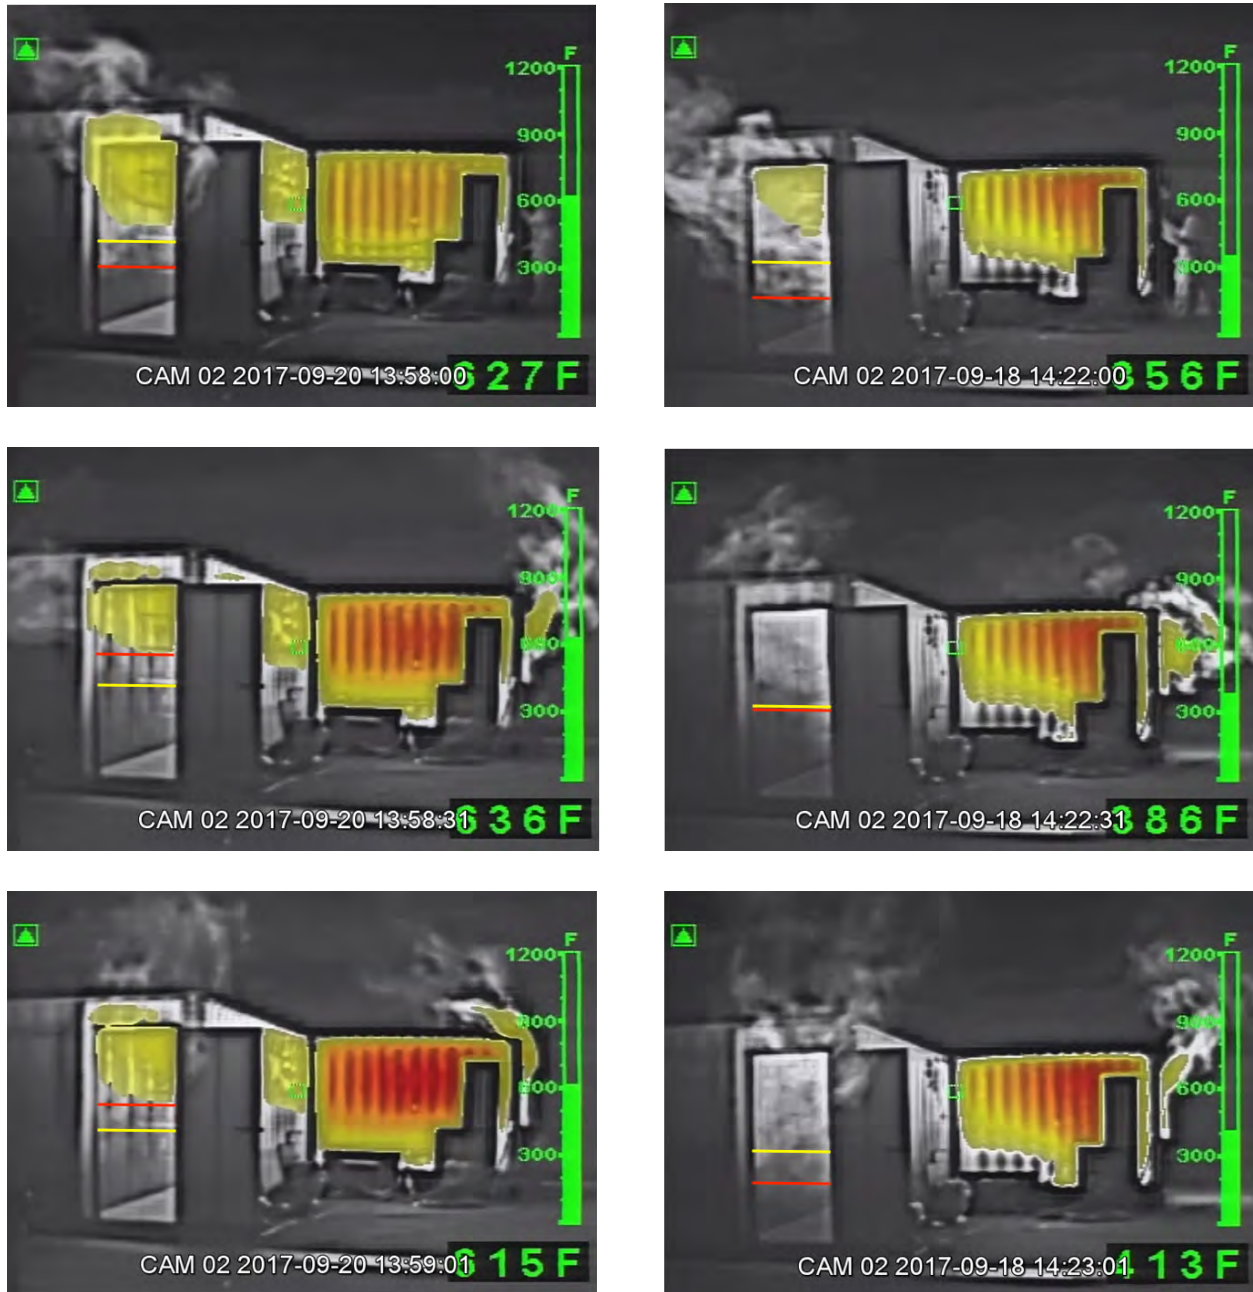
Figure 5.21: Still images from thermal imager video of the Metal Prop exterior one second before (top row), 30 seconds after (middle row), and 60 seconds after (bottom row) the window was opened during tests with the pallets and OSB (left side) and furniture (right side) fuel loads. A red line marks the approximate height of the neutral plane and a yellow line marks the height of the door handle to provide a similar reference point in each image.
