# Evaluation of Ventilation-Controlled Fires in L-Shaped Training Props

Joseph Willi  
Keith Stakes  
John Regan  
Robin Zevotek

UL Firefighter Safety Research Institute  
Columbia, MD 21045

October 16, 2018

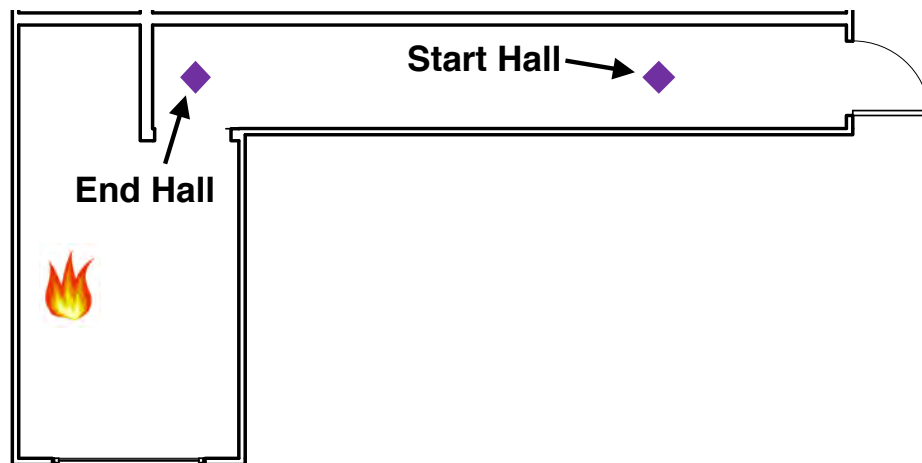
Figure 6.2: Floor plan showing the end hall and start hall heat flux gauge locations. Both were positioned 3.0 ft (0.9 m) above the floor to measure the heat flux in the horizontal direction. The end hall gauge was centered in the fire room doorway and between the hall walls, and the start hall gauge was centered in the hallway and located 8.0 ft (2.4 m) inside the doorway.

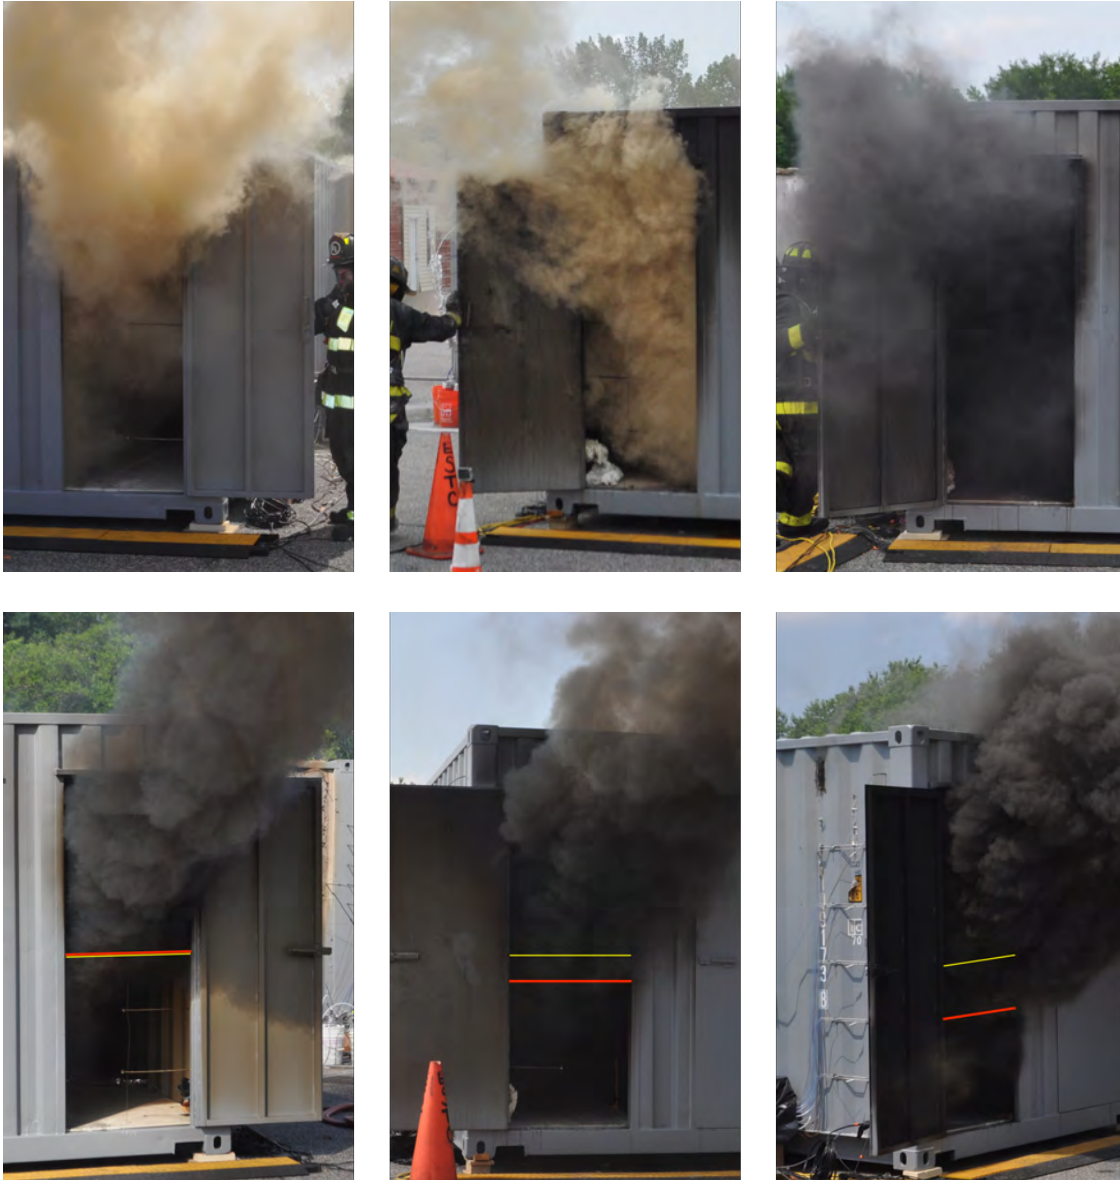
Figure 6.6: Images of the smoke conditions immediately after the hall door was opened (top row) and after the neutral plane developed at the doorway (bottom row) during tests with the pallets (left side); pallets and OSB (middle); and furniture (right side) fuel packages. A red line marks the approximate height of the neutral plane and a yellow line marks the height of the door handle to provide a similar reference point in the photos along the bottom row.

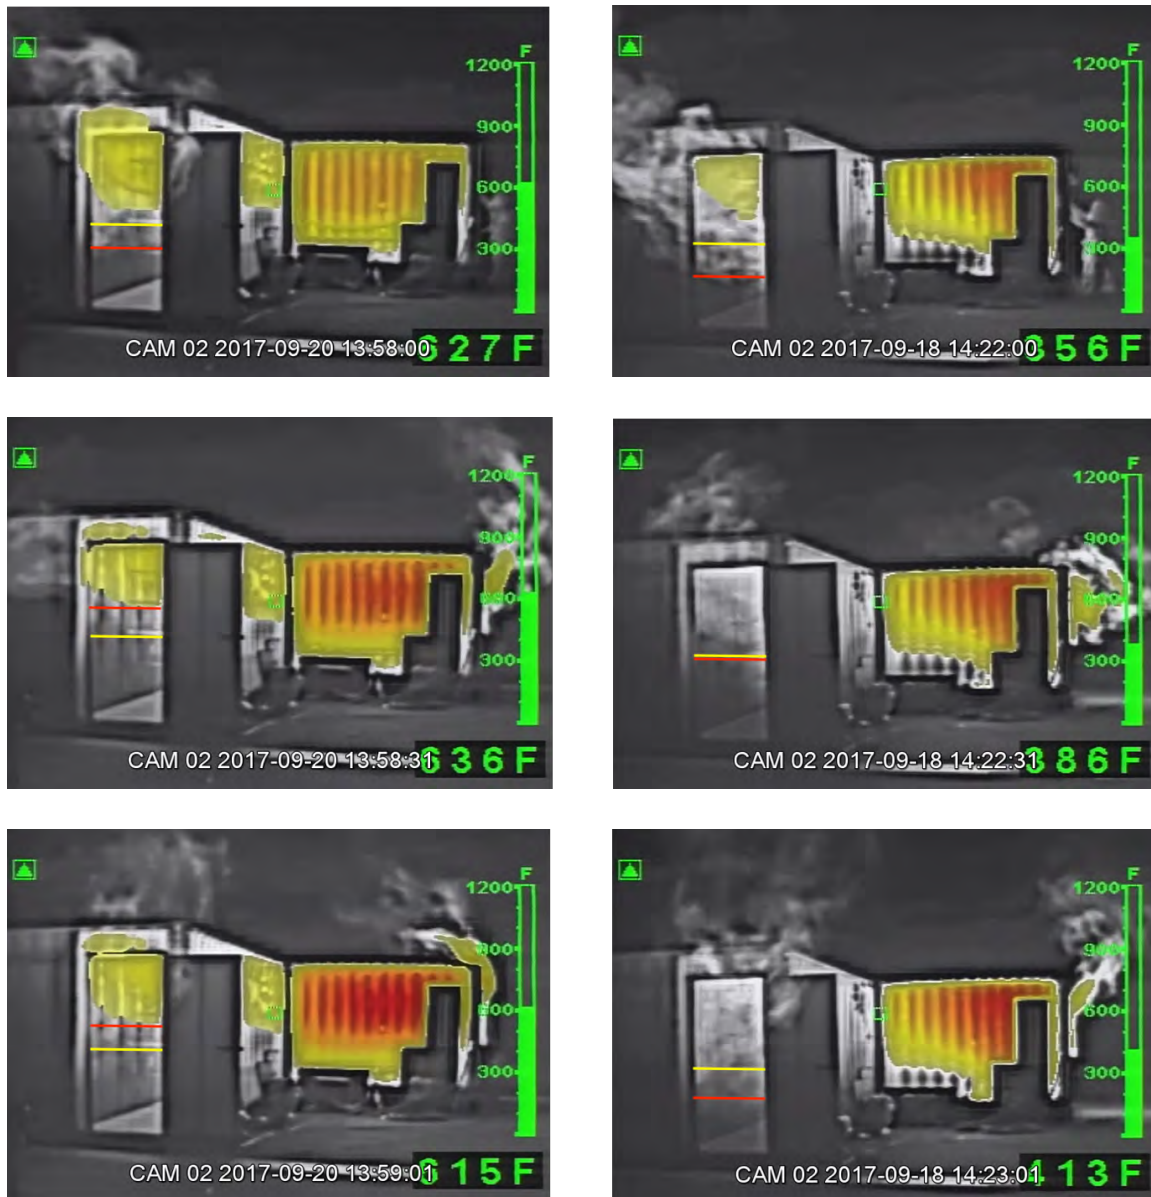
Figure 6.7: Still images from thermal imager video of the Metal Prop exterior one second before (top row), 30 seconds after (middle row), and 60 seconds after (bottom row) the window was opened during tests with the pallets and OSB (left side) and furniture (right side) fuel loads. A red line marks the approximate height of the neutral plane and a yellow line marks the height of the door handle to provide a similar reference point in each photo.

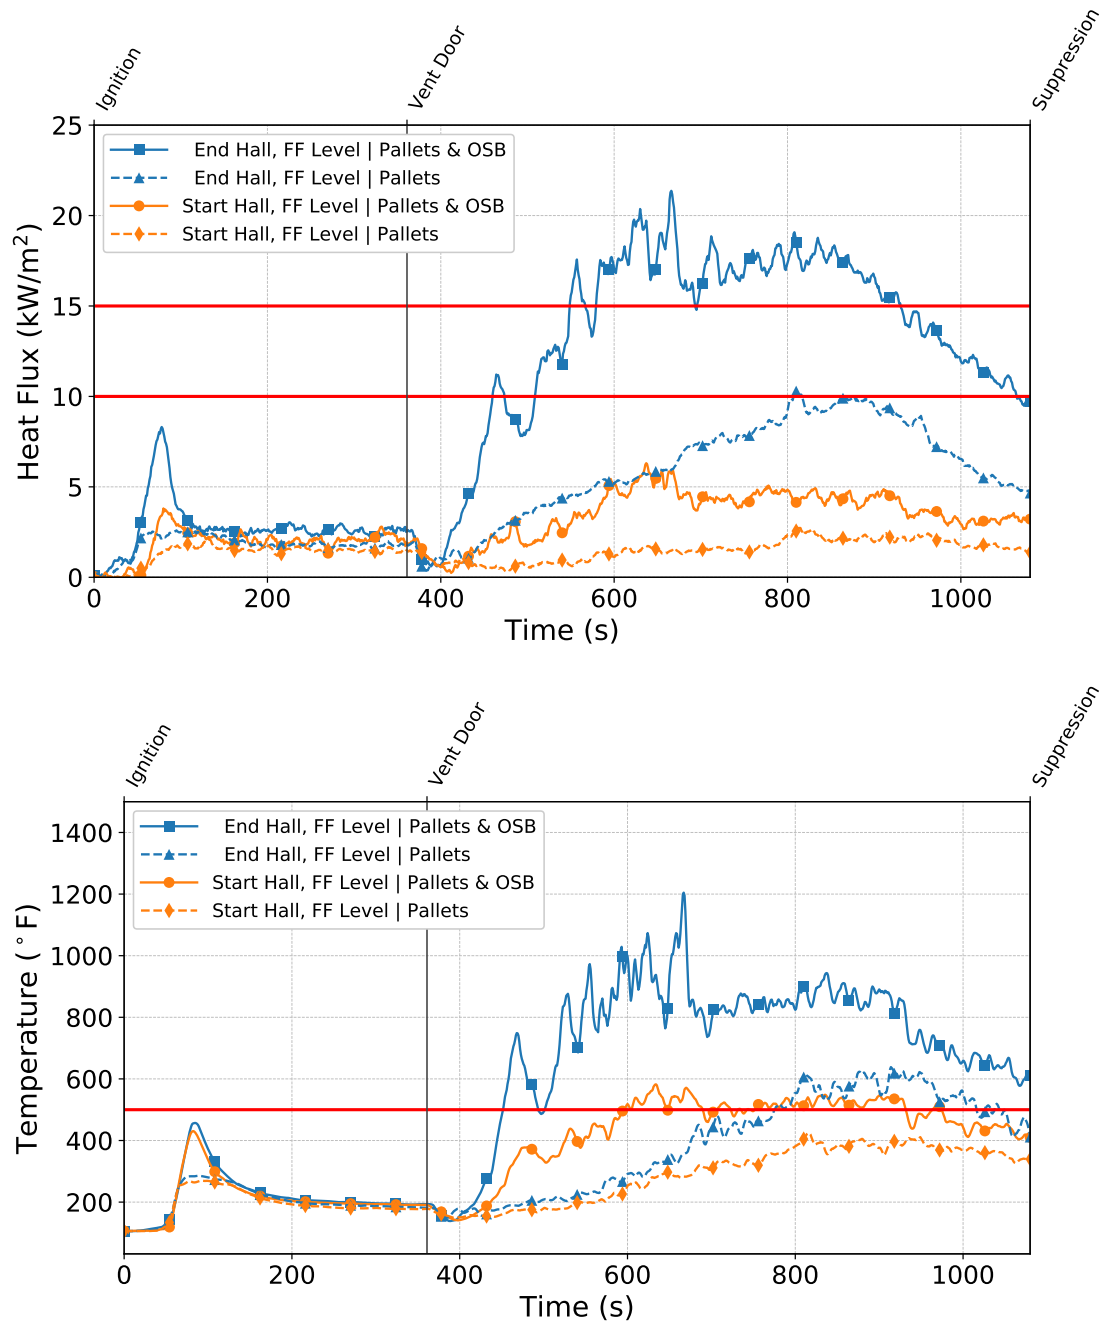
Figure 6.8: Plots of the heat flux (top) and temperature (bottom) measured at the end hall (blue lines) and start hall (orange lines) locations during tests using the pallets and OSB fuel load (solid lines) and the pallets fuel load (dashed lines) in the Metal Prop. The exposure thresholds mentioned in the beginning of this section are marked on the graphs by solid red lines.

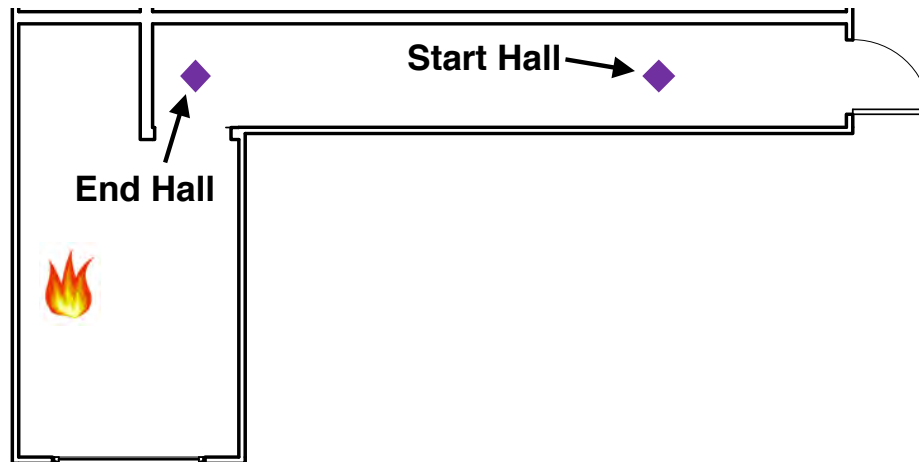
Figure 6.9: Floor plan showing the locations of the start hall and end hall thermocouple array and heat flux gauge pairs. The end hall pair was centered in the fire room doorway and between the hall walls. Likewise, the start hall pair was centered in the hallway and located approximately 8.0 ft (2.4 m) from the hall doorway.

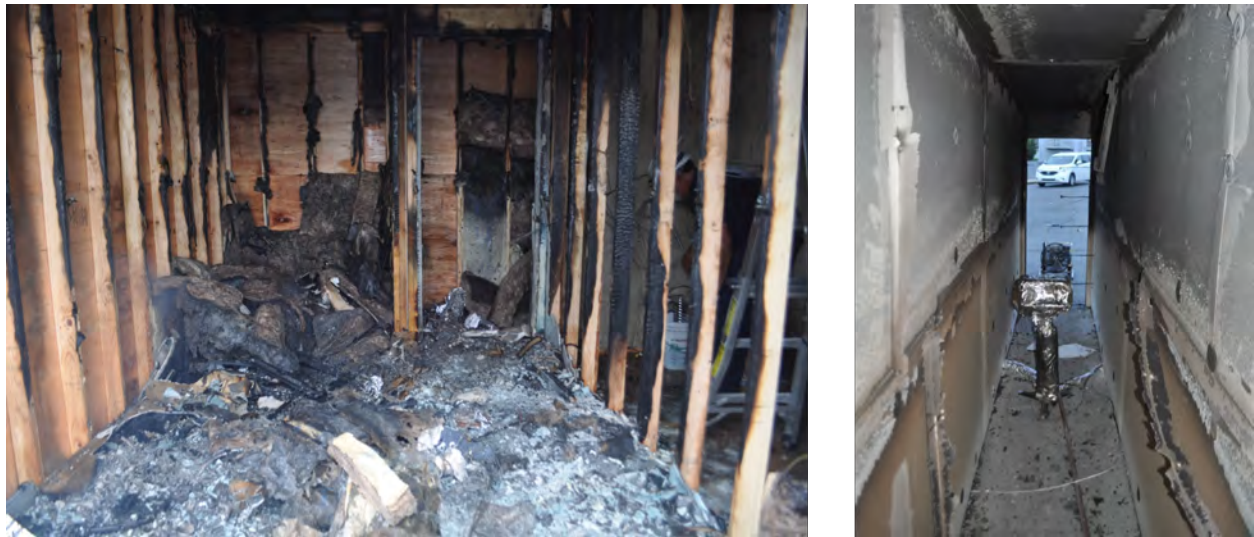
Figure 6.12: Images of the damage in the fire room (left) and hallway (right) of the Gypsum Prop after a single training fire with the pallets fuel load. The damage was caused by the fire and overhaul operations conducted to completely suppress the fire. After every fire, the gypsum board lining the inside needed to be replaced.

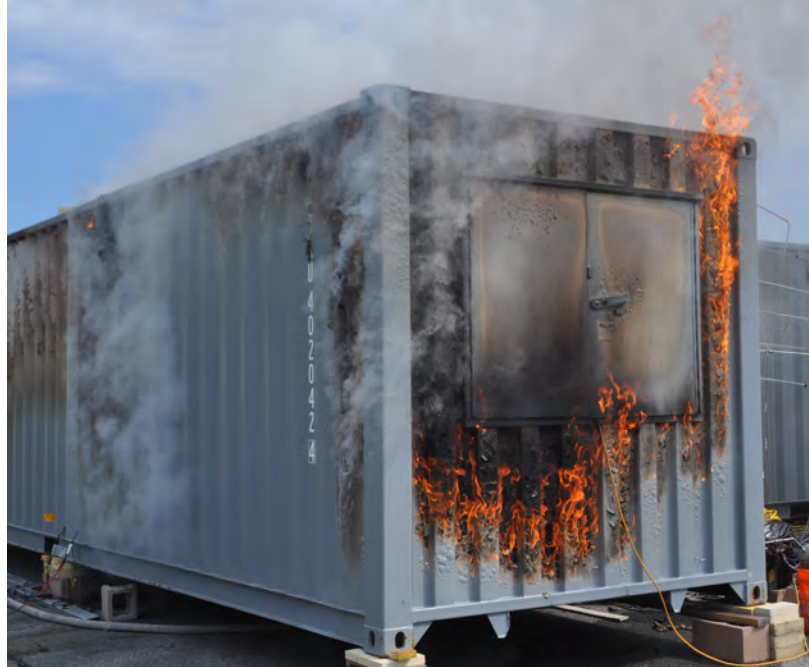
Figure 6.13: Image of fire spread along the exterior surface of the Metal Prop during the Burn In experiment.

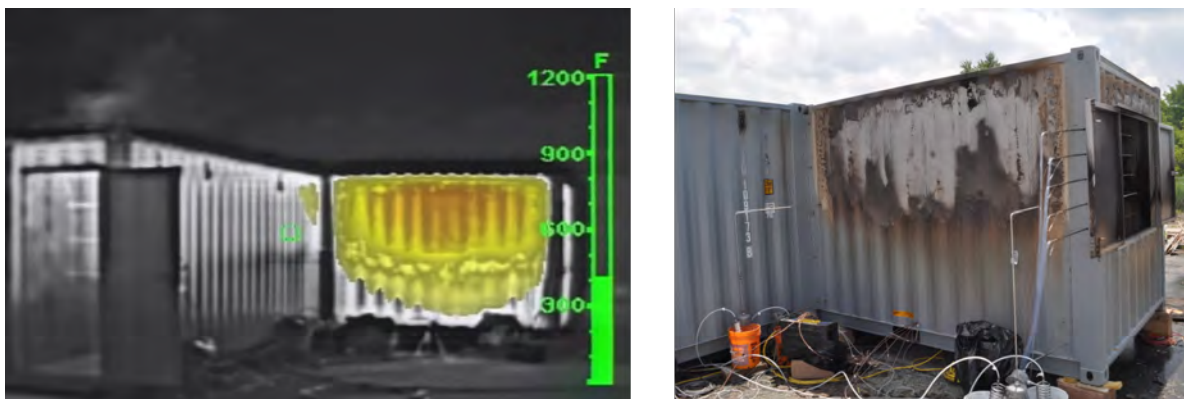
Figure 6.14: Still frame of the Metal Prop exterior from a TIC video recording of the Burn In test (left) and a picture of the exterior damage from after the Burn In test (right). Notice how the colored (hottest) areas from the TIC video correspond to the most damaged portions of the exterior.

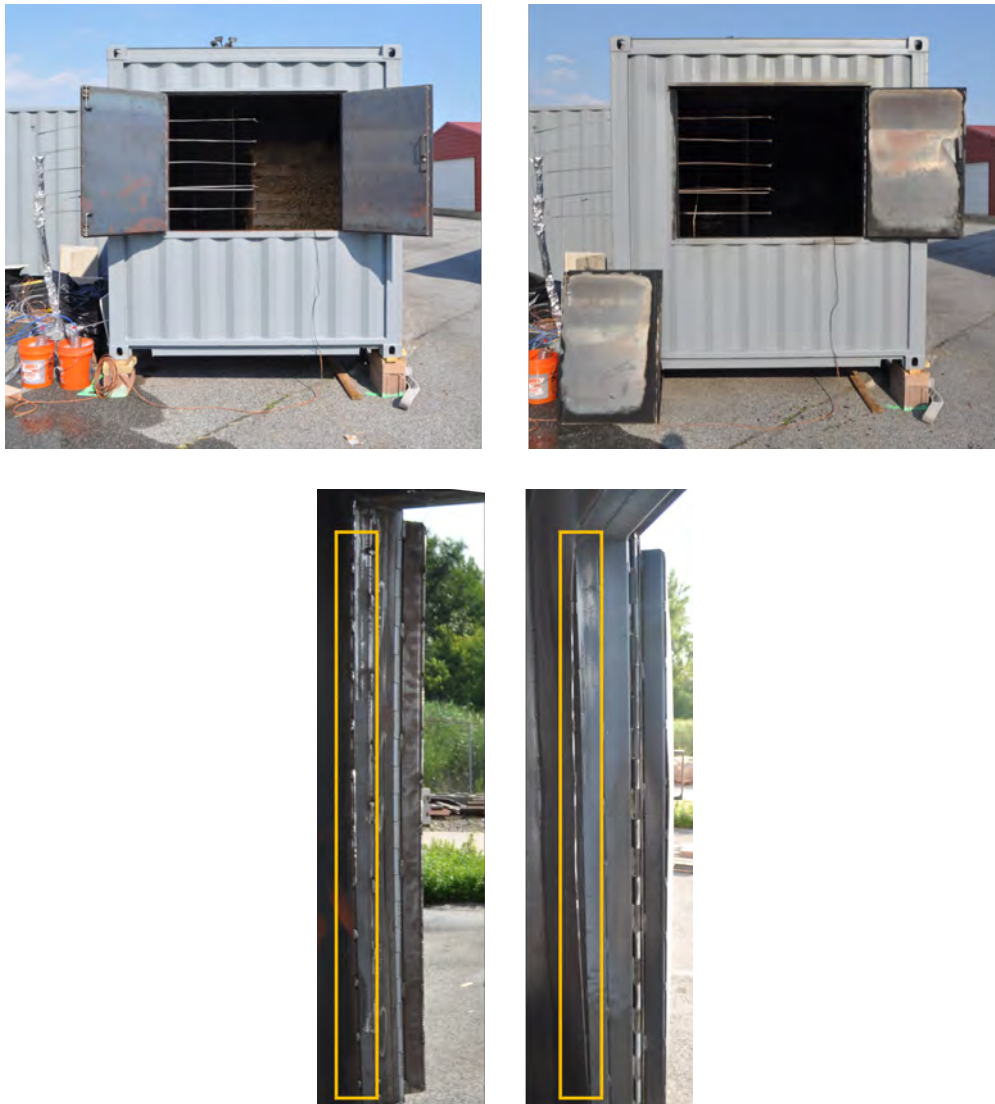
Figure 6.15: Images of the Insulated Metal Prop before (left side) and after (right side) the Burn In test. The top images are of the exterior side of the fire room window, and the bottom images are looking at welds along the edge of a steel sheet on the interior side near the window. The left window shutter became detached from the prop and multiple interior welds were broken as a result of the Burn In experiment.

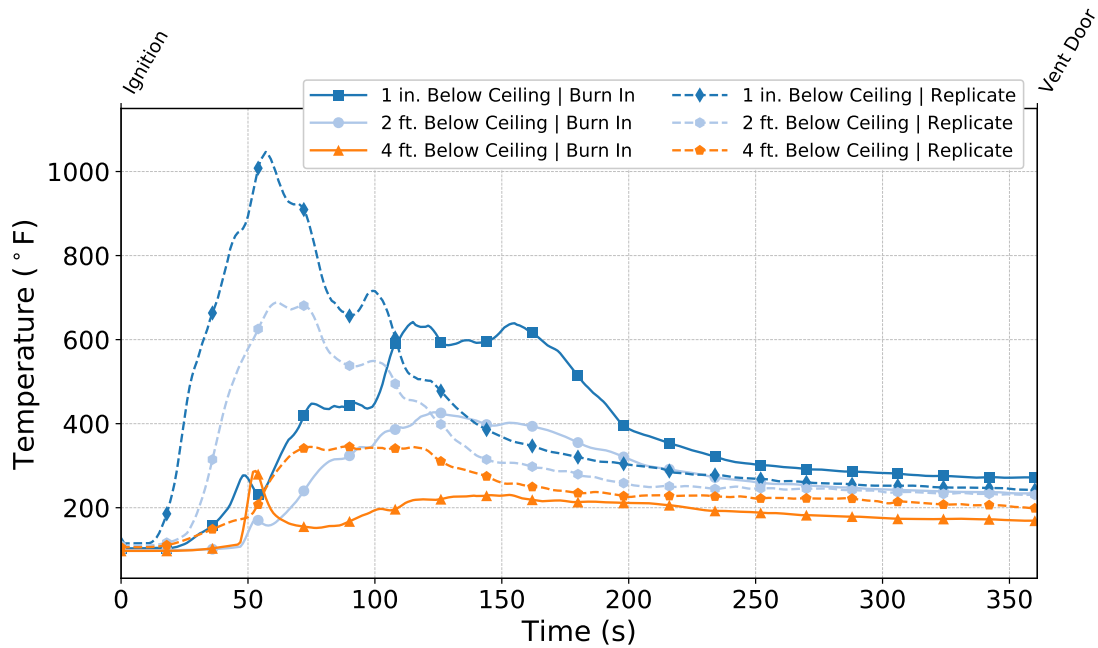
Figure 6.16: Temperatures measured 1.0 in. (25 mm), 2.0 ft (0.6 m), and 4.0 ft (1.2 m) below the ceiling of the fire room plotted over the initial growth period of a Burn In test (solid lines) and the replicate conducted afterwards (dashed lines) in the Metal Prop with the pallets fuel load.

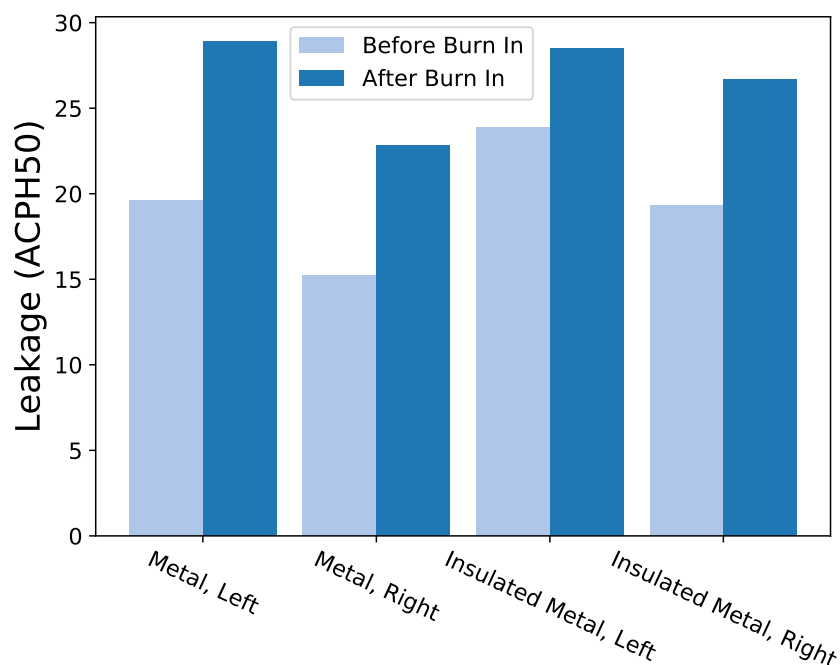
Figure 6.17: Bar graph of prop leakage measured before and after each Burn In test. The initial fire in each side of the metal props increased the prop leakage in all four cases.

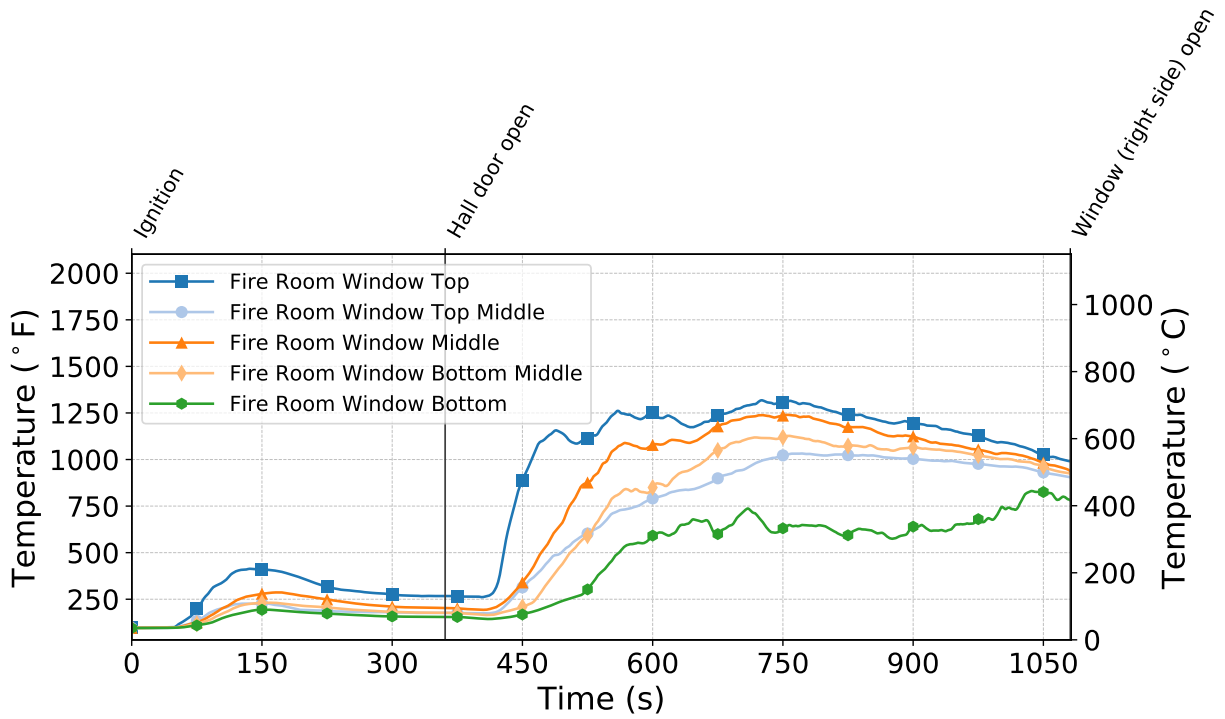
Figure C.2: Temperatures measured by the fire room window thermocouples during Test 1.

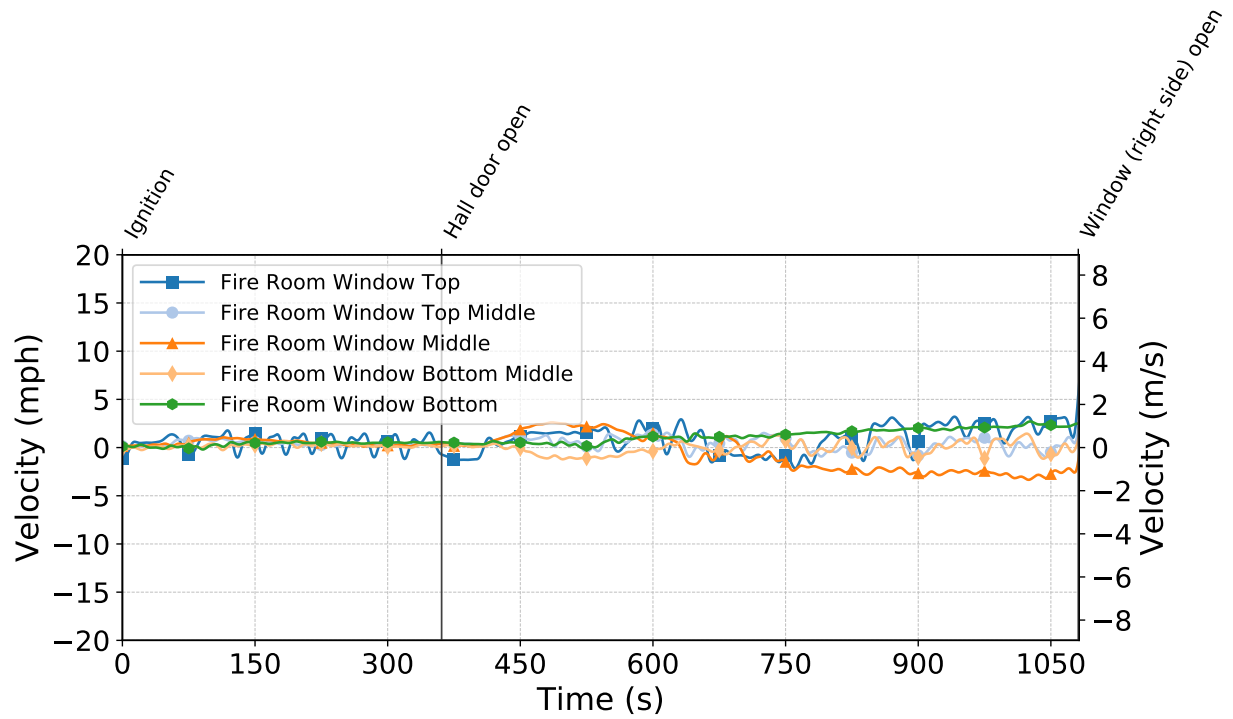
Figure C.11: Gas velocities measured by the fire room window bdps during Test 1.

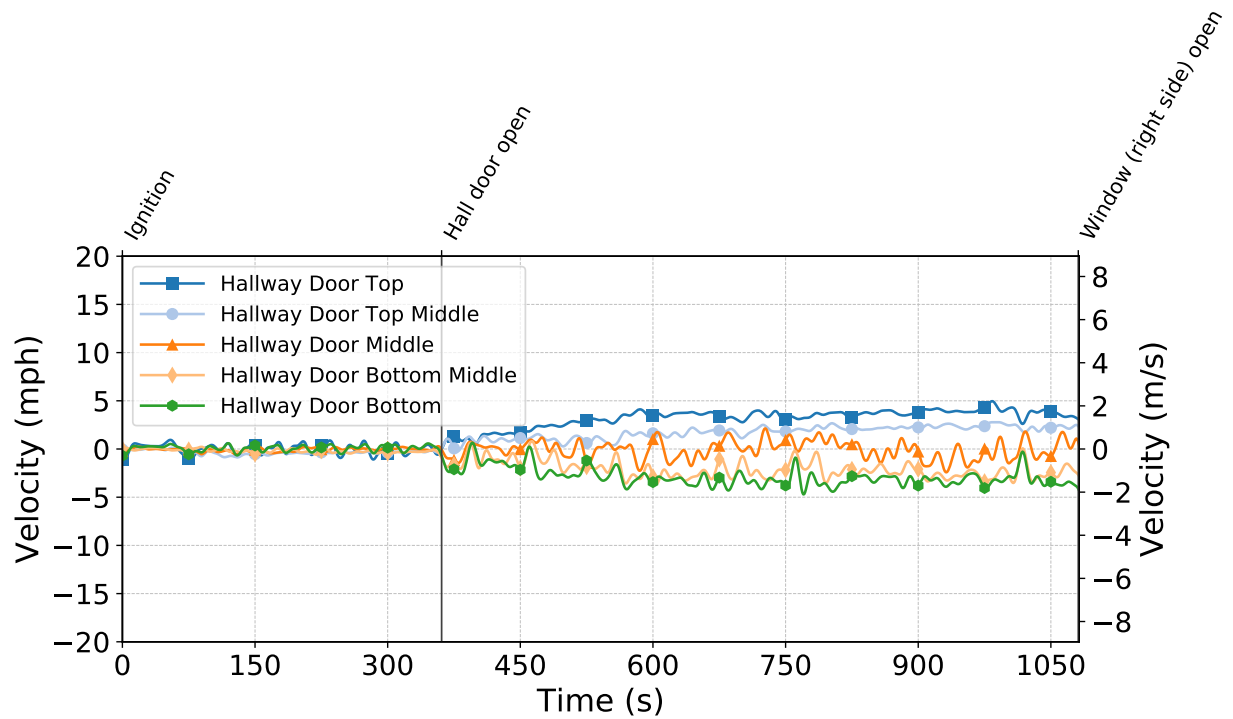
Figure C.12: Gas velocities measured by the hallway door bdps during Test 1.
