Lahaina Fire Incident Analysis Report

Steve Kerber
Derek Alkonis

September 13, 2024
Columbia, MD

This document is the second in a series of three (3) reports commissioned by the Hawai‘i Department of the Attorney General (DOAG) to provide an independent review of the tragic fire that destroyed much of Lahaina, Hawai‘i, on August 8-9, 2023.

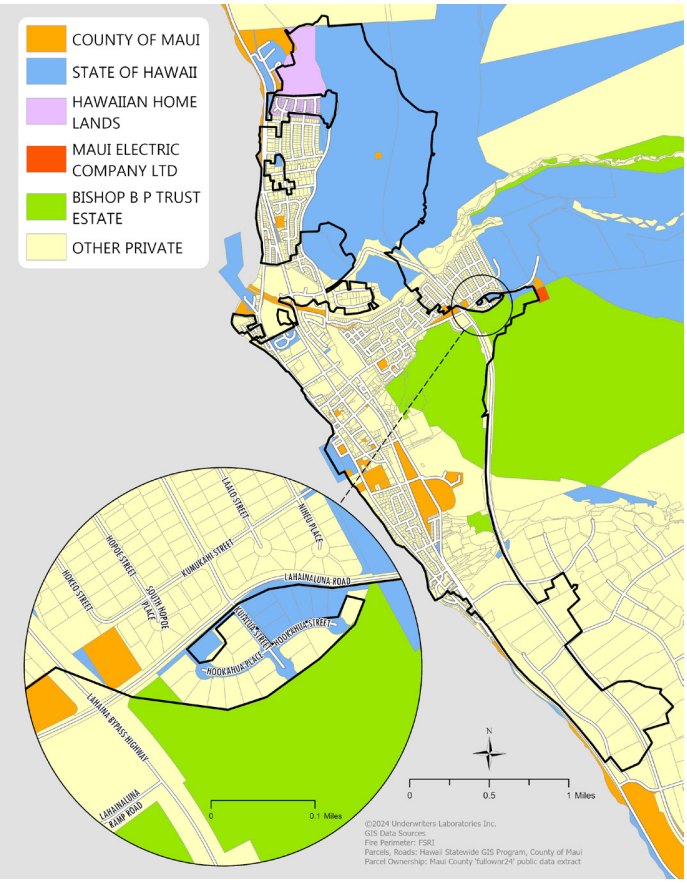
For example, two (2) of the four (4) August 2023 fires impacted state lands. In Lahaina, one (1) parcel of the impacted wildland area is under management of DLNR-Land Division, with no record of vegetation management. Several smaller parcels within the impacted developed area are owned and managed by the State Department of Education (within the blue State of Hawai‘i area), also with no clear accountability for wildfire risk reduction or vegetative fuels management (Figure 3.3.2.2).

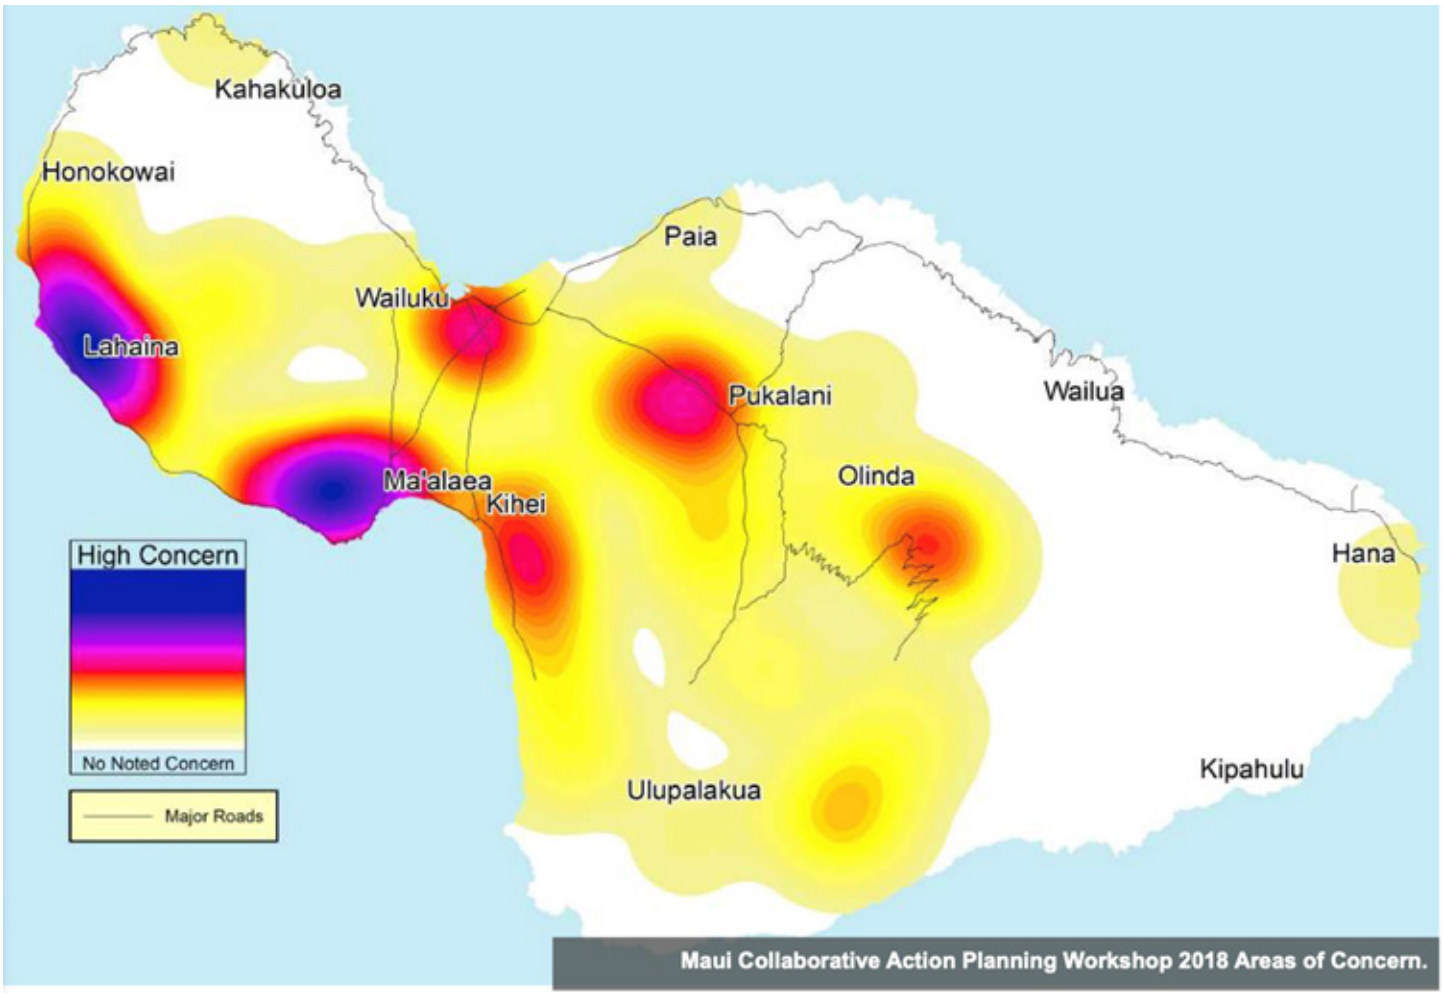
Despite Lahaina being identified as one of the highest priority areas for vegetative fuels management (Figure 3.3.8.1), it appears that relatively little work was actually done, due to the continued combination of funding challenges and lack of incentives, penalties, or financial support for private landowners to participate.[107]

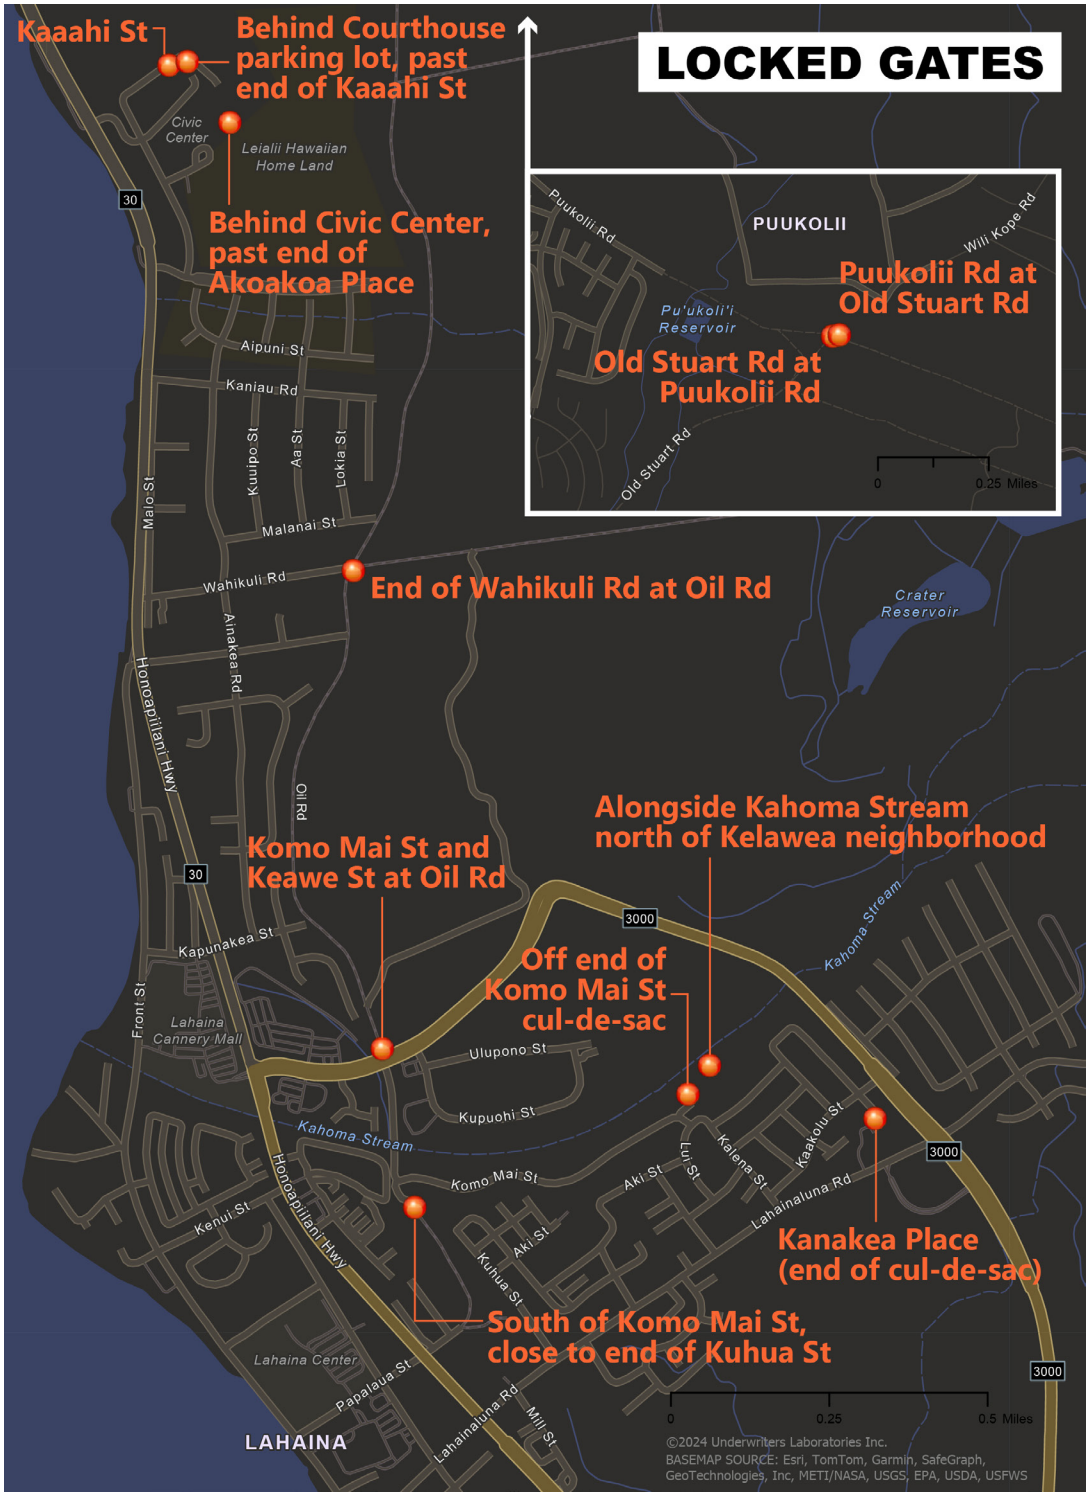
Figure 3.4.2.4.3 Locked Gates Map. Map showing location of locked games preventing access to dirt roads used during August 8-9, 2023. MPD officers shared how they had to cut the locks to open the gates to allow vehicles to escape the fire and smoke.

There were several instances where dirt roads located on private properties were difficult to access due to locked gates. MPD officers shared experiences of having to use cutting tools to break the locking mechanism to allow the gate to be opened. In some cases, vehicles were used to ram or pull the gate open as residents waited in their vehicles while fire and smoke impacted the area. The location of the locked gates identified during technical discussions are shown in Figure 3.4.2.4.3.

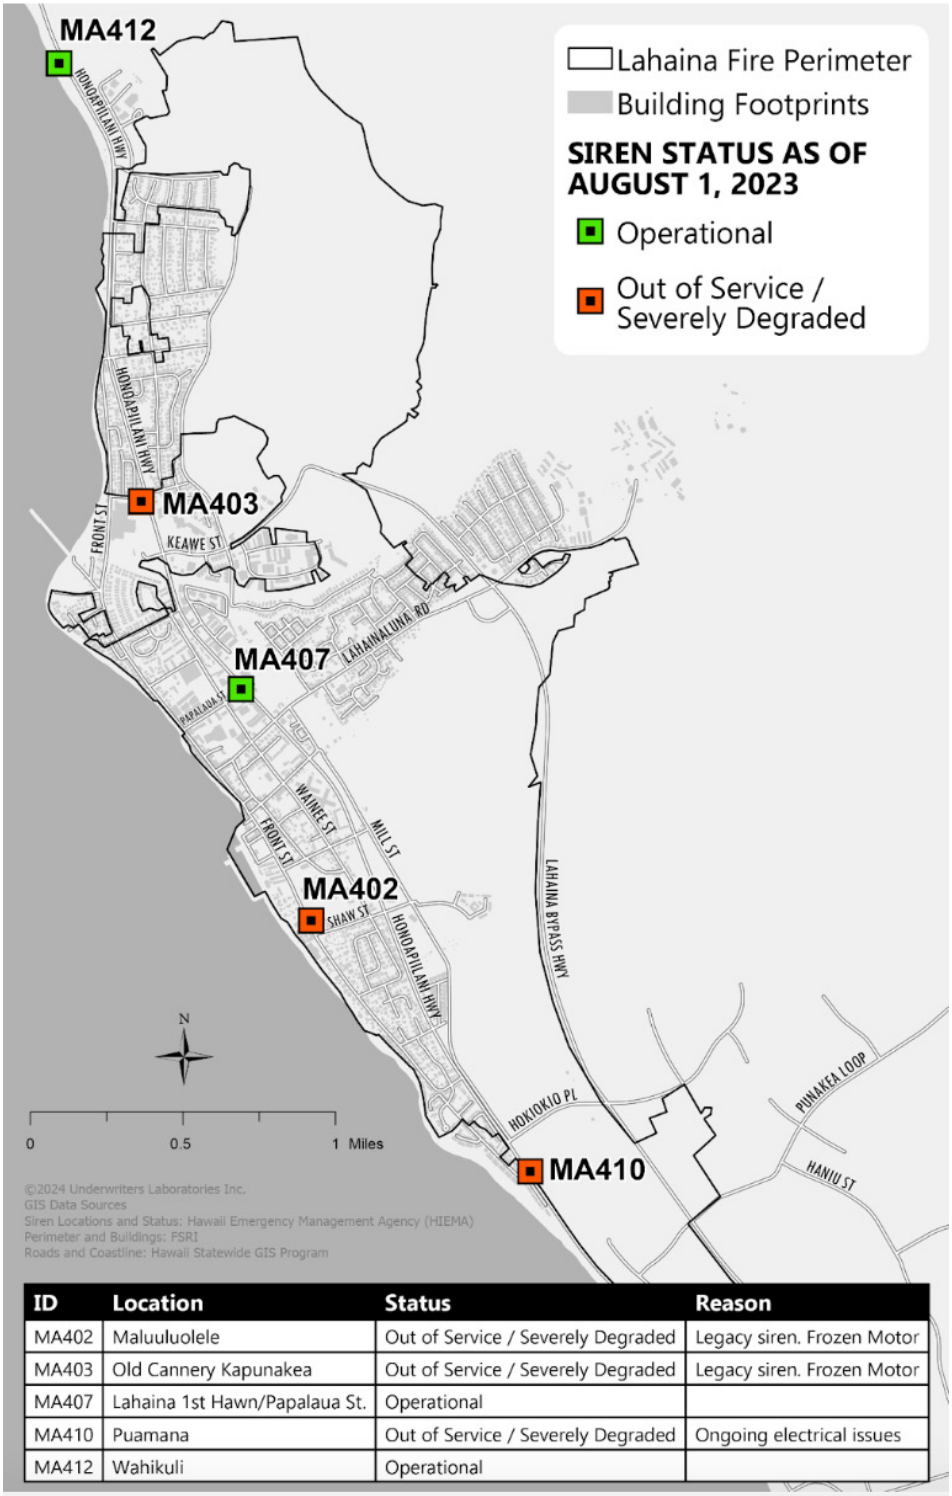
The TELCOMM branch within HI-EMA is required to maintain and repair the sirens. There is no set maintenance schedule for the sirens. HI-EMA does not have adequate staffing to keep up with the maintenance of the siren systems. Sirens within tsunami zones are given priority for repair.

On August 8, 2023, there were five (5) sirens located off of Hwy-30 and near the coastline in the area of the Lahaina PM fire[152] (Figure 3.5.1.2.1). According to siren test records (Appendix Section 6.11) provided by both MEMA and HI-EMA, siren MA407, located near Papalaua Street and Hwy-30, and siren MA412, located off Hwy-30 just north of the Lahaina Civic Center, were the only two sirens operable at the time of the fire.

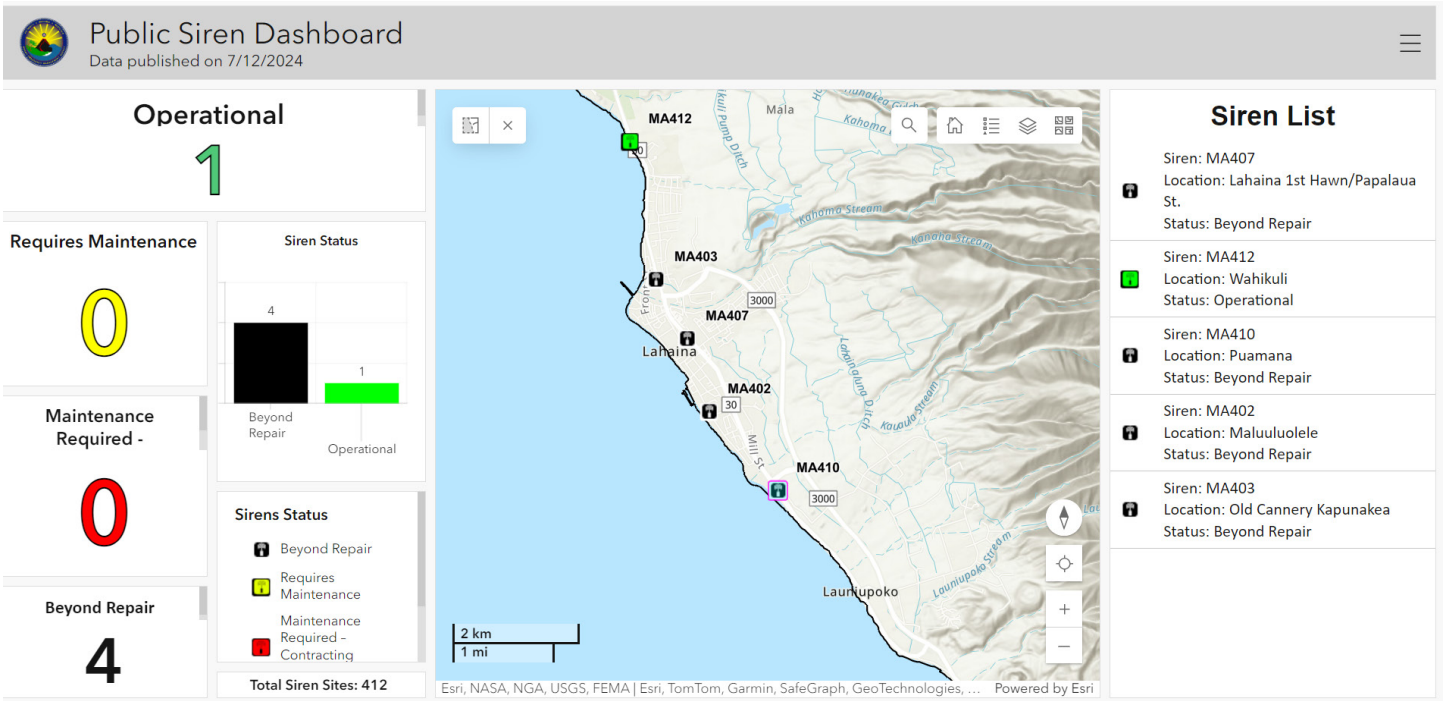
Figure 3.5.1.2.2 The public sirens in Lahaina on August 8, 2023, and their operational status as of July 12, 2024. Source: ARCIS.

The status of the State of Hawai'i Outdoor Warning Siren System is shared via the Public Siren Dashboard.[153] The July 12, 2024, dashboard for the Lahaina area in Figure 3.5.1.2.2 indicates that MA412, just north of the Lahaina Civic Center, is currently (as of July 2024) the only operable siren.

It also identifies four (4) of the five (5) Lahaina sirens as "Beyond Repair." Although the specific reason for being out of service is not disclosed, it is likely MA407 sustained significant thermal damage due to being directly in the fire's path.

Maintenance of the system also needs to be addressed to ensure an adequate number of sirens are operational to effectively alert residents of the hazard.

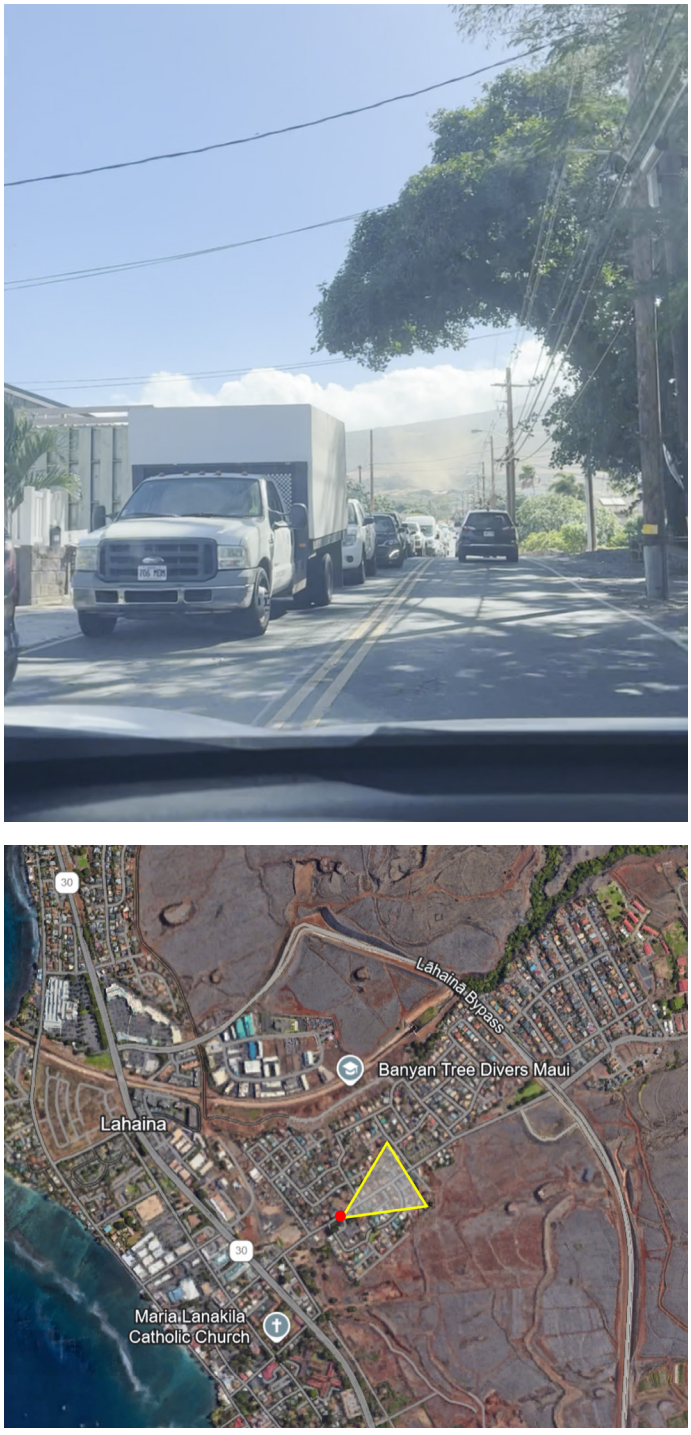
However, the fire was in challenging terrain with void spaces created by rocks in the ravine, which was difficult to access due to the danger of unstable utility poles and steep slopes described above (Figure 3.7.7.2). Additionally, the presence of dust in the area could have obstructed their view. The extreme downslope winds stirred up dust clouds, making it difficult to see any remaining smoke (Figure 3.7.7.3.1).

Figure 3.7.7.3.1 Video image captured on August 8, 2023, at 09:07, taken from a vehicle traveling eastbound (mauka) on Lahainaluna Road. At the far east end (mauka), a dust cloud can be seen near the location where the Lahaina AM fire burned. Insert: Viewpoint looking east (mauka) on Lahainaluna Road.

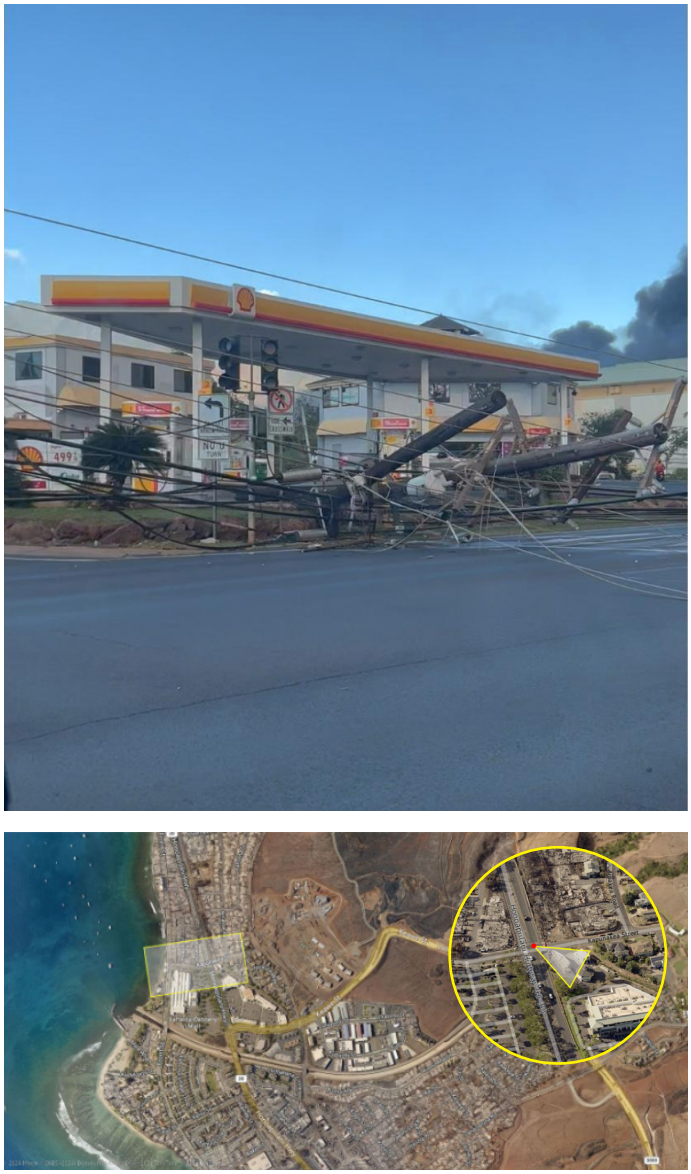
Figure 3.8.2.1 Several downed utility poles and powerlines in the northbound lane of Hwy-30 and Kapunakea Street. Photo taken August 8, 2023, at 16:52. Inset: Viewpoint of photo of downed utility poles and electrical lines at Hwy-30 and Kapunakea Street.

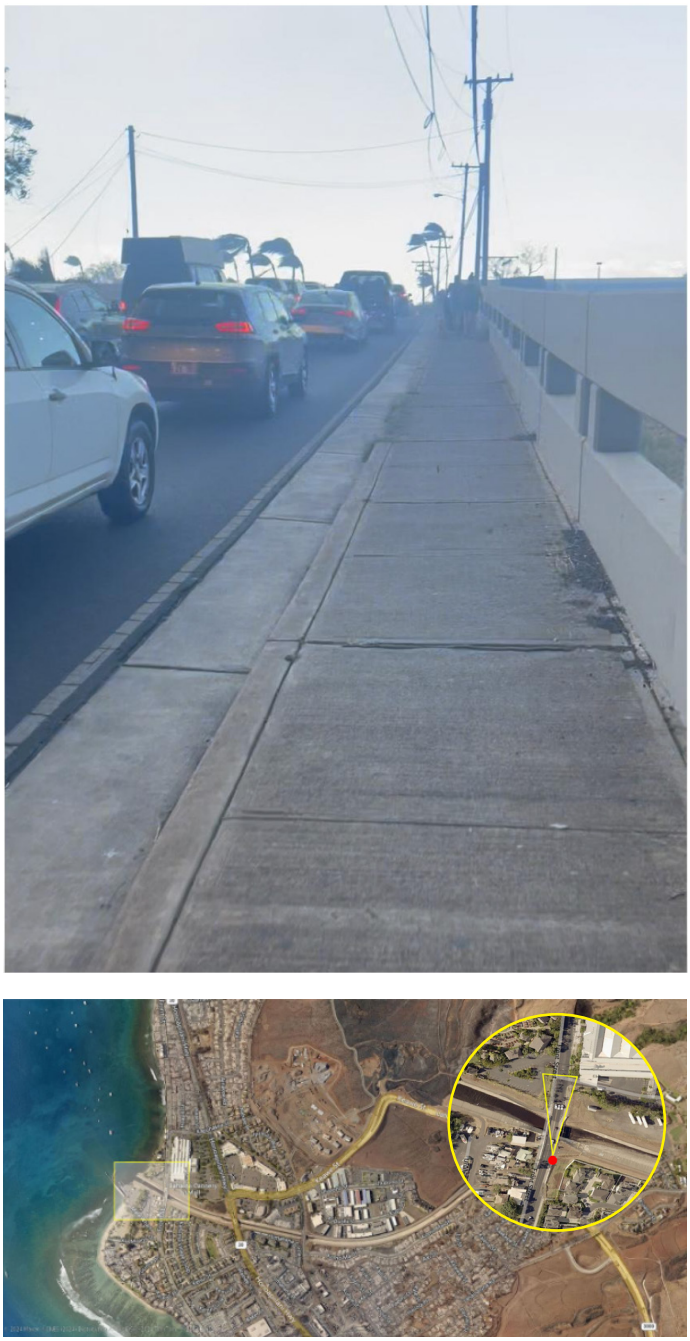
These limited egress points meant any blockage, disabled vehicle, or accident could hinder residents' ability to evacuate quickly.

Figure 3.8.2.2 Northbound Front Street traffic over Kahoma Stream on August 8, 2023, at 17:05. Inset: Viewpoint of northbound Front Street traffic over Kahoma Stream on August 8, 2023, at 17:05.

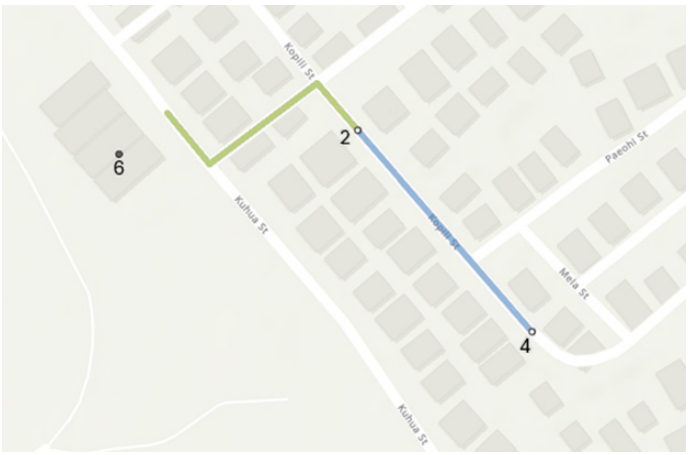
Based on resident reports and media stories, a large tree came down blocking Kuhua Street just south of Aki Street, and a utility pole came down across Kuhua Street just north of Aki Street. All six (6) victims lived on Kopili Street and likely traveled north on Kopili Street, then west on Aki Street to Kuhua Street, where they became trapped, unable to go north or south without hitting an obstruction (Figure 3.8.10.6).

Figure 3.8.10.6 Potential egress routes for fatalities recovered from 8[redacted] Kuhua Street.

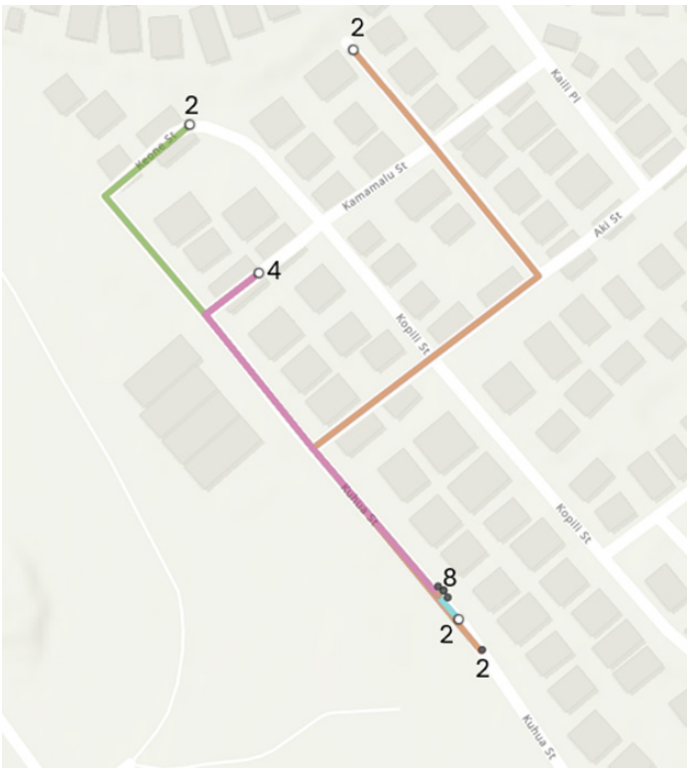
This address is where two (2) of the victims (Terri Thomas and Dale Richter) were reported to have lived. Tony Takafua, Salote Tone, Fa'aoso Tone, and Malui'fonua Tone were presumably evacuating from 9[redacted] Kuhua Street in their car headed south on Kuhua Street toward Lahainaluna Road. Juan Deleon and Ediomede Castillo were presumably evacuating from their home at 3[redacted] Keone Street in their car, headed south on Kuhua Street toward Lahainaluna Road (Figure 3.8.10.8).

It is not known what time they all reached this area. However, they were able to get past the area on the corner of Aki Street and Kuhua Street. The fire first reached the area of Kuhua Street and Lahainaluna Road at 15:57. At 16:25, homes were reported to be on fire in this area. The vehicles in front of 8[redacted] Kuhua Street were consumed by fire, while the vehicle in front of 8[redacted] does not appear to have been consumed by the fire (Figure 3.8.10.9).

Figure 3.8.10.8 Potential egress routes for those recovered in vehicles in front of 8[redacted]-8[redacted] Kuhua Street.

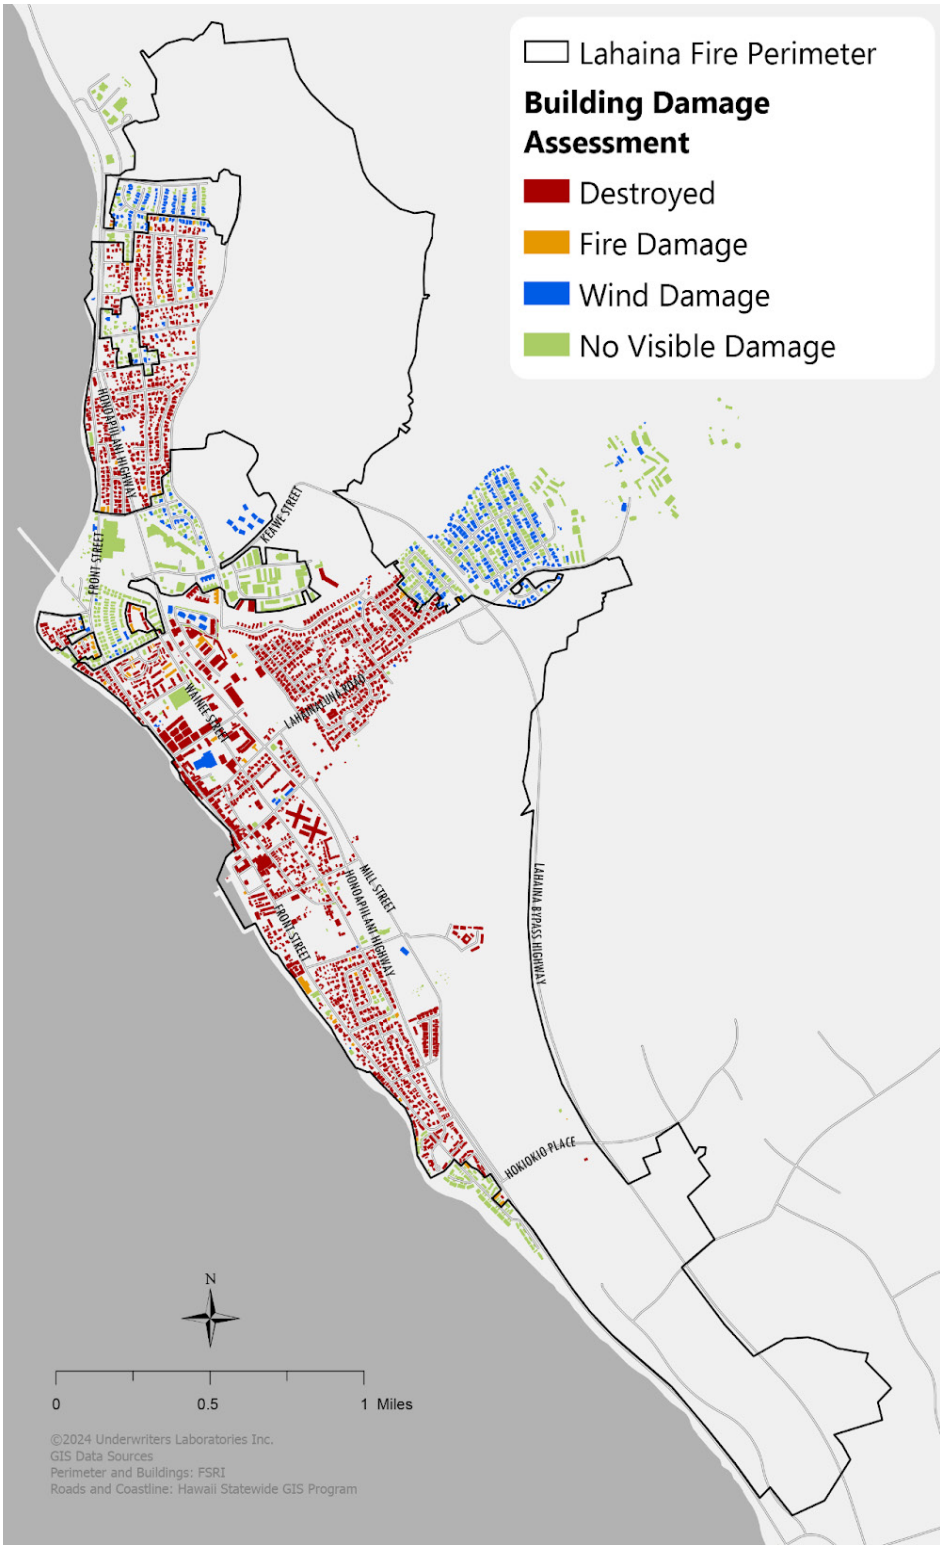
Figure 4.2.1.1 is the structure damage assessment based on data available and current understanding that combines information gleaned from previously published datasets with ground truth from Phase One evidence.

Figure 4.2.1.1 Structure damage assessment map of Lahaina as a result of the August 8-9, 2023 fire.

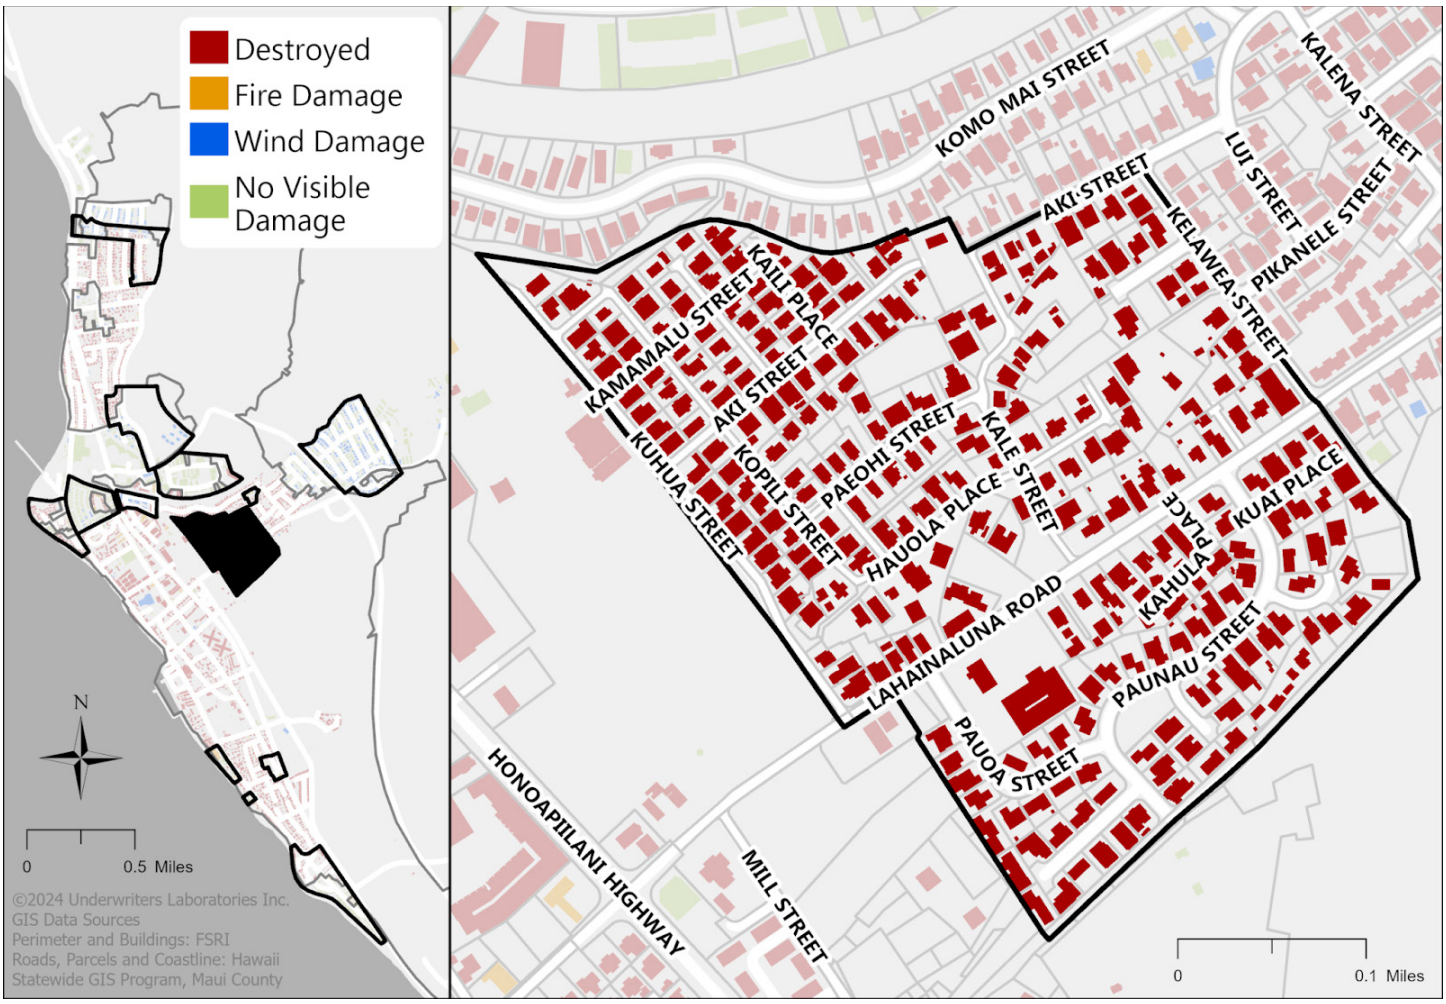
Figure 4.3.3.1.2 Damage classification assessment map of Kelawea Community analysis area.

The neighborhood is bound on the west (makai) by a large industrial area that had once been the Pioneer Sugar Mill, and was originally constructed as employee housing for the mill. All of the structures in this area were destroyed (Figure 4.3.3.1.2).

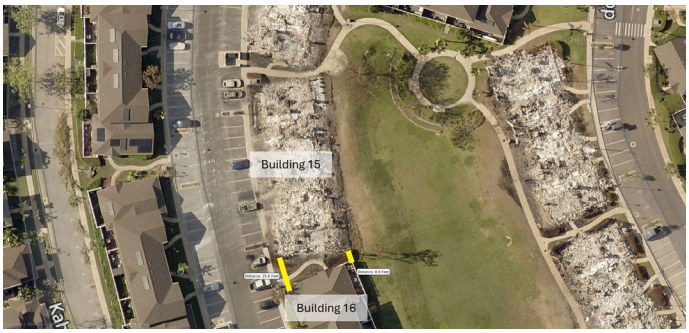
Figure 4.3.3.5.12 Distance between Building 15 (undestroyed) and Building 16 (destroyed) and several vehicles lost during the fire.

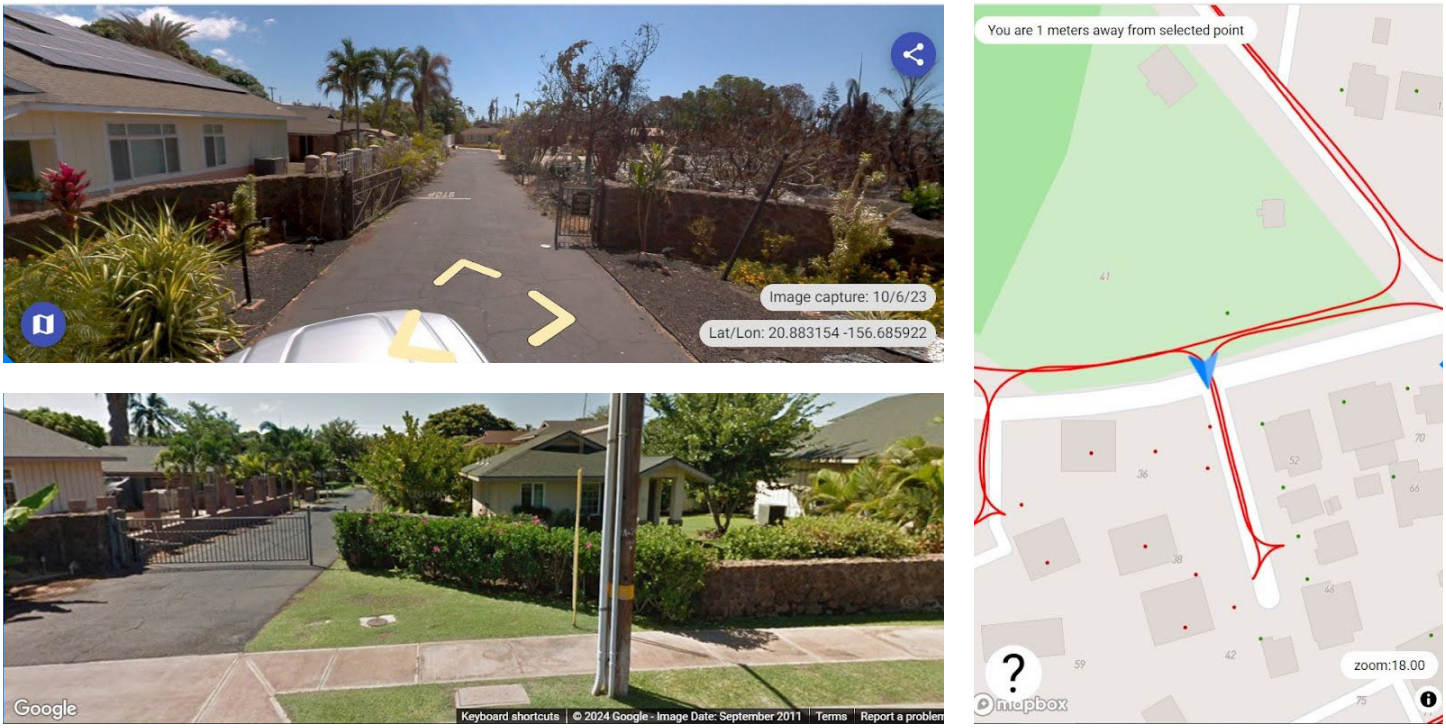
Figure 4.3.3.6.3 Pre- and post-fire Google Street View imagery of Ala Moana Street private driveway. This road is a demarcation of destruction, nearly all of the structures on the ocean (makai) side are destroyed.

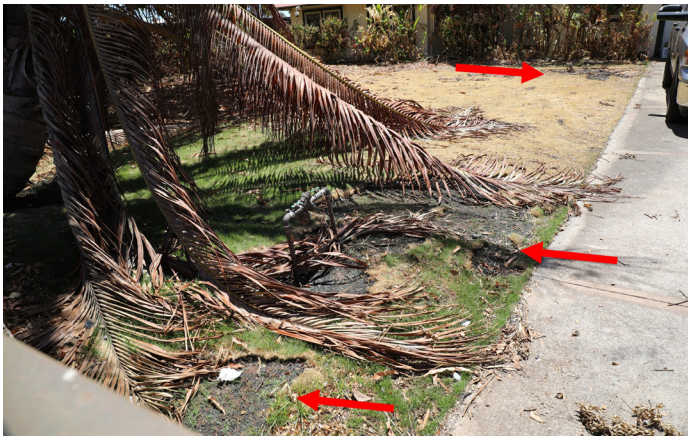
Figure 4.3.4.1.11 Ember-created spot fires in the front lawn of 4[redacted] Front Street (top). Bottom panel shows the map location and street image before and after the fire at 4[redacted] Front Street.

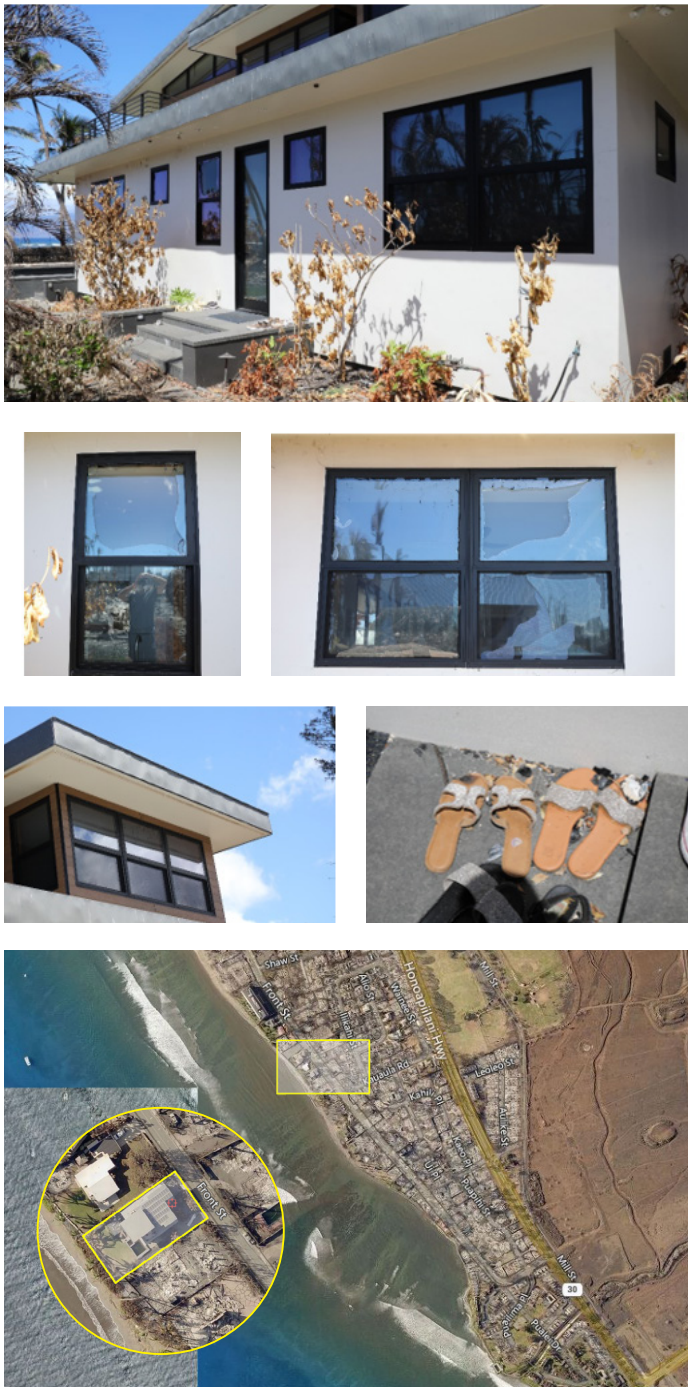
Figure 4.3.4.1.13 Window damage on the south side of 4[redacted] Front Street. Ember damage to shoes on doorstep indicates energetic embers were present in the area, which could have increased risk for ignition of interior combustibles had windows completely failed. Inset: Viewpoint showing the area depicted in the photographs above.

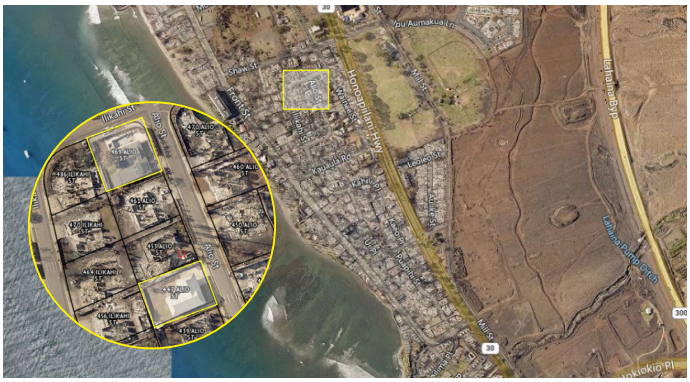
Figure 4.3.4.2.17 Surviving structures at 4[redacted] and 4[redacted] ʻĀlīʻō Street, dimensioned from the pre-fire image (top) superimposed on the post-fire image (bottom right). Inset: Viewpoint showing the area depicted in the photographs above.

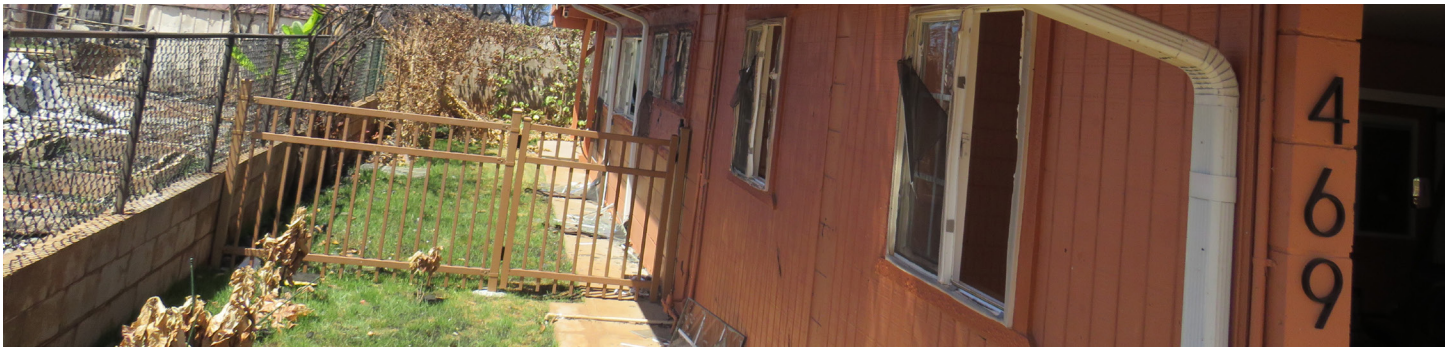
A window treatment in a bedroom and outdoor lamp in the garage showed signs of deformation due to heating, but no interior materials appeared to have ignited. The timing of these window failures relative to other structure fires in the area and shifting winds all impacted the relative risk created by these openings.

Figure 4.3.4.2.18 Radiant heat damage to the structure and household belongings at 4[redacted] ʻĀlīʻō Street was noted primarily on the north side.

These large openings in the building envelope would have provided relatively easy access for embers to enter and accumulate inside this structure if enough energetic materials were transported to this area after the windows failed.

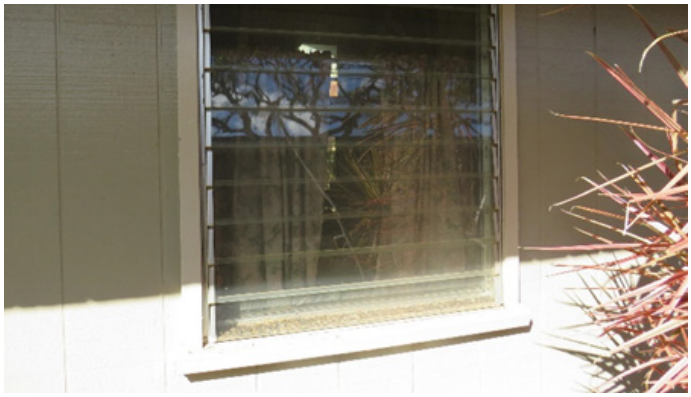
Figure 4.3.4.4.15 Examples of open/broken windows on surviving structures in Puamana.

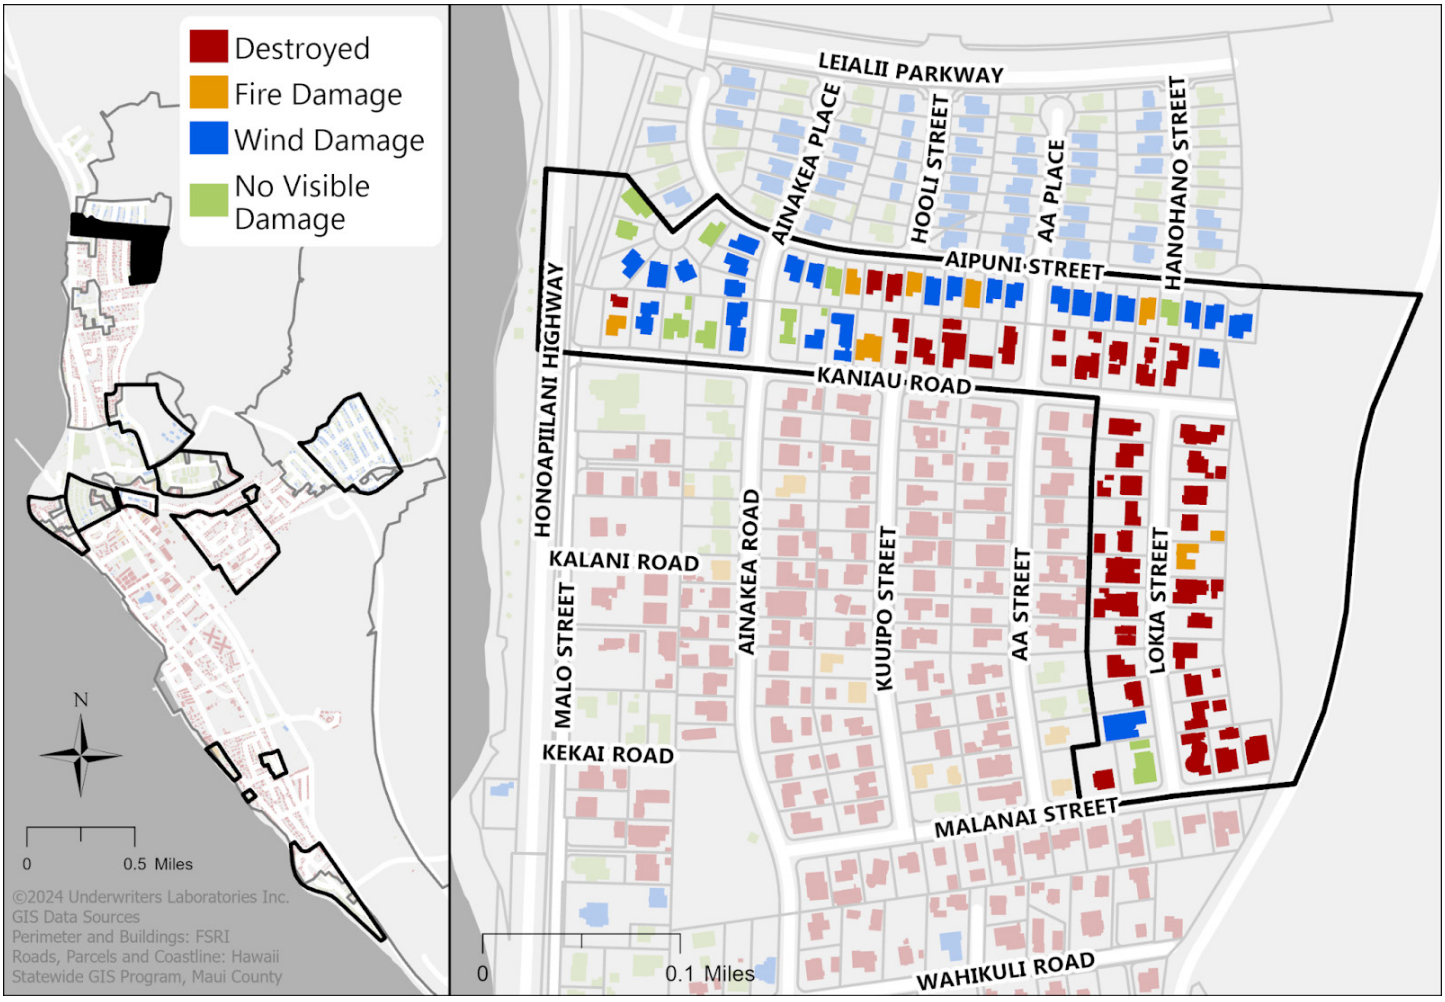
Figure 4.3.5.3.2 Damage classification assessment map of analysis area.

In the North zone, structures between Kaniau Road and ‘Aipuni Street were the northernmost structures to be destroyed by the fire (Figure 4.3.5.3.1). Only 13 of the 31 structures on the north side of Kaniau Road survived the fire, with most of the surviving structures grouped toward the west (makai) end of this road (Figure 4.3.5.3.2).

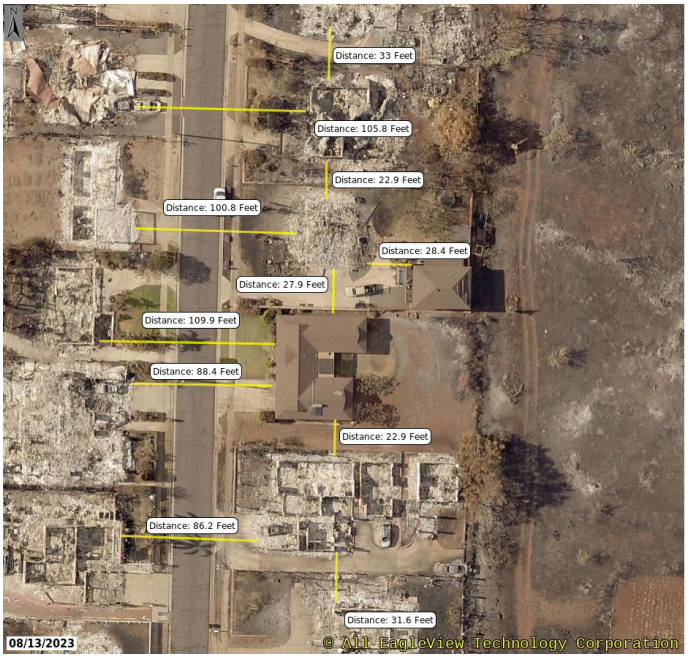
Figure 4.3.5.3.4 Structure spacing along Lokia Street in the vicinity of the surviving structures on the east side (mauka) of the street, abutting the grassland fire.

The vegetation fire in the grassland propagated into the east (mauka) yard of 16[redacted] Lokia Street, but had limited impact on the structure itself. A sprinkler was noted in the east (mauka) yard in the vicinity of where the vegetation fire ended.

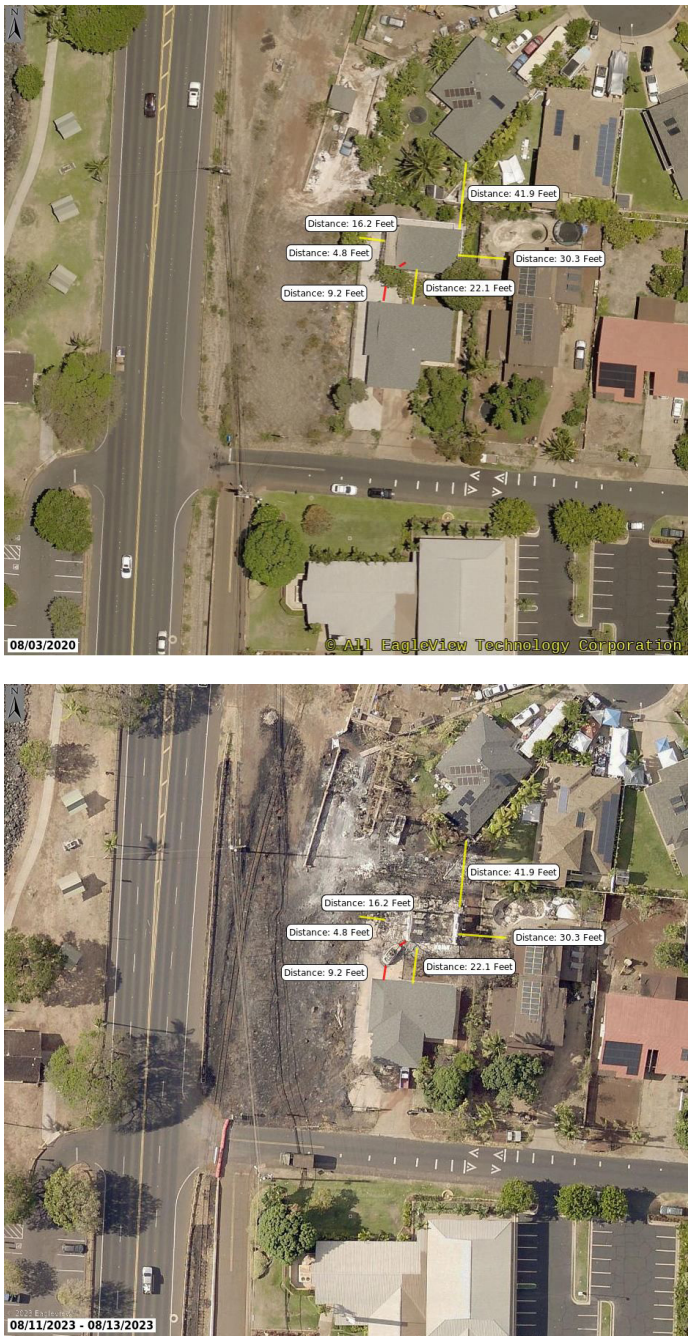
Figure 4.3.5.3.8 Structure spacing near destroyed accessory structure at 1[redacted] Kaniau Street.

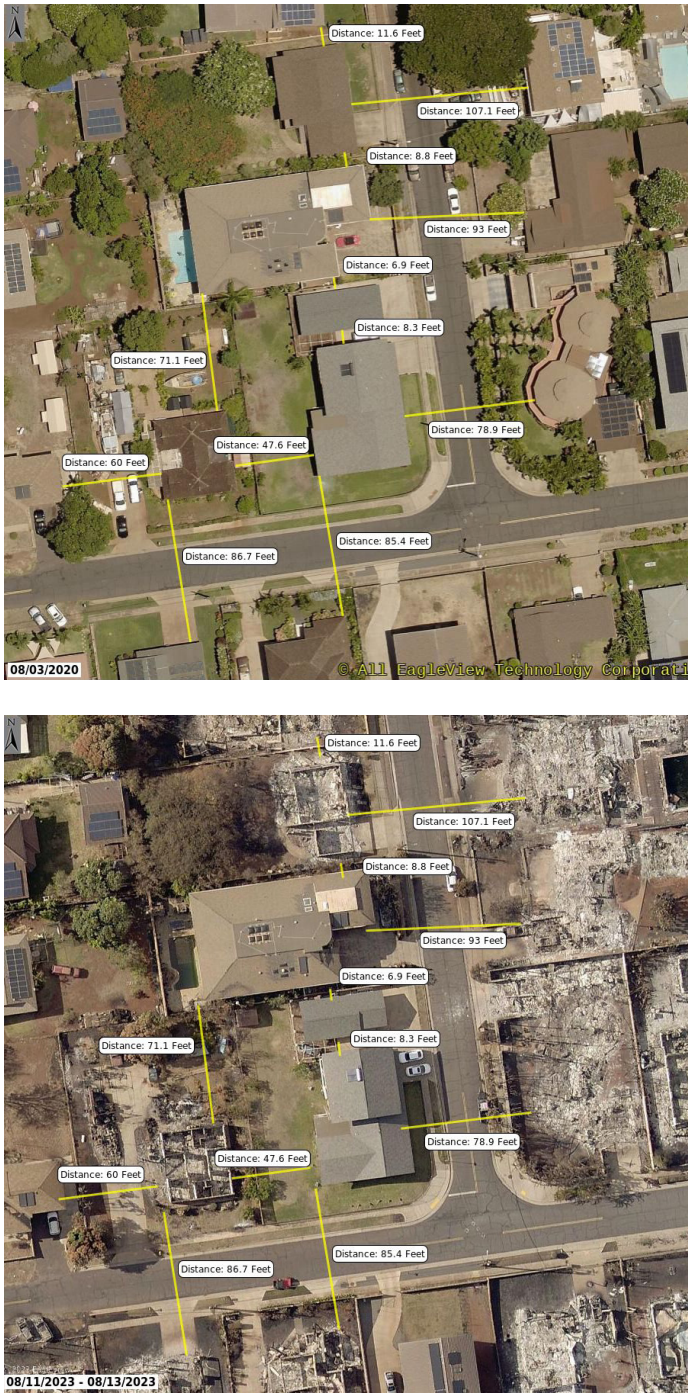
Figure 4.3.5.3.12 Structure spacing near surviving structures on the west side (makai) of the south end of Lokia Street.
