Lahaina Fire Incident Analysis Report

Steve Kerber
Derek Alkonis

September 13, 2024
Columbia, MD

This document is the second in a series of three (3) reports commissioned by the Hawai‘i Department of the Attorney General (DOAG) to provide an independent review of the tragic fire that destroyed much of Lahaina, Hawai‘i, on August 8-9, 2023.

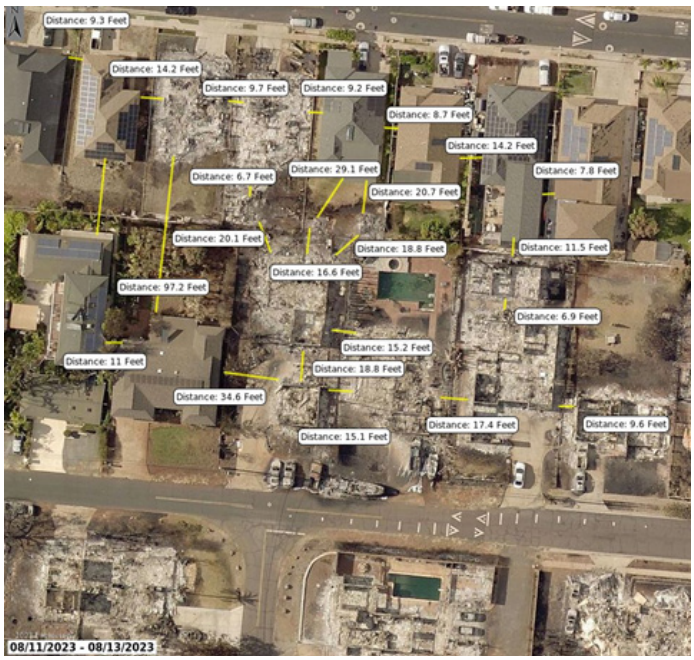
Figure 4.3.5.3.14 Structure spacing near surviving structures on the north side of Kaniau Street and south side of ‘Aipuni Street.

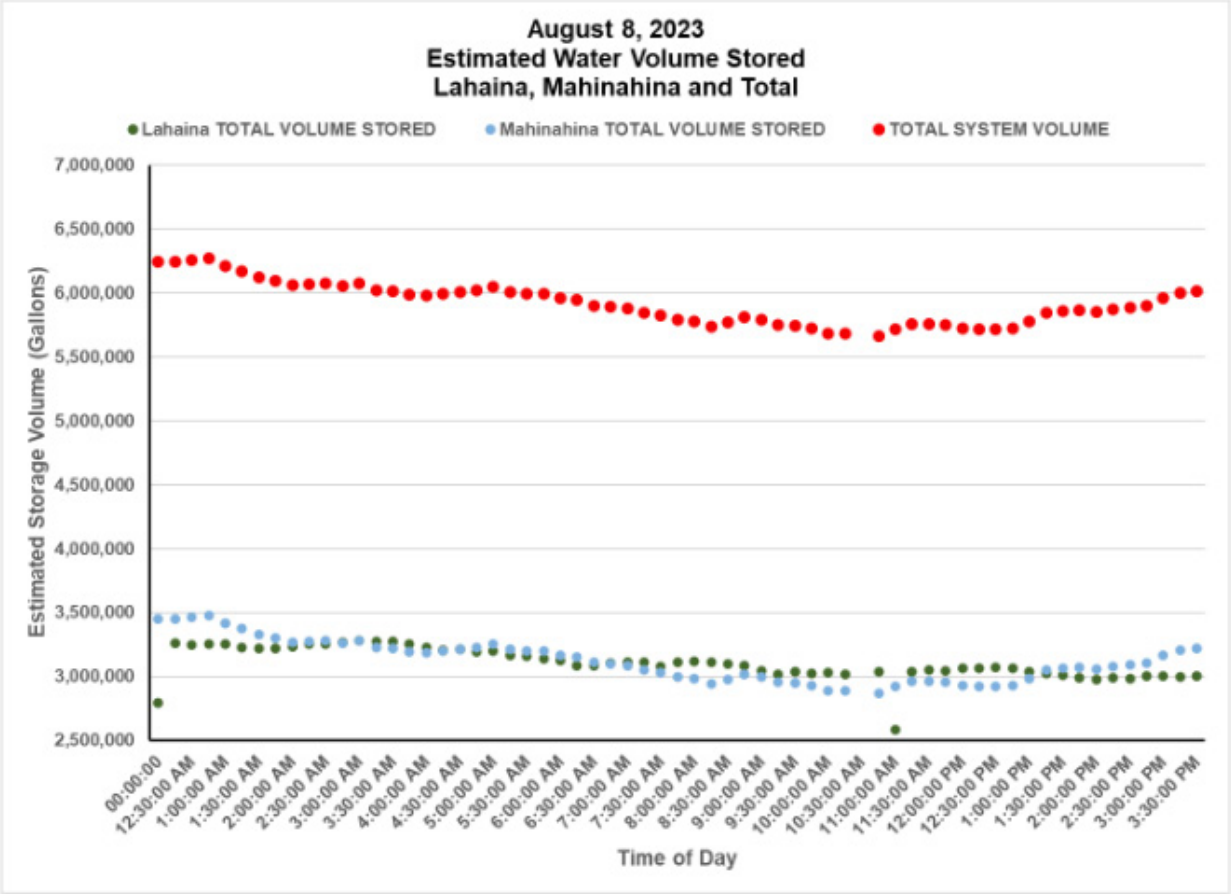
Figure 6.8.3 Estimated water volume stored in Lahaina and Māhinahina on August 8, 2023.

As per Figure 6.8.3, total system volume on August 8, 2023, ranged from just less than 7 MG to less than 6 MG until 15:30 when data was no longer available. Therefore, the amount of water stored in the two (2) systems met the state requirements for the required average daily demand until data was no longer available as described above.

A data recording system for the County of Maui Department of Water Supply routinely records the water level in each of the water storage tanks in both the Lahaina and Māhinahina storage and distribution systems. The graph below shows the time variation of water volume stored versus time for the Lahaina, Māhinahina and the two (2) systems combined. The recording of water level data by the county ceases at 3:30 p.m. on August 8, 2023, for all storage tanks in both the Lahaina and Māhinahina systems. The reason given by the county for the simultaneous loss of all tank level data was a power outage.

Note: The volumes calculated in the graph above are preliminary estimates based upon the tank capacity and the tank level recorded by the system. The recording system stopped recording data at 15:30 on August 8, 2023.
