## Firefighter Safety and Photovoltaic Installations Research Project

### **Robert Backstrom**

### **David A. Dini, P.E.**

Issue Date: November 29, 2011

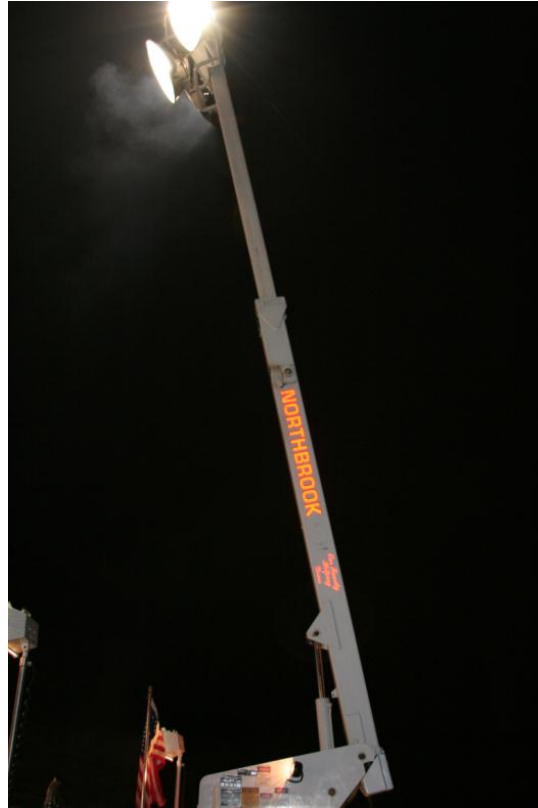
**Figure 71 Light Truck No. 2 boom lights**

Artificial Light from a Fire Truck - In most cases under these artificial lighting conditions, the light trucks were able to produce enough illumination to cause an electrical shock hazard. Although significantly less than the 240 milliamp threshold for ventricular fibrillation of the heart, both of the trucks were each able to produce enough light to cause the array to produce over 40 milliamps, the “lock-on” threshold, even at distances as far away as 38 feet from the array.

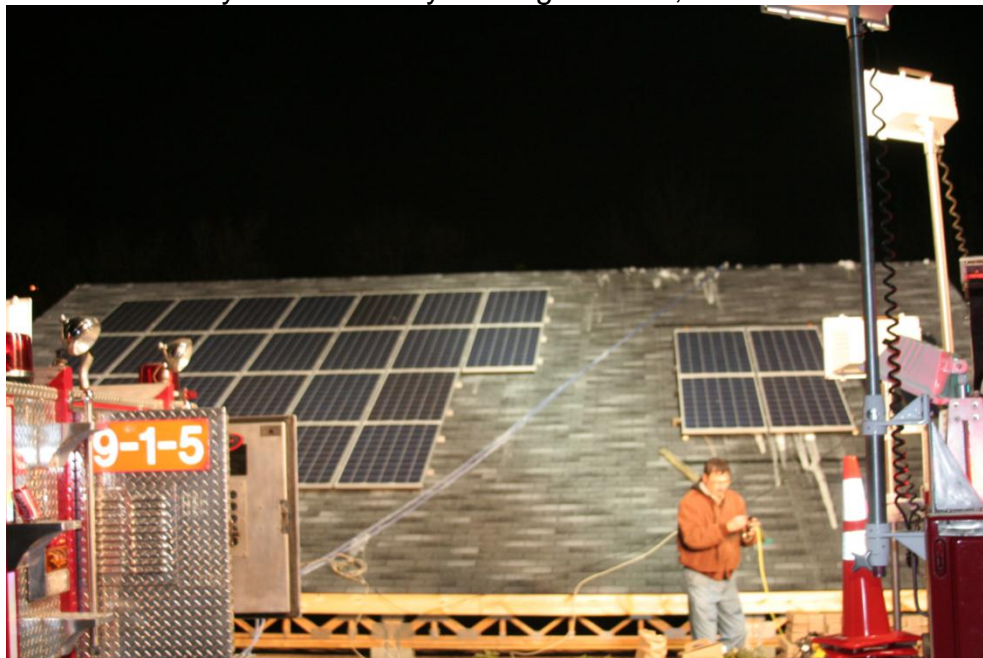
**Figure 72 Both trucks lighting the array**

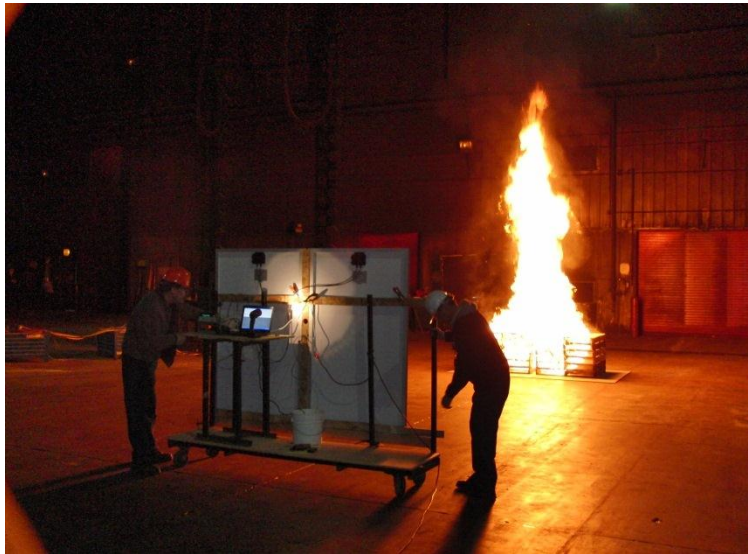
Figure 73 Test fixture with modules approaching fire

Light from a Fire - Under these test conditions, the illumination from this fire was able to produce currents of over 40 milliamps, the “lock-on” threshold at distances as far away as 75 feet from the fire.

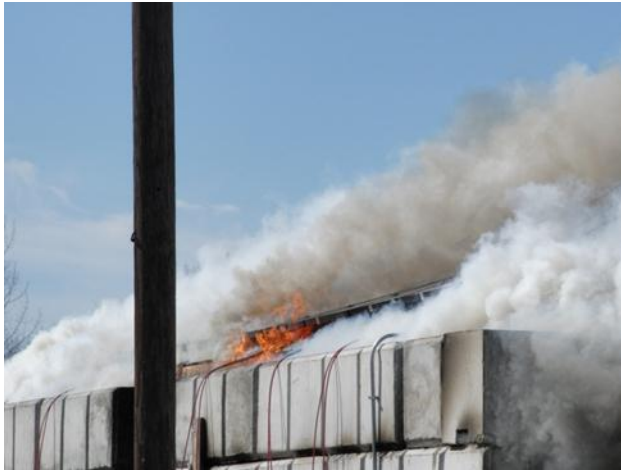
After 2 minutes (elapsed time), the pallets were fully engulfed in flames, and some smoke was observed coming out the door and window. After 4 minutes some smoke was observed under the panels, but there was no breach in the roof. At 6 minutes 40 seconds, the ground-fault detection and interruption fuse within the inverter opened, and the inverter turned off. The density of the smoke continued to increase, and after 9 minutes 30 seconds some flames were observed coming from the top of the roof. At 12 minutes there was open flaming at the back gable end, and at 13 minutes some water was applied at that location to help force the fire towards the center of the roof structure. At 16 minutes there was some horizontal sag observed in the modules between the upper and lower strings, and at 17 minutes flames breached completely through the roof. At 18 minutes 30 seconds, the roof and PV array collapsed into the building, and water was applied to extinguish the fire.

Figure 101 illustrates the ignition and burning of the roof deck. Figure 102 provides a view of the array and roof assembly deflection. Figure 103 illustrates the roof and array prior to structural collapse. Figure 104 illustrates the test structure after collapse and suppression.

**Figure 101 Open flames on roof**

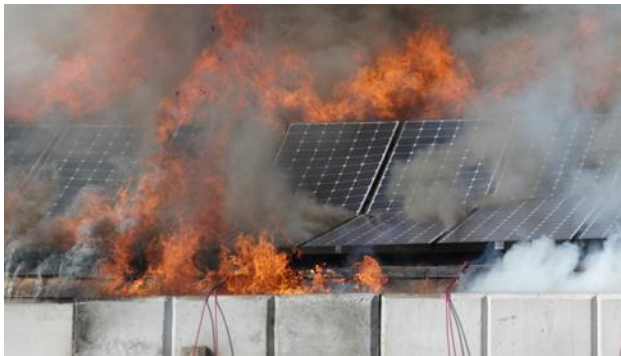
**Figure 103 Roof and modules collapsing**

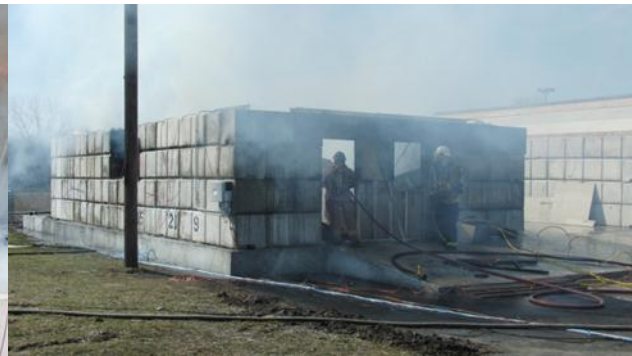
**Figure 104 Roof collapsed -fire extinguished**

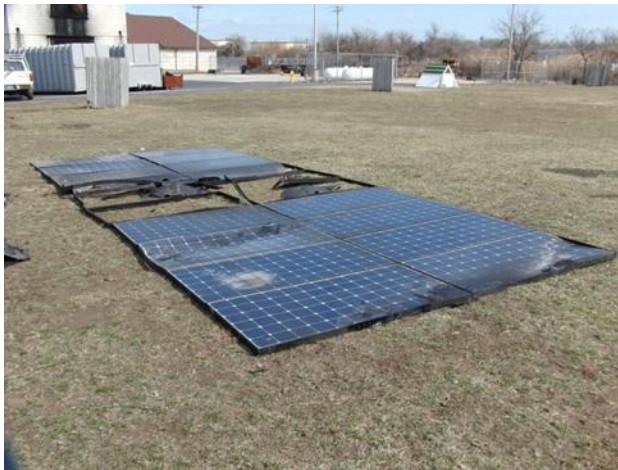
After the fire, each module was cut from the string, removed from the bunker, and placed in an open field where voltage and current measurements could be made in full sun. Modules E1, E2, F1, F2, and G1 were completely destroyed and producing no power. Modules A2, B1, and G2 had some damage and were producing less than full voltage. The remaining modules were fully functional and capable of producing full rated voltage and current. Figure 112 illustrates array damage. Figure 113 provides a view of the front of the array after the fire. Figure 114 provides a view of the back of the array after the fire.

Figure 113 Post fire, front surface

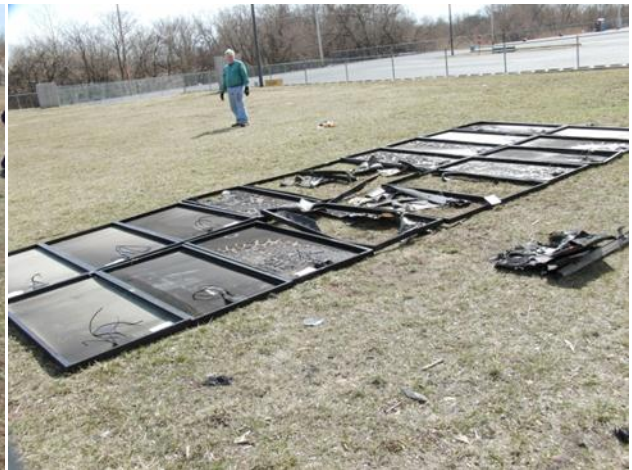
Figure 114 Post fire, back surface

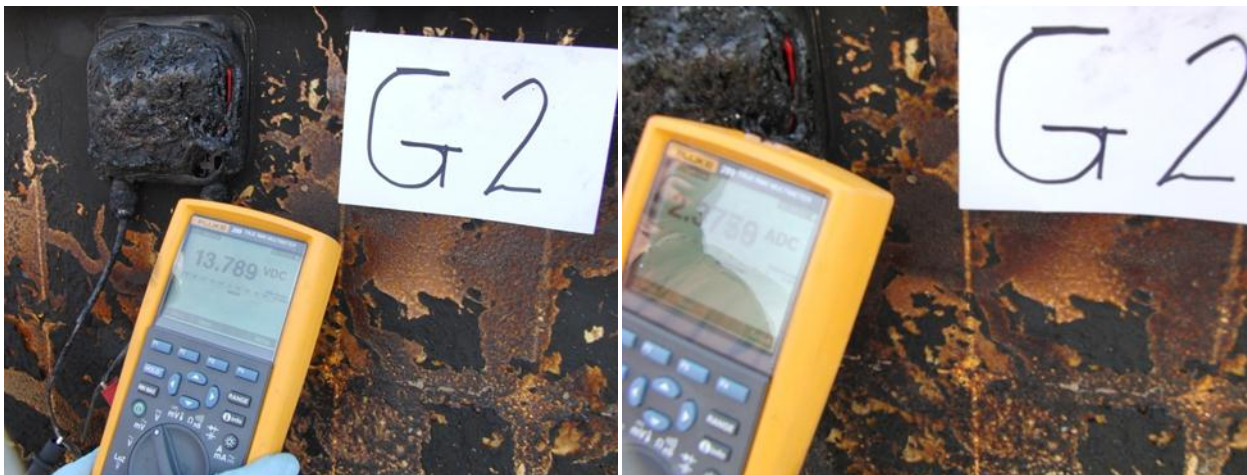
**Figure 119 Module G2 – still producing voltage and current**

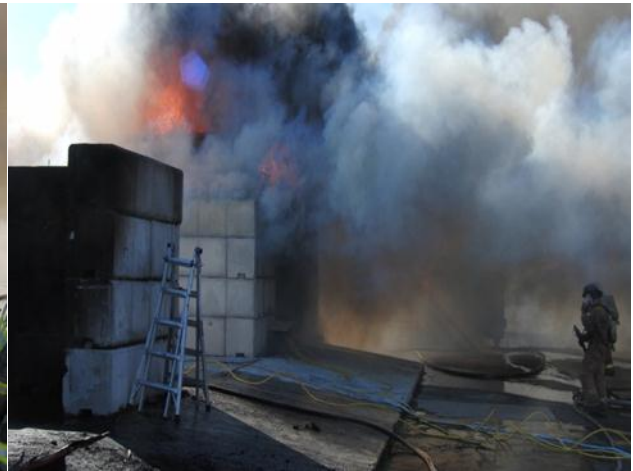
After 2 minutes (elapsed time), the pallets were fully engulfed in flames, and by 4 minutes some smoke was observed at the bottom edge of the roof. After 6 minutes, the non-PV side of the roof appeared to be burning and smoking more than the PV (metal pan) side of the roof, and at 6 minutes 15 seconds the inverter turned off. At 8 minutes and 30 seconds, flames were observed at the front top peak of the gable end of the bunker. At 17 minutes some sag was observed in the cement board (non-PV) side of the roof, and at 19 minutes 30 seconds the roof and PV array collapsed into the building, and water was applied to extinguish the fire.

**Figure 126 Roof and laminates collapsing**

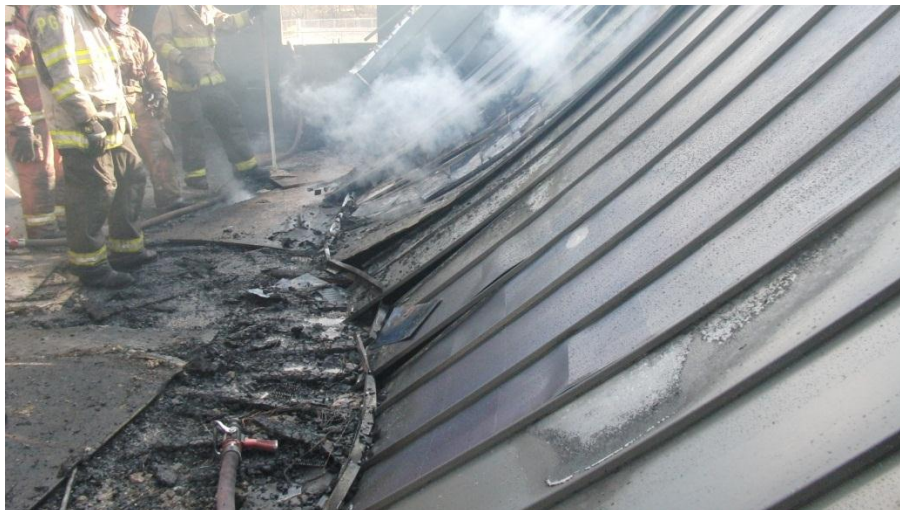
**Figure 128 Firefighters approaching Collapsed Laminates after Fire**

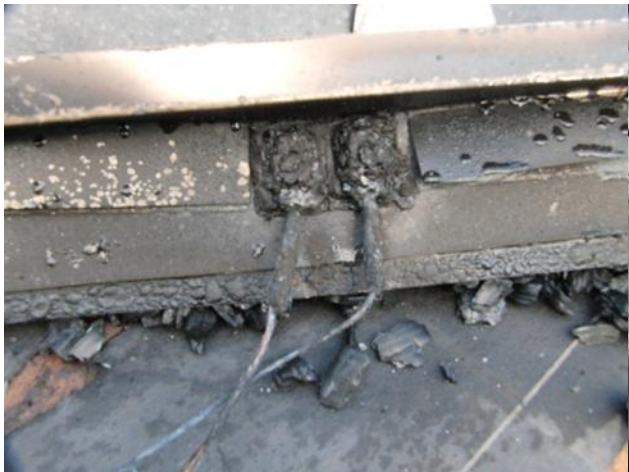
Figure 136 through Figure 139 views of damage to the laminate including exposed wiring and bus..

Figure 138 Exposed bare wires at junction box

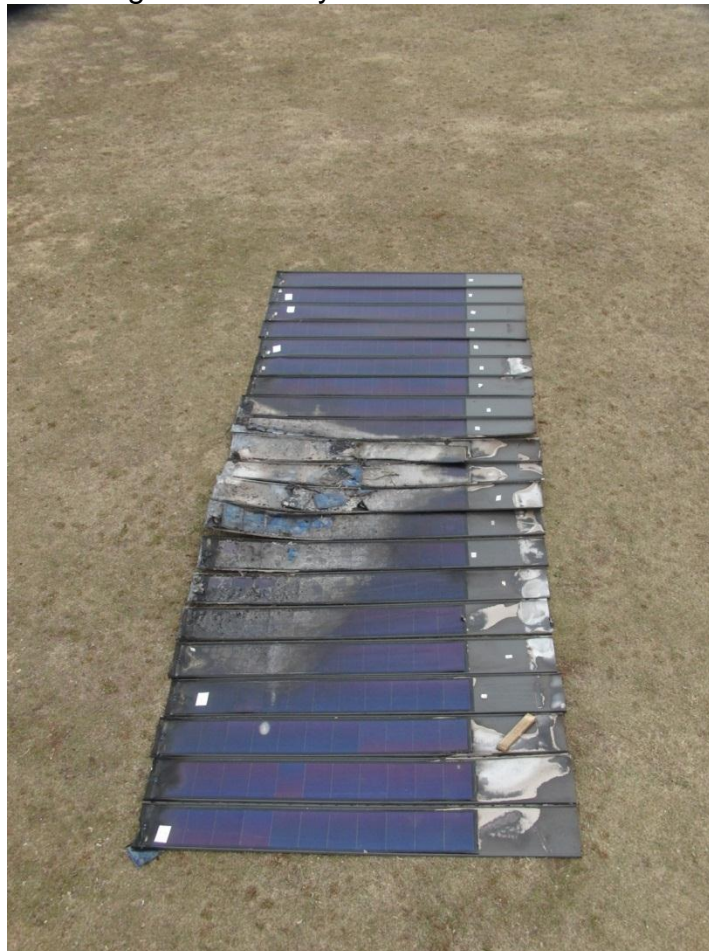
After the fire, and while still in the collapsed position within the bunker, an examination and analysis of the damaged PV array was made. Only laminate numbers 1, 4, 17, 19, and 20 were able to measure any voltage as found after the fire while in that condition. A voltage of 3.5 volts was found on laminate #1 from an exposed lead pad at the junction box to the metal pan. Laminate numbers 4, 17, 19, and 20 measured 22 volts either between leads, or between a lead and the metal pan. There was typically a voltage potential from the positive lead of the laminate to the metal roof pans.

Figure 141 illustrates damage of the array.

**Figure 141 Array reconstructed on ground, post-fire**

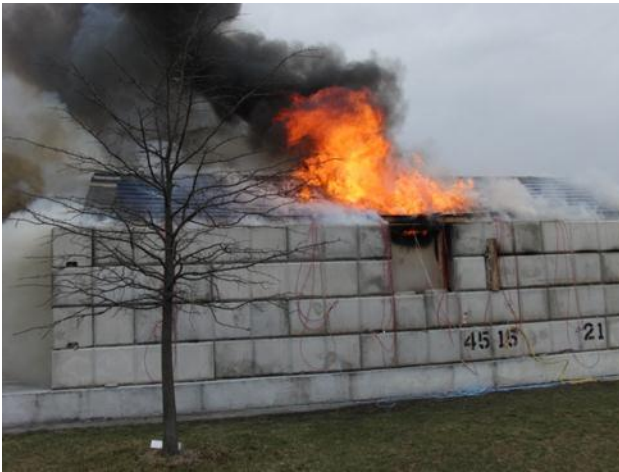
**Figure 146** Solar shingles on fire

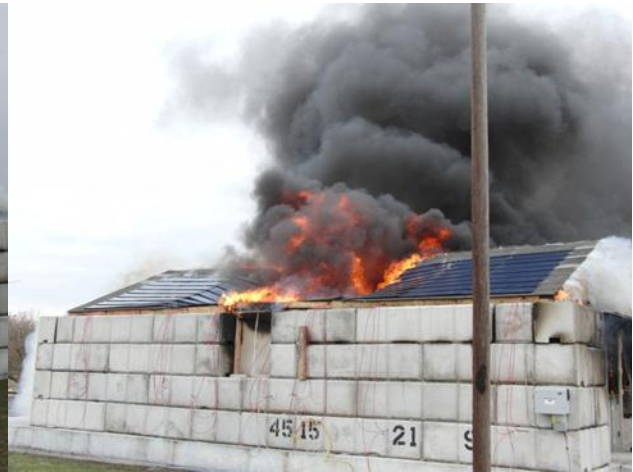
**Figure 147** Roof beginning to collapse

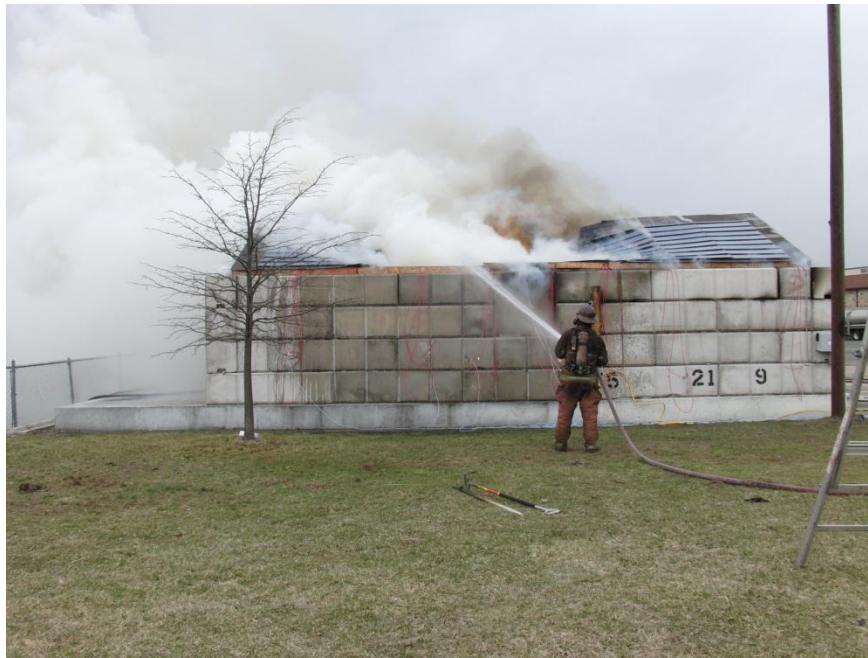
Figure 148 - Partial collapsed roof during extinguishment

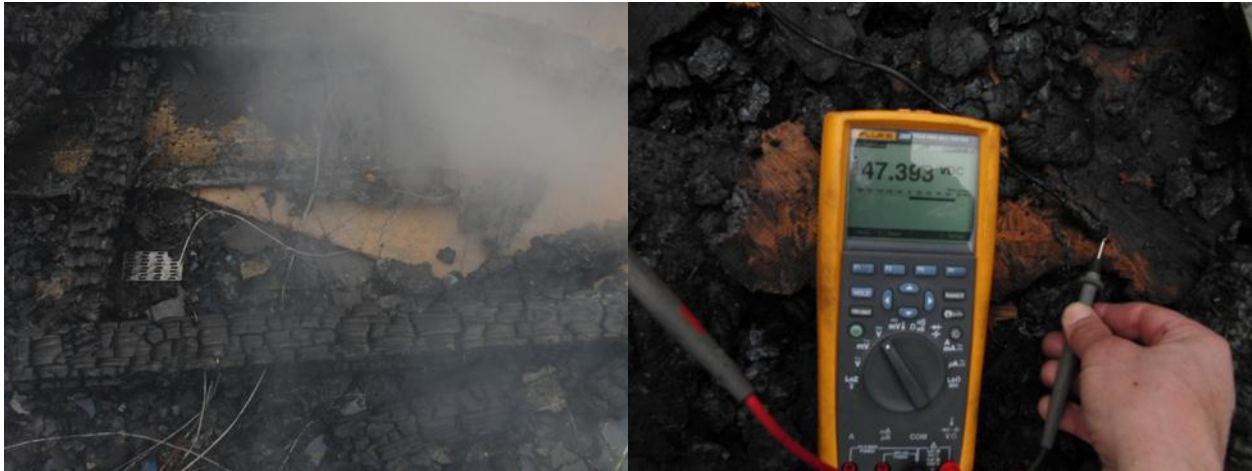
After the fire, and while still in the collapsed position within the bunker, an examination and analysis of the damaged PV array was made. The “home run” was found exposed with most of the conductor insulation burned off. 47 volts open circuit and 150 milliamps short circuit was measured between the bare home run and shingle G2 within the rubble.

Figure 155 illustrates array damage. Figure 156 and Figure 157 illustrate exposed conductors and voltage from a damaged module.

Figure 156 Exposed lead conductors in rubble    Figure 157 Voltage between exposed wires

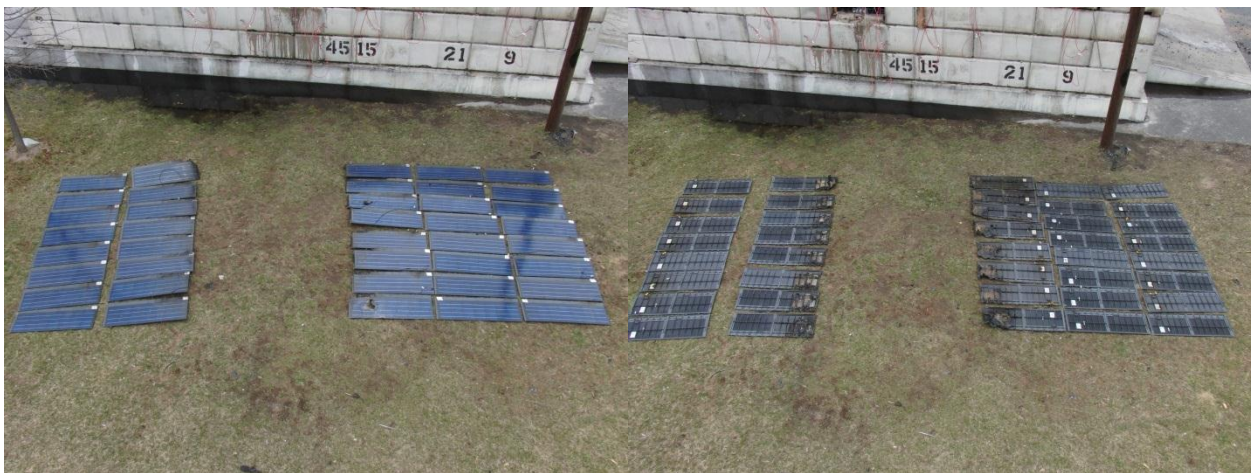
The shingles were then cut from the string, removed from the bunker, and placed in an open field where voltage and current measurements could be made in full sun. Shingles B1, C1 – C8, D1 – D8, E1 – E8, F1 – F8, G4, and G8 were destroyed and producing no power. The remaining shingles were fully functional and capable of producing full rated voltage and current. However, many of these functional modules were badly burned exposing live copper bus and bare conductors. See Figures 5.8.10.2 and 5.8.10.5.

Figure 158 Array reconstructed on ground, post-fire

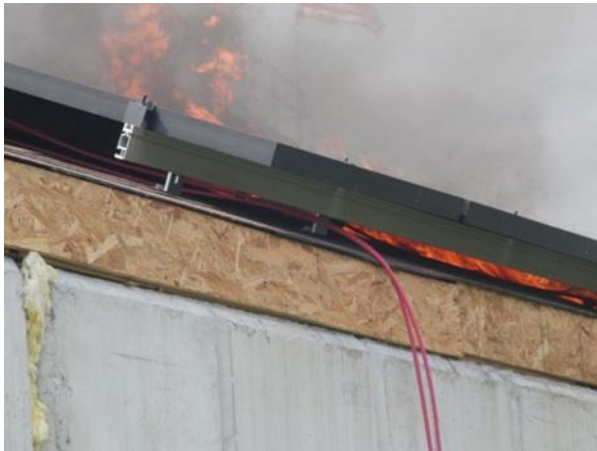
**Figure 173 Fire propagating under modules**

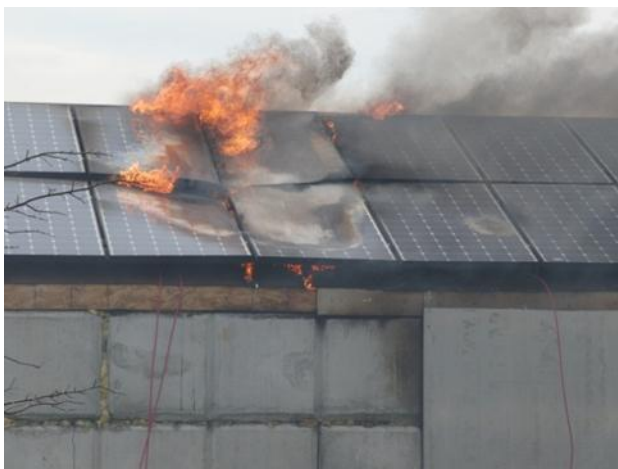
The test was continued by placing and igniting an “A Brand” under module D2. After 6 minutes into this continuation of the test, open flames were observed and module D2 began to sag. By 12 minutes, vertical flames were observed along the complete length of module D2. At 13 minutes, there was heavy smoke and flames, and module D2 had completely sagged in, and at 14 minutes the inverter turned off, with the array voltage still over 300 volts. For the next several minutes flames were noticed between modules C2 and D2, and flames also at the top peak of the roof at modules D1 and E1. At 21 minutes the test was terminated, and water was applied. The array voltage was about 230 volts at the end of the test. There was no structural damage to the roof.

**Figure 175 Modules sagging from heat**

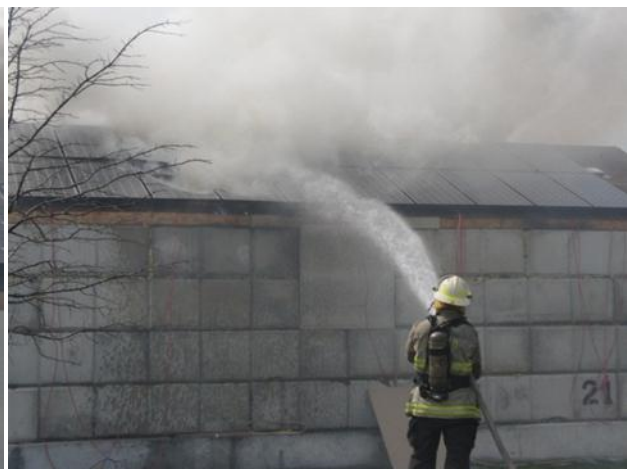
**Figure 176 Fire being extinguished**

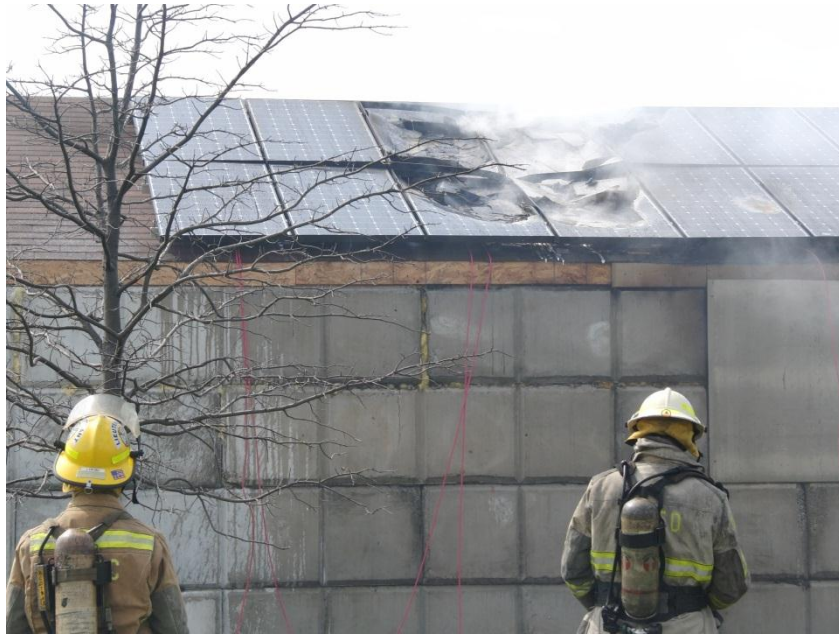
**Figure 177 Firefighters assessing damage after fire**

With the assistance of the professional PV installation contractor, the situation of the fire damaged PV array was analyzed to determine if hazardous energy was still present, and how the array could be safely disassembled and removed from the roof to ground. From general observations of the array, modules C1, D1, C2, D2 and E1 were heavily damaged. Since there were voltage sense leads attached to the modules for test purposes, it was easy to determine that most of the remaining modules had full voltage. It should be noted that in a real fire situation, this would not be as easy to determine. Also, it was observed that the fire had damaged the wire insulation to many of the conductors, and also had melted the aluminum mounting rail in several places, thus possibly losing ground continuity.

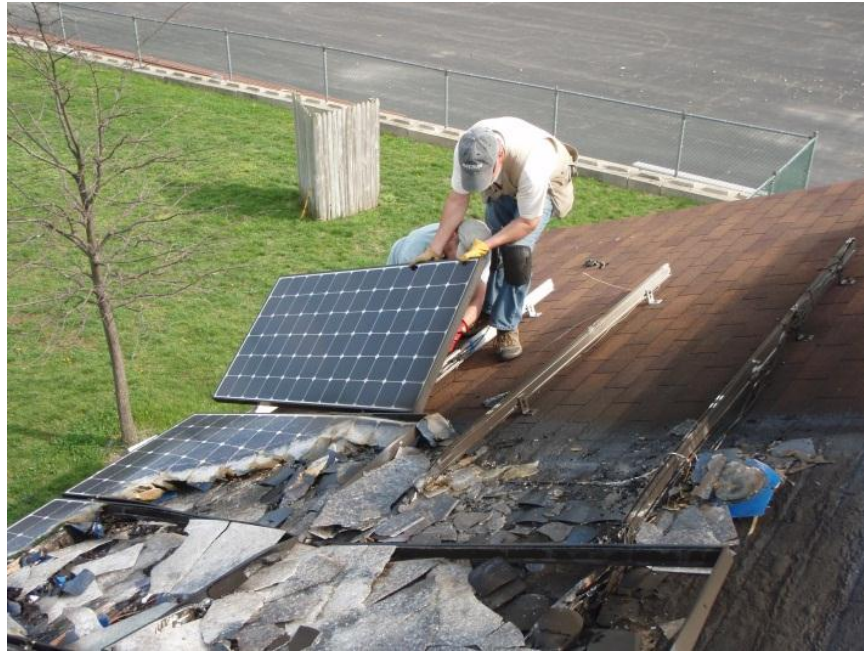
**Figure 186 Work continues closer to damaged modules**

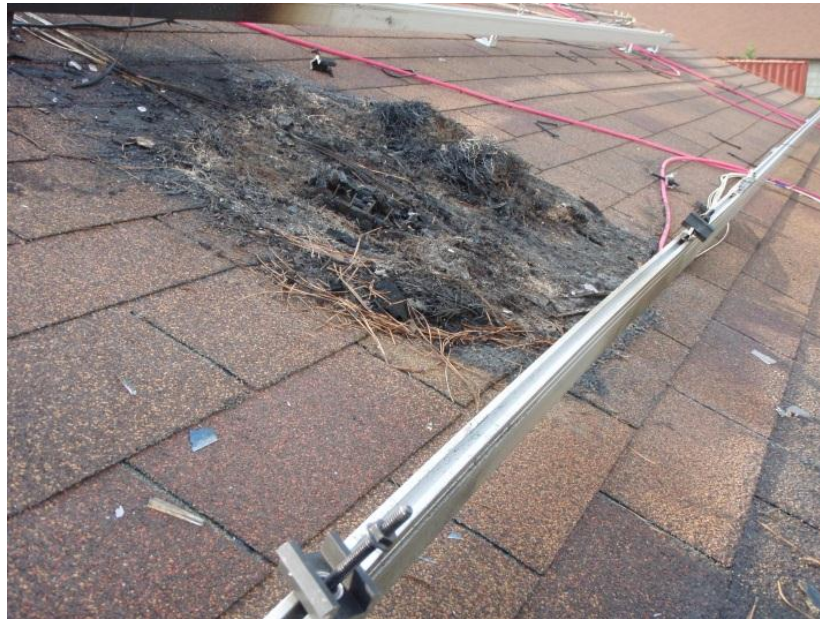
**Figure 187 Roof after modules removed**

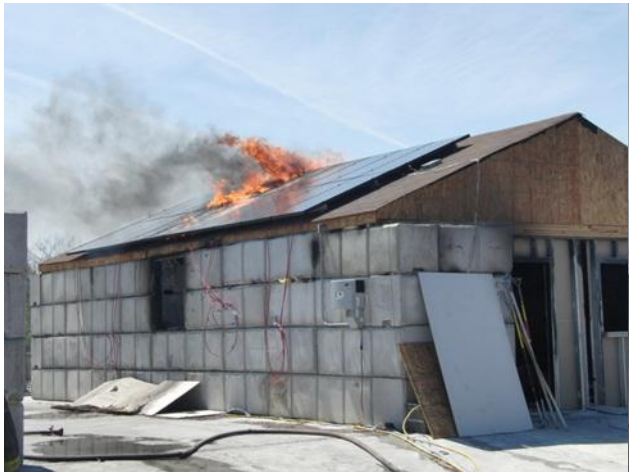
**Figure 189 Ignited pine straw under modules**

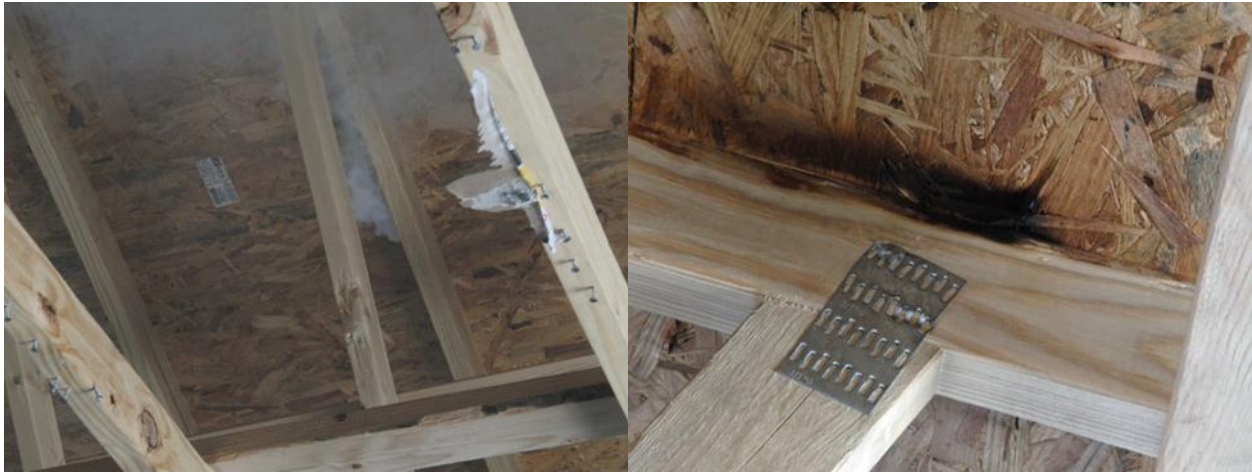
**Figure 192** Smoke developing on inside of roof   **Figure 193** Charring on inside of roof

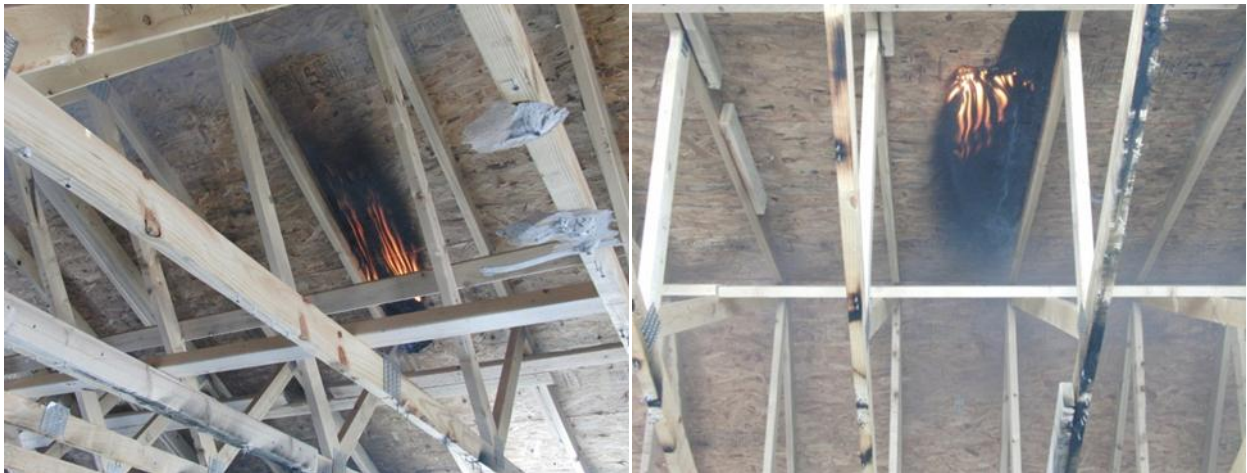
**Figure 194** Flaming of underside of roof deck   **Figure 195** Close up of flaming

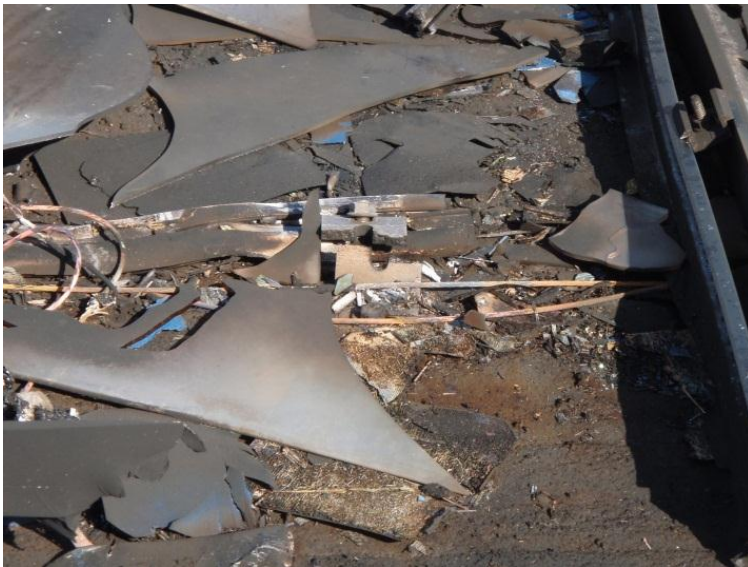
The modules were removed from the roof using the same precautions as done previous with the first test. An analysis of the modules showed that modules C1, D1, E1, F1, G1, D2, E2, F2, and G2 had been completely destroyed by the fire. The remaining modules were fully functional. It was noted that functional module B1 also had bare conductor exposed.

**Figure 197 Bare Conductors in Debris on Roof**
