# Four Firefighters Burned in Residential House Fire - Georgia

Mark B. McKinnon  
Daniel Madrzykowski

UL's Fire Safety Research Institute  
Columbia, MD 21045

Revised April 24, 2023

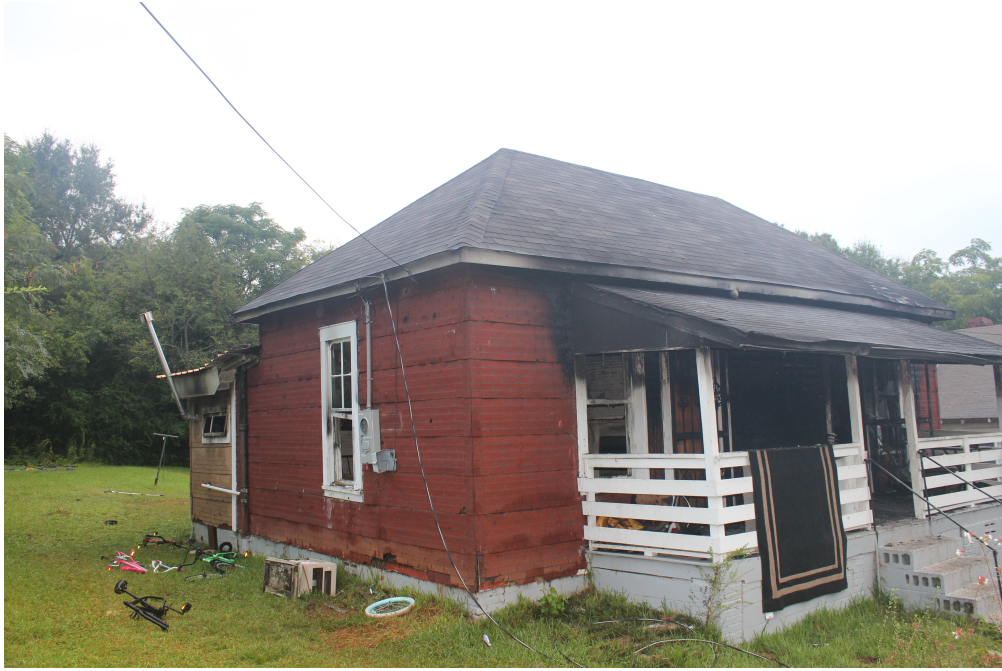
Figure 4.4: Photograph of the A/B corner of the structure.

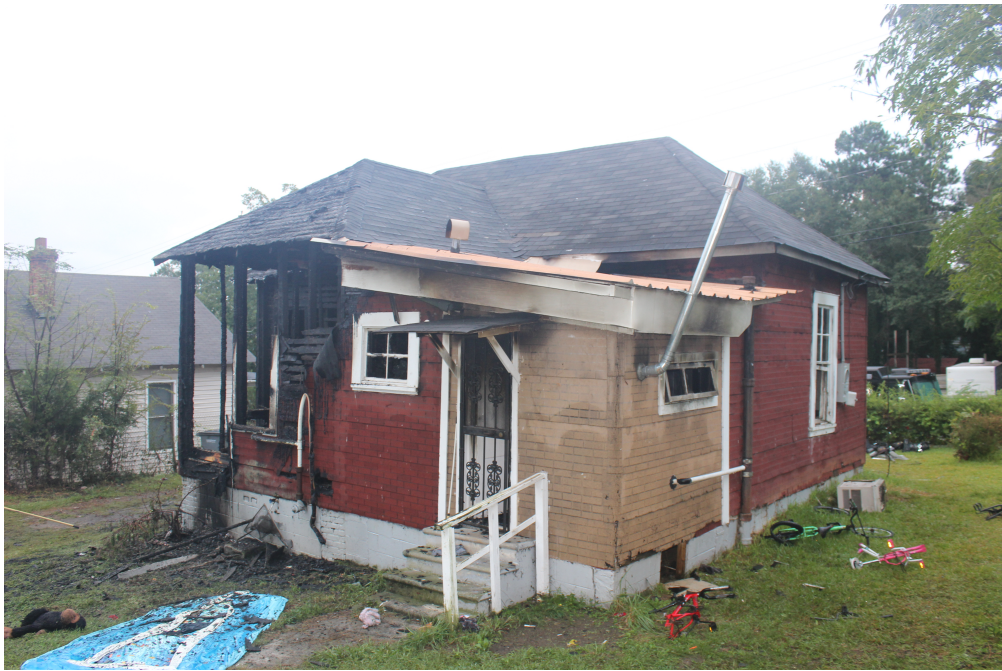
Figure 4.5: Photograph of the B/C corner of the structure.

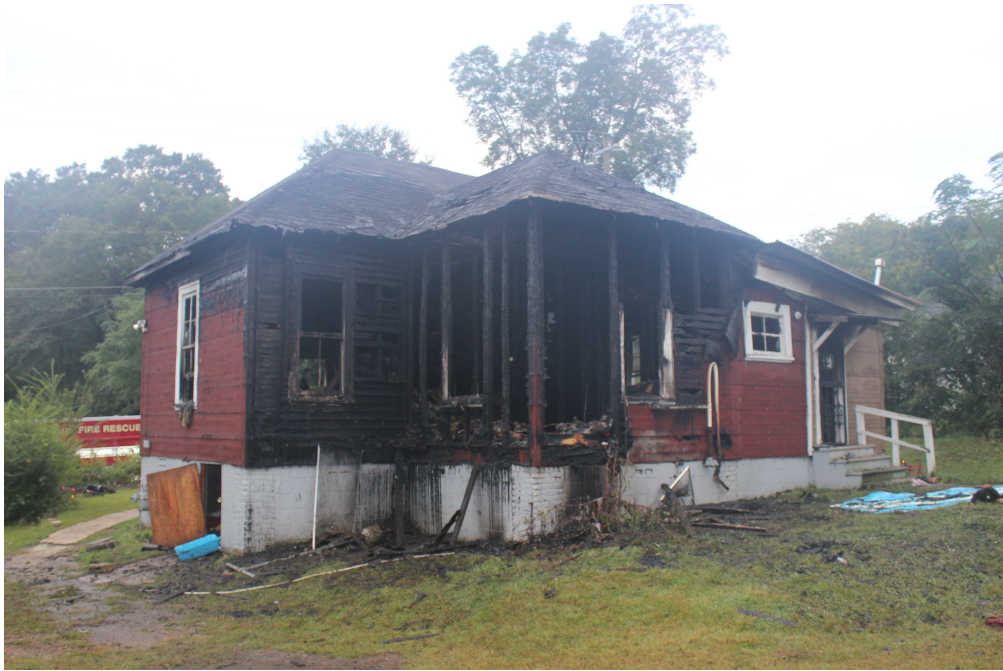
Figure 4.6: Photograph of the C/D corner of the structure.

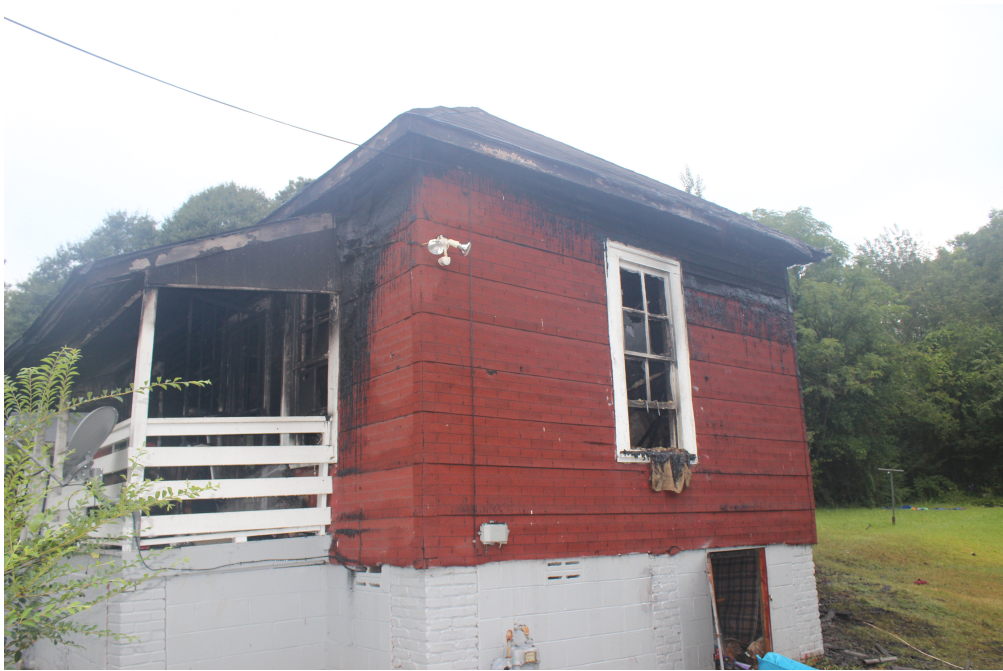
Figure 4.7: Photograph of the A/D corner of the structure.

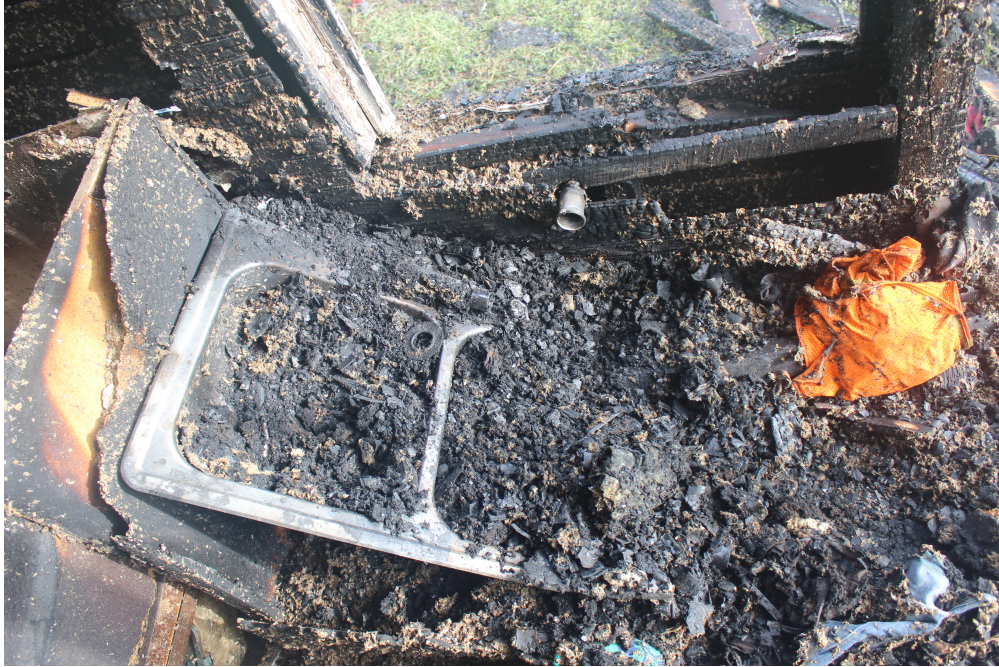
Figure 4.14: Photograph of the sink cabinet below the window on the side C wall.

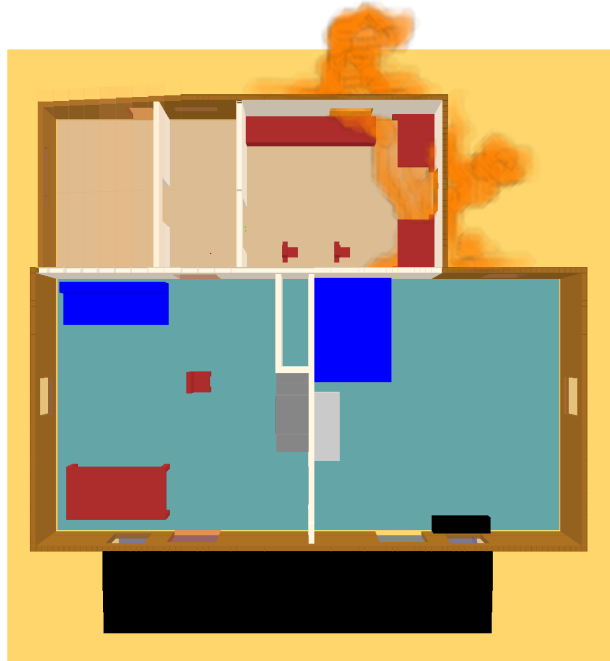
Figure 5.5 displays a plan view of the isosurfaces of a HRRPUV of 200 kW/m<sup>3</sup> at the approximate time the Search and Fire Control crews entered the structure. This isosurface may be interpreted as the approximate flame progression when the firefighters entered the structure. Figure 5.5 shows that the flames were confined to the interior of the kitchen, the exterior C and D sides of the kitchen, and the exterior C side of the bedroom at the time the firefighters made entry which is consistent with the model definition and the observations of the firefighters.

Figure 5.5: Approximate flame progression at firefighter entry

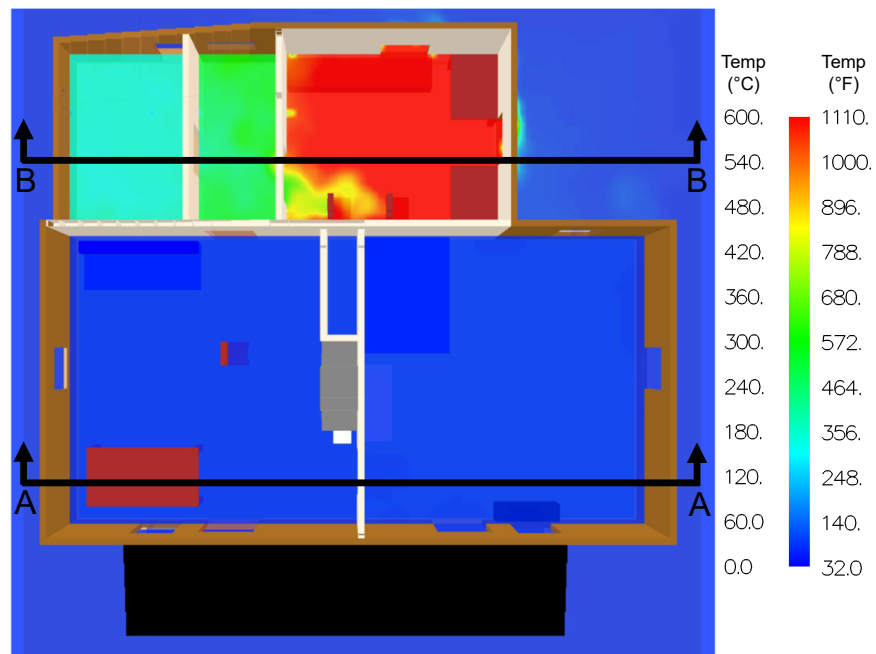
Figure 5.6 shows temperature contours of the residence at the approximate time of firefighter entry at an elevation of 35 in (0.9 m). This is the approximate height of a crawling firefighter. It is evident with the door between the living room and the hallway to the kitchen closed that the gas temperatures in the living room and bedroom were only slightly above ambient temperature while the temperatures in the kitchen, hallway, and bathroom were significantly elevated. These temperatures are consistent with firefighter observations of visibility to their feet in a standing position and the feeling of little heat within the bedroom and living room.

Figure 5.6: Gas temperatures at the time of firefighter entry at an elevation of 35 in (0.9 m). Solid black lines indicate locations of cross-sections.

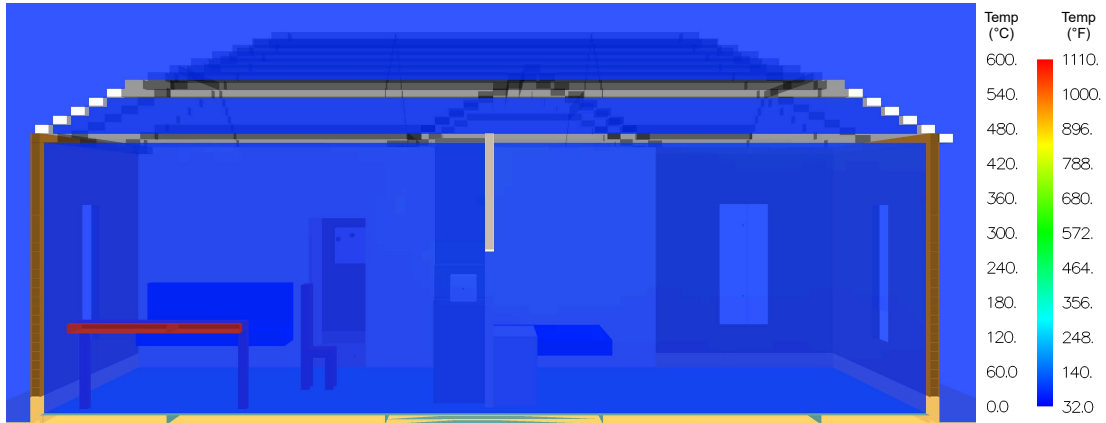
floor to ceiling in the bedroom and living room at the time of firefighter entry were in the range of 32°F (0°C) to 140°F (60°C). These temperatures are consistent with the observations from the Search crew. At the same time, the temperatures throughout the kitchen were above 1112°F (600°C) as shown in Figure 5.8. As a result of flow through open doorways from the kitchen into the hallway and from the hallway into the bathroom, the temperature in the bathroom was in the range of 248°F (120°C) to 356°F (180°C).

Figure 5.7: Gas temperatures in the bedroom and living room at the time of firefighter entry

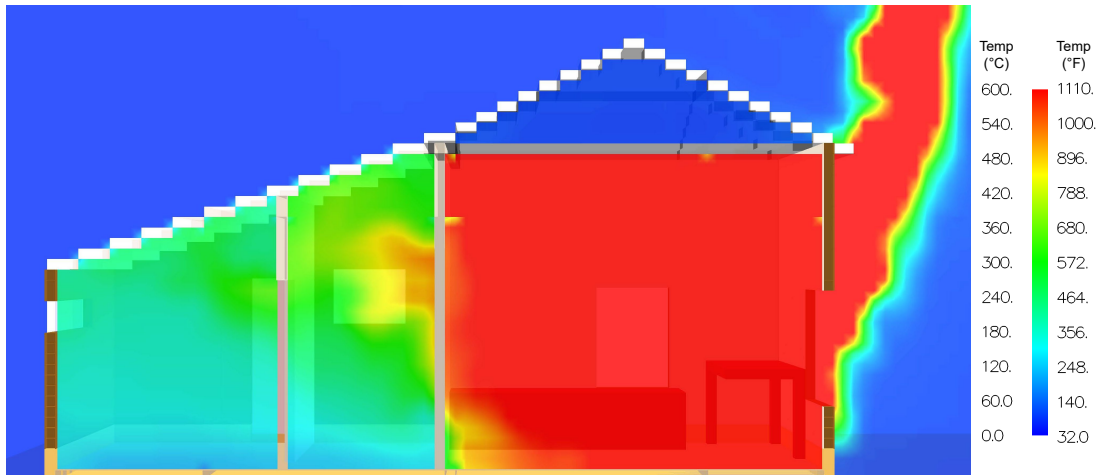
Figure 5.8: Gas temperatures in the bathroom and kitchen at the time of firefighter entry

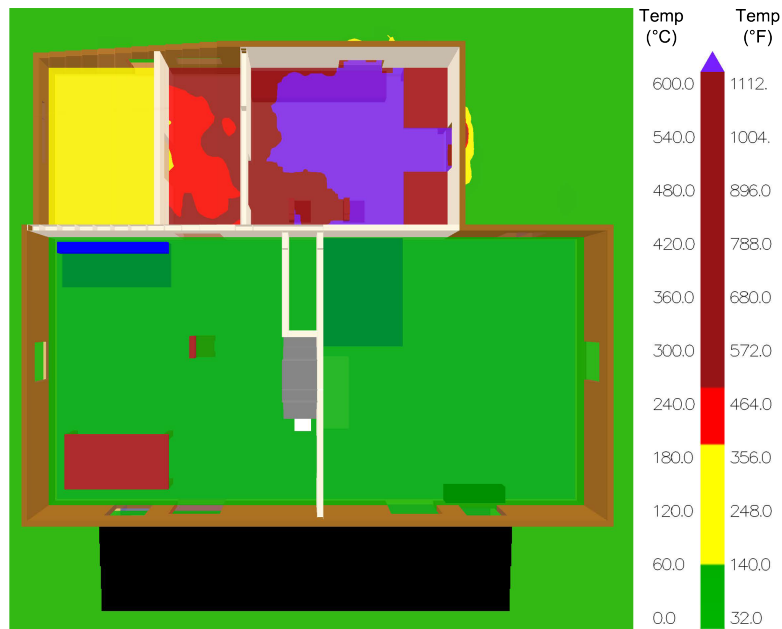
Figure 5.9 displays a plan view of the structure with temperature contours at an elevation of 35 in (0.9 m) colored according to the previously defined thermal operating classes at the approximate time the Search and Fire Control crews entered the structure. Consistent with the accounts by the Search and Fire Control crews, the bedroom and living room were in Routine thermal operating class. The kitchen had reached flashover conditions and was in the Emergency III and Emergency II class, while the hallway was in the Emergency I and Emergency II classes, and the bathroom was in the Ordinary class.

Figure 5.9: Gas temperatures colored according to thermal operating classes at the time of firefighter entry

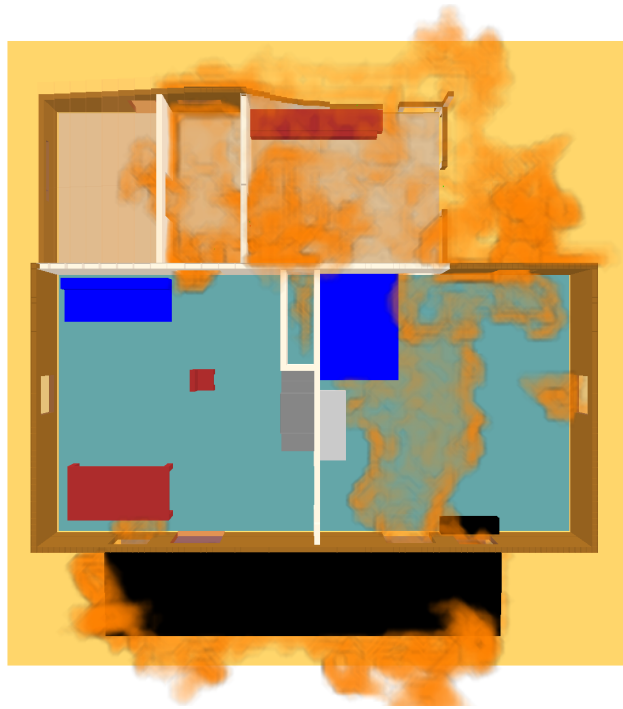
Figure 5.10 displays the plan view of the residence with isosurfaces of HRRPUA generated when the bedroom was completely involved in the fire after flame spread from the exterior of side C of the bedroom into the bedroom through the window opening. The image is from the approximate time of the first Mayday call.

Figure 5.10: Approximate flame progression at the time of the Mayday call

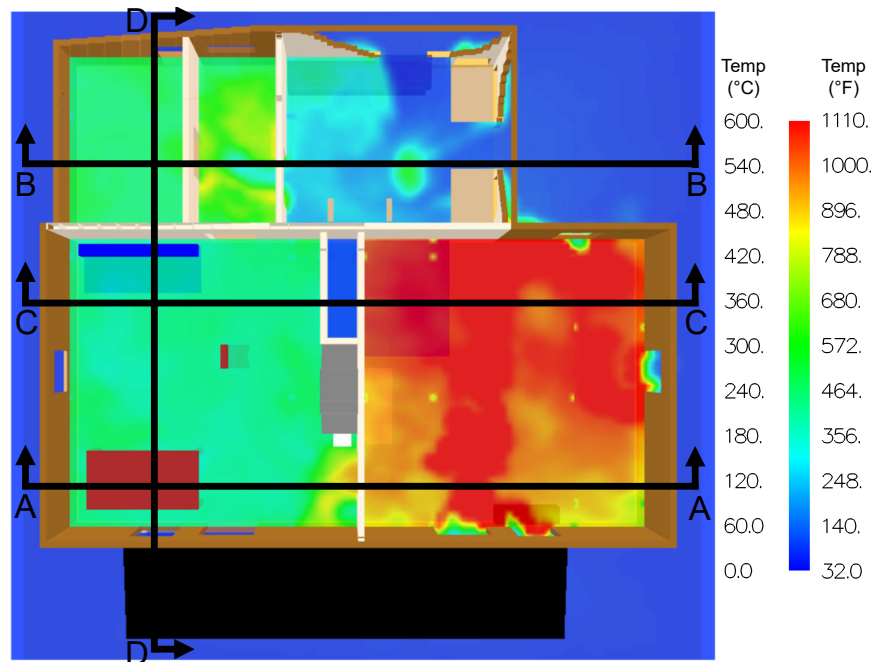
Figure 5.11 displays temperature contours from throughout the structure at the approximate time of the first Mayday call at an elevation of 35 in (0.9 m). At this elevation, temperatures throughout the bedroom exceeded 896°F (480°C), temperatures in the living room were in the range of approximately 356°F (180°C) to 464°F (240°C), and the temperatures in the bathroom were in the range of 464°F (240°C) to 572°F (300°C). The accounts from involved firefighters include that E1 Lt entered the bathroom after the hose burned through and closed the door behind him. The post-fire walk through revealed large portions of the upper half of the door had burned away, but it is unclear when in the timeline that occurred. The closed bathroom door was represented in the simulations but burning away of the door was not explicitly represented, and the temperatures indicated in the figures may be lower than those that E1 Lt actually experienced in the bathroom.

Figure 5.11: Gas temperatures at the time of the first Mayday call at an elevation of 35 in (0.9 m). Solid black lines indicate locations of cross-sections.

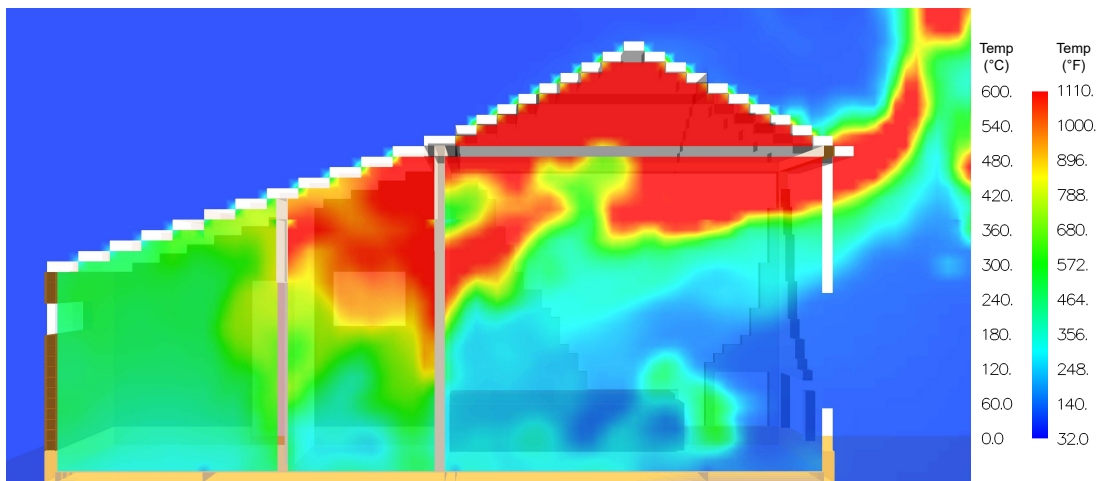
The cross-sections indicated in Figure 5.11 are displayed in the following figures. The cross-section through the bedroom and living room (A-A) is displayed in Figure 5.12. The cross-section through the kitchen, the hallway, and the bathroom (B-B) is displayed in Figure 5.13. The temperatures throughout the bedroom at the first Mayday call were above 480°C (896°F). Temperatures at elevations below approximately 47 in (1.2 m) in the living room and the bathroom were less than 240°C (464°F) and below approximately 35 in (0.9 m) were less than 180°C (356°F) at the time of the first Mayday call. 47 in (1.2 m) typically corresponds to a low squat position which E1 Lt may have been in while searching for egress from the bathroom.

Figure 5.13: Gas temperatures in the bathroom and kitchen at the time of the first Mayday call

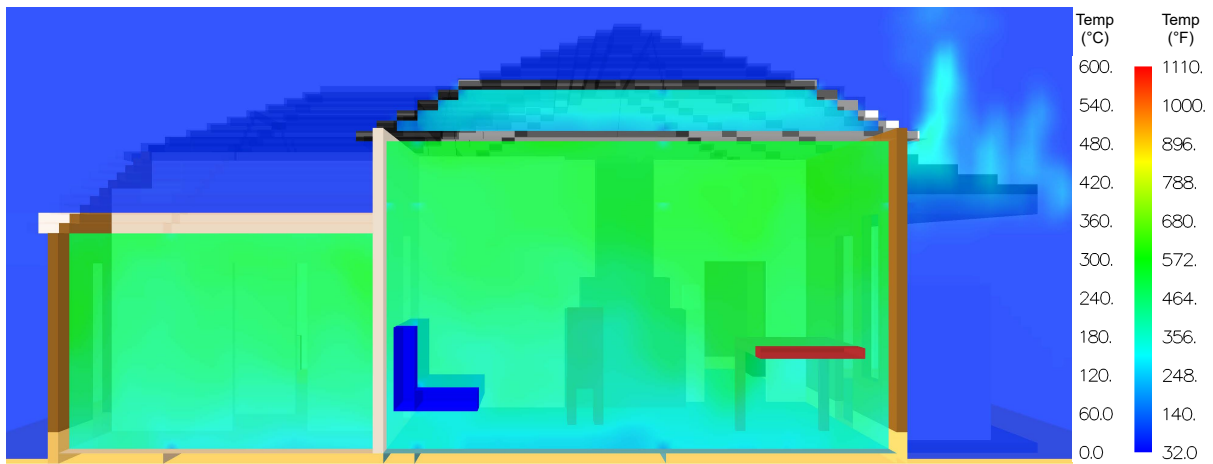
The accounts from the Search crew place them in the BC corner of the living room at the time they made the Mayday call. Figure 5.14 displays the temperature contours at side C of the living room and bedroom (C-C in Figure 5.11) and Figure 5.15 displays temperature contours through the bathroom and living room (D-D in Figure 5.11) at the time of the first Mayday call. At the approximate location of the Search crew when the first Mayday call was made, the gas temperatures were consistent with those in the front of the living room. The temperatures at 47 in (1.2 m) elevation were approximately 464°F (240°C) and less than 356°F (180°C) below 35 in (0.9 m) elevation. The temperatures were slightly lower at the same elevation moving closer to the front of the living room (to the right in Figure 5.15). Based on the condition of the turnout gear, it does not appear that the gear was exposed to temperatures in excess of 500°F (260°C) for long periods of time, so these temperatures are consistent with the available information.

Figure 5.15: Gas temperatures on side B of the bathroom and living room at the time of the first Mayday call

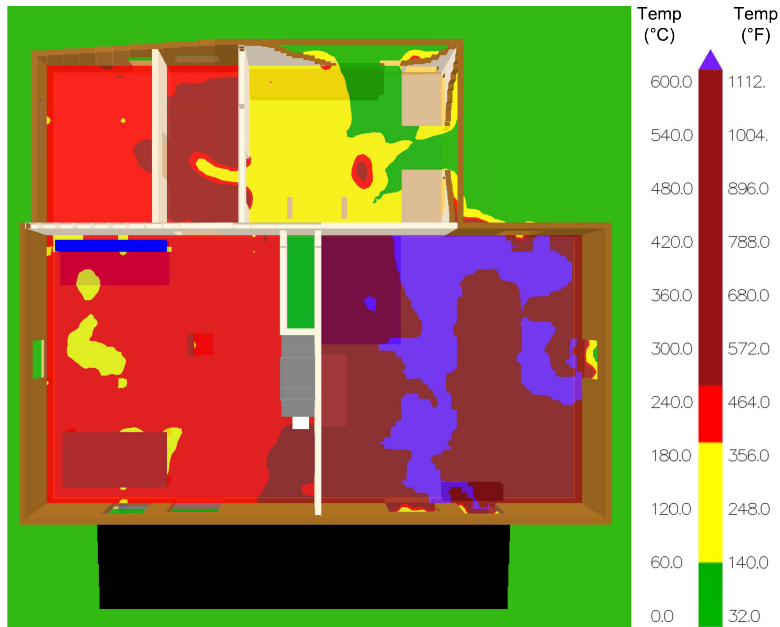
Figure 5.16 displays a plan view of the structure with temperature contours at an elevation of 35 in (0.9 m) colored according to the thermal operating classes at the time of the first Mayday call. The bedroom had reached post-flashover conditions and fire had spread back to the kitchen prior to the first Mayday call. According to the analysis, much of the living room was in the Emergency I operating class with some areas in the Ordinary operating class at an elevation consistent with the firefighters squatting or kneeling. This indicates that there were local areas within the hallway and living room where gas temperatures were above those for which the PPE was designed and explains why the Fire Control crew was approaching a point where the heat was intolerable and why they were searching for an exit.

Figure 5.16: Gas temperatures colored according to thermal operating classes at the time of the first Mayday call

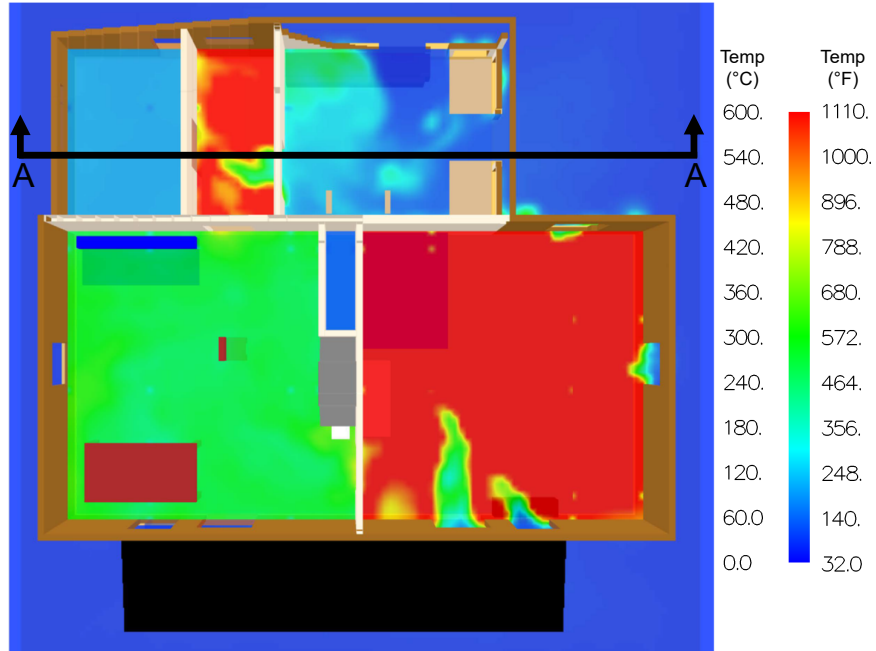
After the first Mayday call, temperatures throughout the residence continued to increase and resulted in the Search crew making a Mayday call approximately two minutes after the first Mayday call. Figure 5.17 shows a plan view of the residence with temperature contours at an elevation of 35 in (0.9 m). Exterior fire attack had commenced between the first Mayday call and the second Mayday call, so temperatures displayed in the living room and bedroom in the figure are likely higher than those that were observed during the actual Mayday situation.

The state of the bathroom door in the simulation changed from opened to closed between the first and second Mayday calls to maintain consistency with the accounts from the involved firefighters, and this is evident in Figure 5.17. The cross-section shown in Figure 5.17 is displayed in Figure 5.18. The temperatures from floor to ceiling in the bathroom in the simulation when the door was closed were in the range of 212°F (100°C) to 248°F (120°C). These temperatures indicate the door provided some safety from the thermal conditions in the burning areas of the residence until the door started to burn through.

Figure 5.17: Gas temperatures at the time of the second Mayday call at an elevation of 35 in (0.9 m). Solid black lines indicate locations of cross-sections.

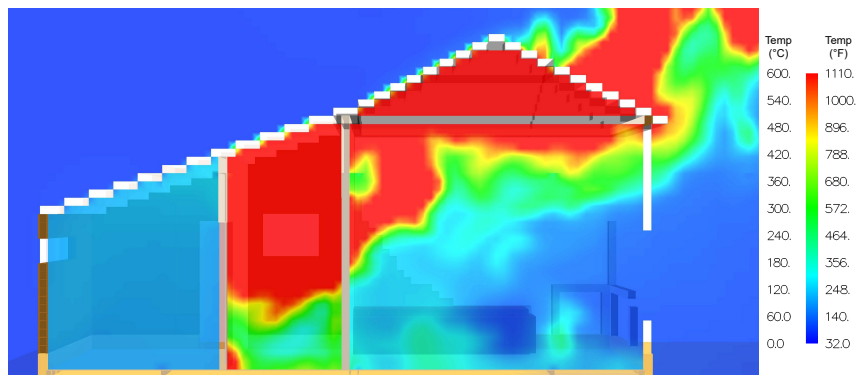
Figure 5.18: Gas temperatures at the time of the second Mayday call at an elevation of 35 in (0.9 m)

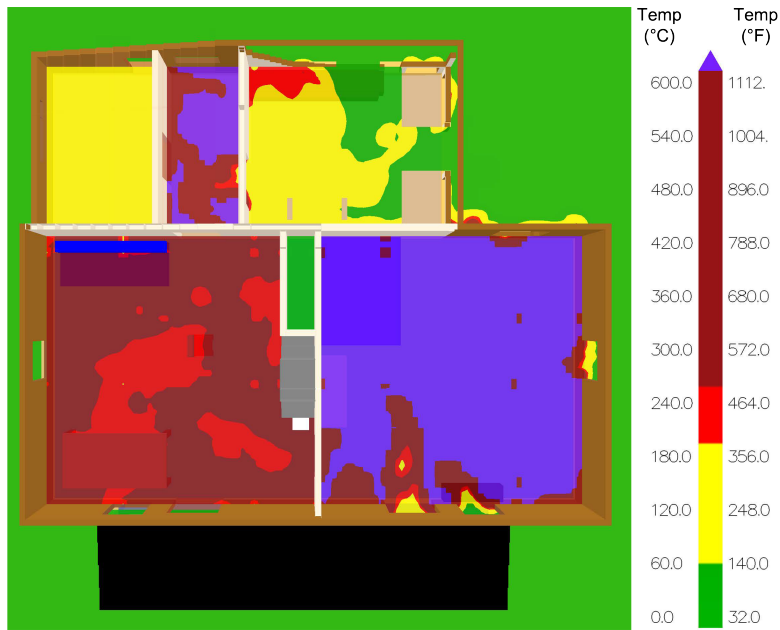
Figure 5.19 displays a plan view of the structure with temperature contours at an elevation of 35 in (0.9 m) colored according to the thermal operating classes at the time of the second Mayday call. Flashover conditions and the corresponding Emergency III operating class were evident in the bedroom and the hallway, which led to the second Mayday call. Between the first and second Mayday calls, higher temperature conditions developed in the living room, exemplified by Emergency I and Emergency II class conditions throughout the living room, and created a situation where evacuation was necessary to preserve the lives of the firefighters.

Figure 5.19: Gas temperatures colored according to thermal operating classes at the time of the second Mayday call

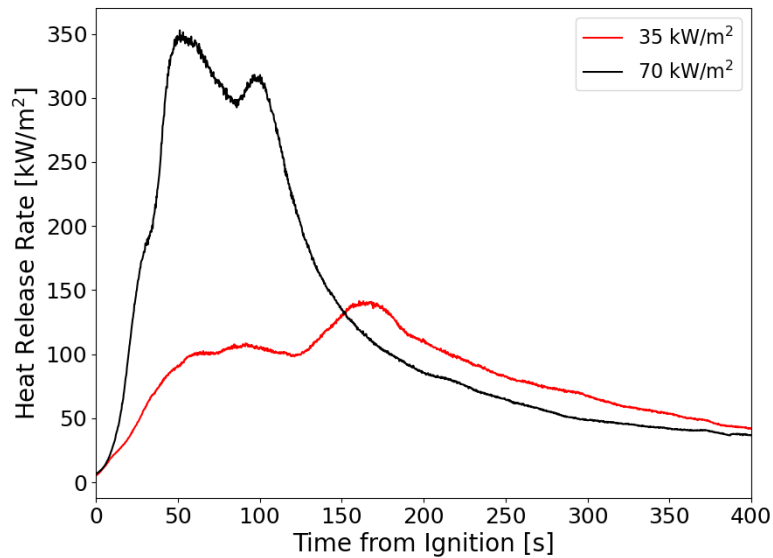
As is evident in the HRRPUA data measured with the cone calorimeter with an incident heat flux of 70 kW/m<sup>2</sup>, the heat release rate increased over approximately 50 s to a steady mean value of approximately 325 kW/m<sup>2</sup>. The HRRPUA remained relatively steady for 70 s and gradually decreased over the next 300 s. To represent this behavior as closely as possible in the model, the material was defined with a steady HRRPUA of 325 kW/m<sup>2</sup> after the ignition temperature was achieved. The ignition temperature could not be directly inferred from the cone calorimeter data, so the ignition temperature was assumed as a relatively low value to ensure flame spread within the model that was consistent with the observations at the scene. It is expected that a heat flux higher than 70 kW/m<sup>2</sup> incident to the asphalt siding was possible due to flame impingement, although no data were available on the HRRPUA measured in higher incident heat flux experiments. The relatively low ignition temperature defined in the model was intended to compensate for the potential higher HRRPUA that would be expected from the asphalt siding exposed to higher incident heat fluxes. The density of the asphalt siding was directly measured and the thermal conductivity, heat capacity, and emissivity were assigned values from the *Handbook of Fire Protection Engineering* [16].

Figure A.1: Heat release rate data collected from asphalt siding in cone calorimeter tests

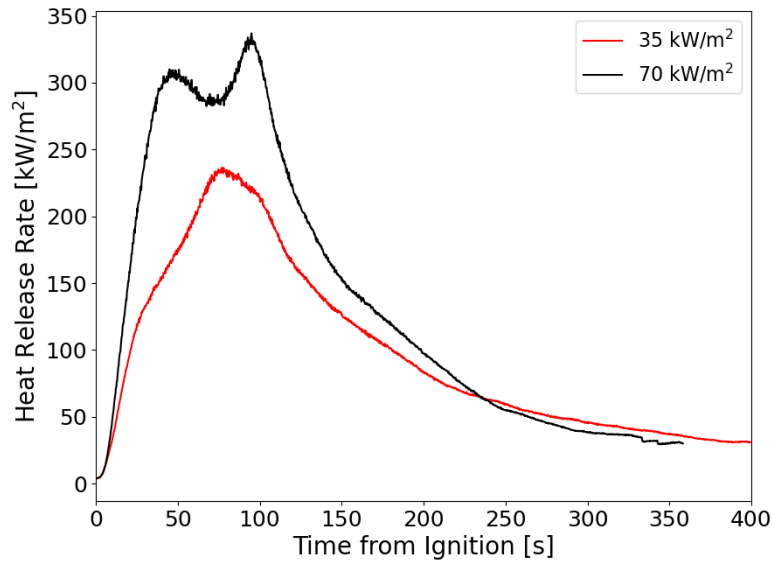
Figure A.2 shows the heat release rate data measured for the carpet tile. The mean time to ignition for the carpet tiles when exposed to a total heat flux of 35 kW/m<sup>2</sup> was approximately 95 s and the mean time to ignition when exposed to a total heat flux of 70 kW/m<sup>2</sup> was approximately 13 s. The carpet acted as a target for ignition and contributed to late-stage growth of the fire. The heat flux incident from the hot gas layer to the floor at the onset of flashover is typically approximated as a minimum of 20 kW/m<sup>2</sup>. The density of the carpet samples collected from the scene was

Figure A.2: Heat release rate data collected from carpet tiles in cone calorimeter tests

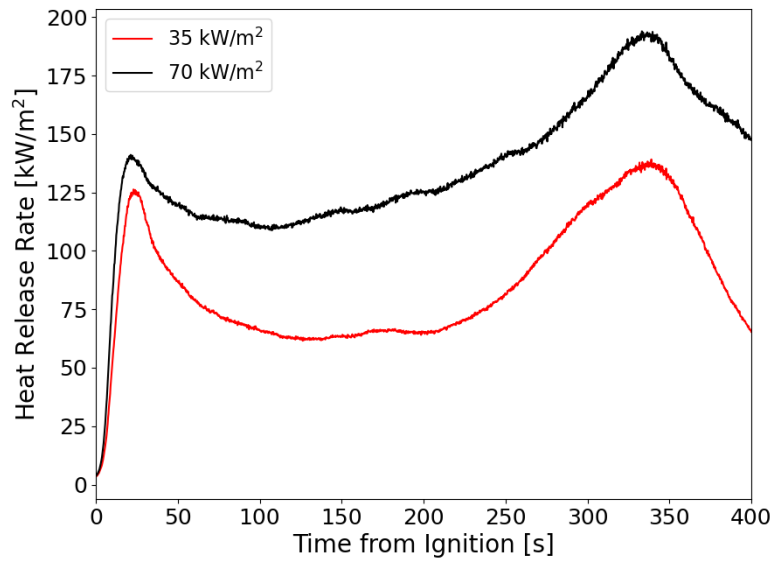
Figure A.3 shows the heat release rate data measured for the painted beadboard. The mean time to ignition for the beadboard when exposed to a total heat flux of  $35 \text{ kW/m}^2$  was approximately 60 s and the mean time to ignition when exposed to a total heat flux of  $70 \text{ kW/m}^2$  was approximately 7 s. The beadboard and other wood products in the structure were some of the first items ignited as well as targets in later stages of the fire. The density of the beadboard was measured directly from the samples collected at the scene. The thermal conductivity, heat capacity, emissivity, and ignition temperature were defined according to values for various painted and unpainted wood samples presented in the *Handbook of Fire Protection Engineering* [16]. The properties for the wood beadboard were assigned to all wood products defined in the model because the minor variations between wood species and products was assumed to be inconsequential.

Figure A.3: Heat release rate data collected from beadboard in cone calorimeter tests

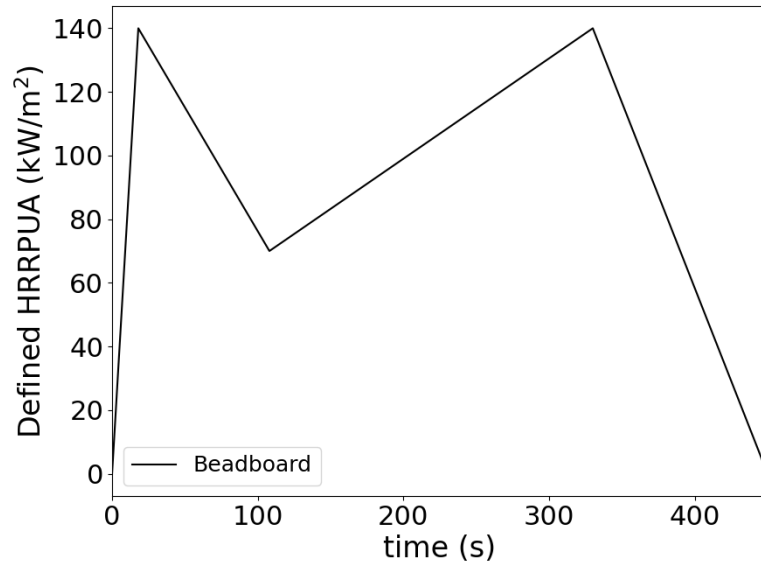
The ceiling and walls were lined with the painted beadboard and so it is likely that the beadboard experienced a wide range of incident heat fluxes and charred during the fire. Charring would change the thermal properties of the bulk material and result in an overall decrease in the HRRPUA of the material. The HRRPUA in the model was defined to be similar to the data collected in the cone calorimeter with an incident heat flux of  $35 \text{ kW/m}^2$ . The HRRPUA as defined in the model is plotted in Figure A.4.

Figure A.4: Model heat release rate definition for painted beadboard

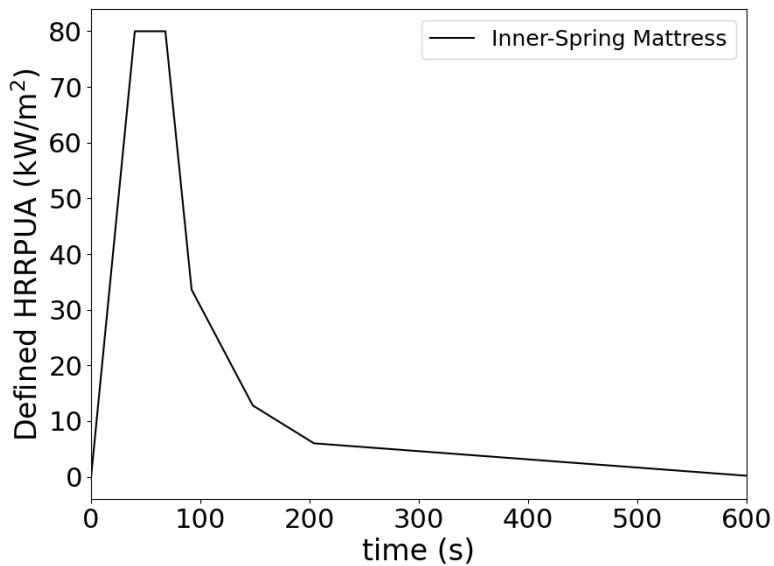
inner-spring mattress tested to assess the combustion behavior of upholstered furniture [26]. The defined HRRPUA as a function of time is plotted in Figure A.5.

Figure A.5: Defined HRRPUA for the mattress
