## Firefighter Safety and Photovoltaic Installations Research Project

### **Robert Backstrom**

### **David A. Dini, P.E.**

Issue Date: November 29, 2011

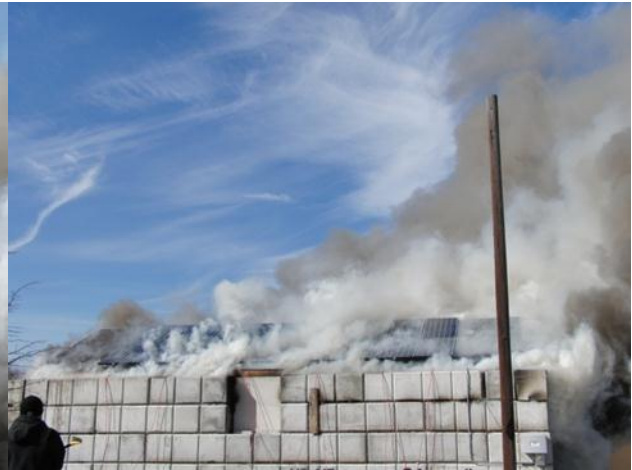
Figure 101 illustrates the ignition and burning of the roof deck. Figure 102 provides a view of the array and roof assembly deflection. Figure 103 illustrates the roof and array prior to structural collapse. Figure 104 illustrates the test structure after collapse and suppression.

**Figure 102 Modules sagging**

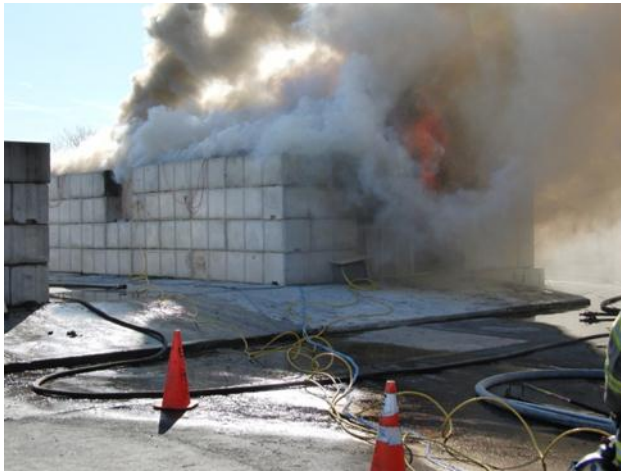
**Figure 125 - Flames developing**

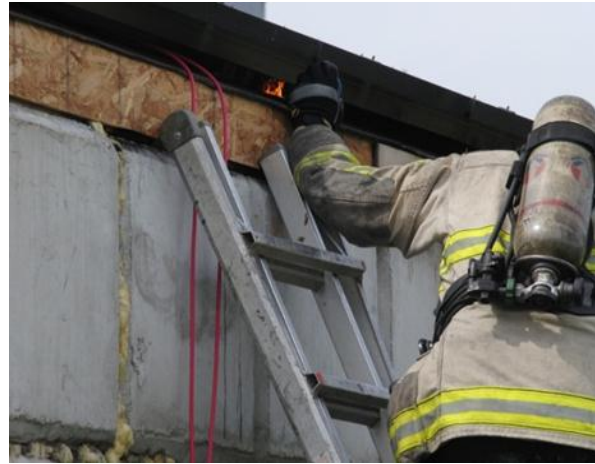
**Figure 172 Igniting pine straw**

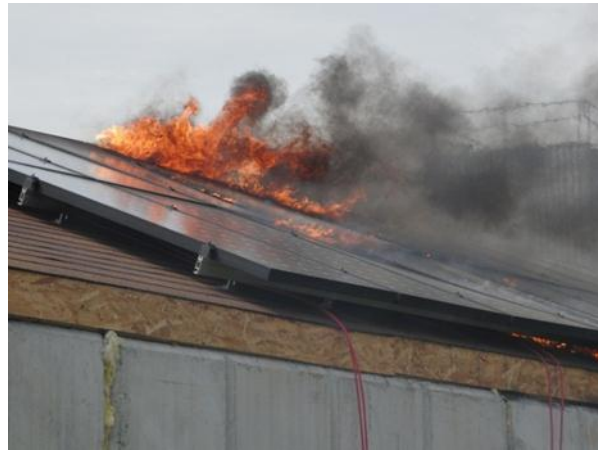
**Figure 174 Flames spreading**

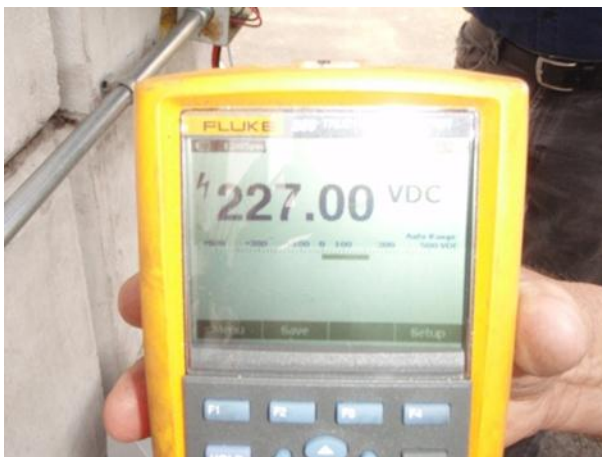
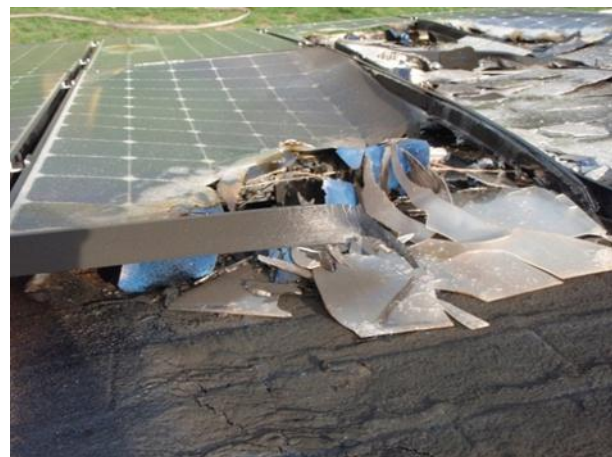
Disassembling the array after the fire presented some challenges to the PV installer. Some options the installer considered was waiting until after dark, or using a tarp to block illumination to the modules. With the DC disconnect opened, the installer measured about 2 amps of current still within some portions of the array. This was likely the result of multiple ground faults. In the end, the installer chose to use electrical voltage rated rubber gloves and an insulated wire cutter to begin cutting wires to the modules on the roof. The rubber gloves were needed because blind reaching under a damaged module was often needed to get access to these wires, and it was not immediately known if the wires were damaged and bare conductor was present. Also, it was possible that frames of modules and/or sections of the aluminum mounting rail could be energized as the grounding system became compromised during the fire. The installer also used a hand-held voltmeter to periodically check voltages on exposed conductive parts. As each module was disassembled from the rail, and cut free from the string, it was handed down to a person at ground level for safe storage. An analysis of the modules on the ground showed that modules C1, C2, D1, D2, and E1 had been completely destroyed by the fire. Module E2 had a damaged bus and was producing about half rated voltage and current. The remaining modules were fully functional. Figure 181 and Figure 182 illustrate the extent of damage to the array and a voltage produced by the damaged modules.

Figure 181 Installer identifies hazardous voltage      Figure 182 Assessing Damaged Modules

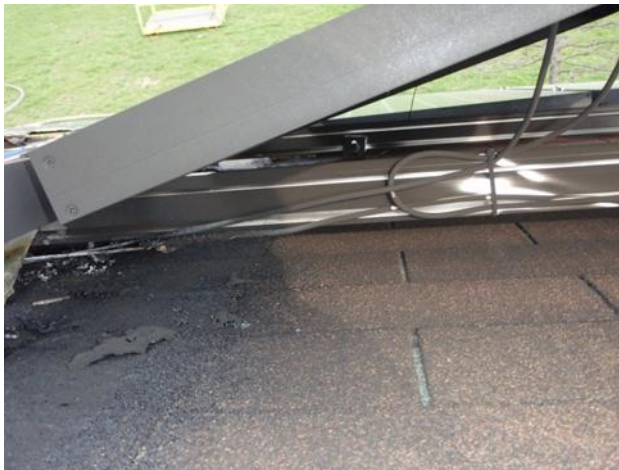
**Figure 184 Looking under module for dangers**

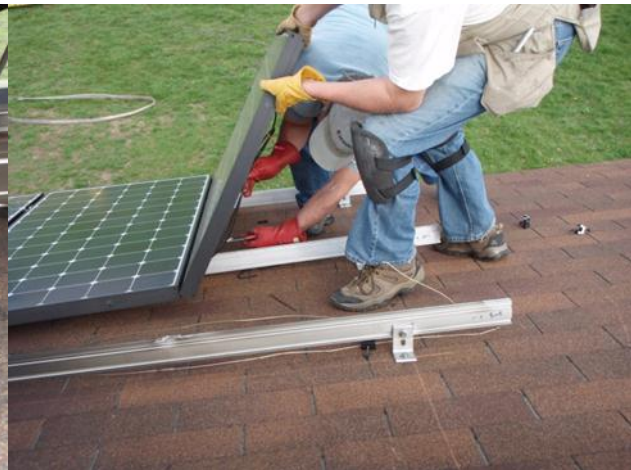
**Figure 185 cutting leads**

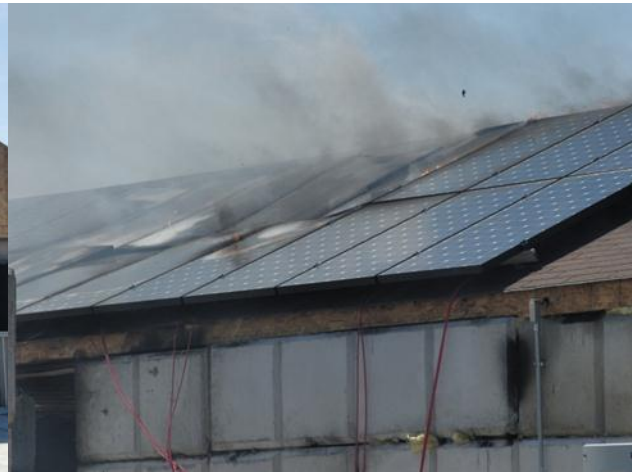
**Figure 190 Smoke after pine straw burns**
